Production status of GEM chambers for the CMS Experiment at Large Hadron Collider

Roberto Campagnola, for CMS collaboration

CMS Muon System for High Luminosity LHC

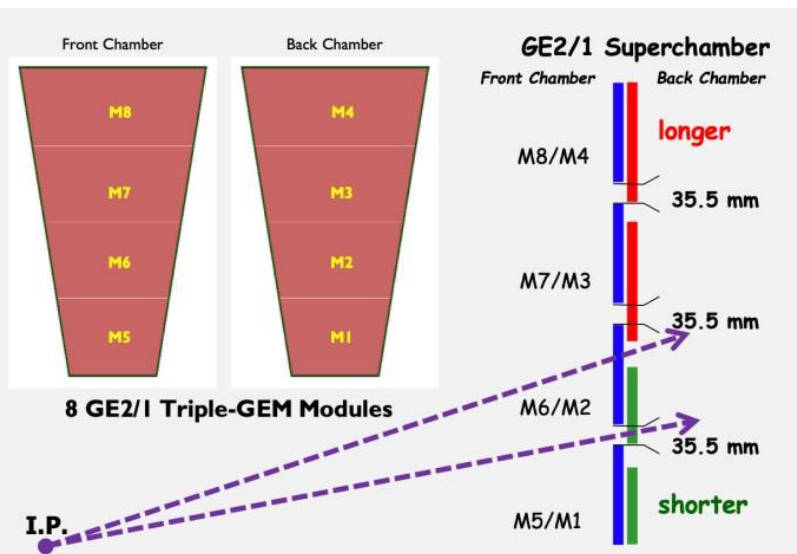
Schema dei 4 tipi di moduli

The detector consists of a **stack of three GEM foils inserted between a drift electrode and a readout electrode**, held together by an external frame. Inside the volume, a mixture of Ar/CO₂ (70/30) is fluxed. The three GEM foils are stacked at their edges using thin internal frames. **GEM foils are segmented into strips to protect them from irreversible damage, reducing the energy released from a potential discharge.** The modules are divided into 12 sectors, each composed of 128 strips. Four modules of different sizes form a *chamber*. The construction of 72 chambers is planned (36 for each endcap).

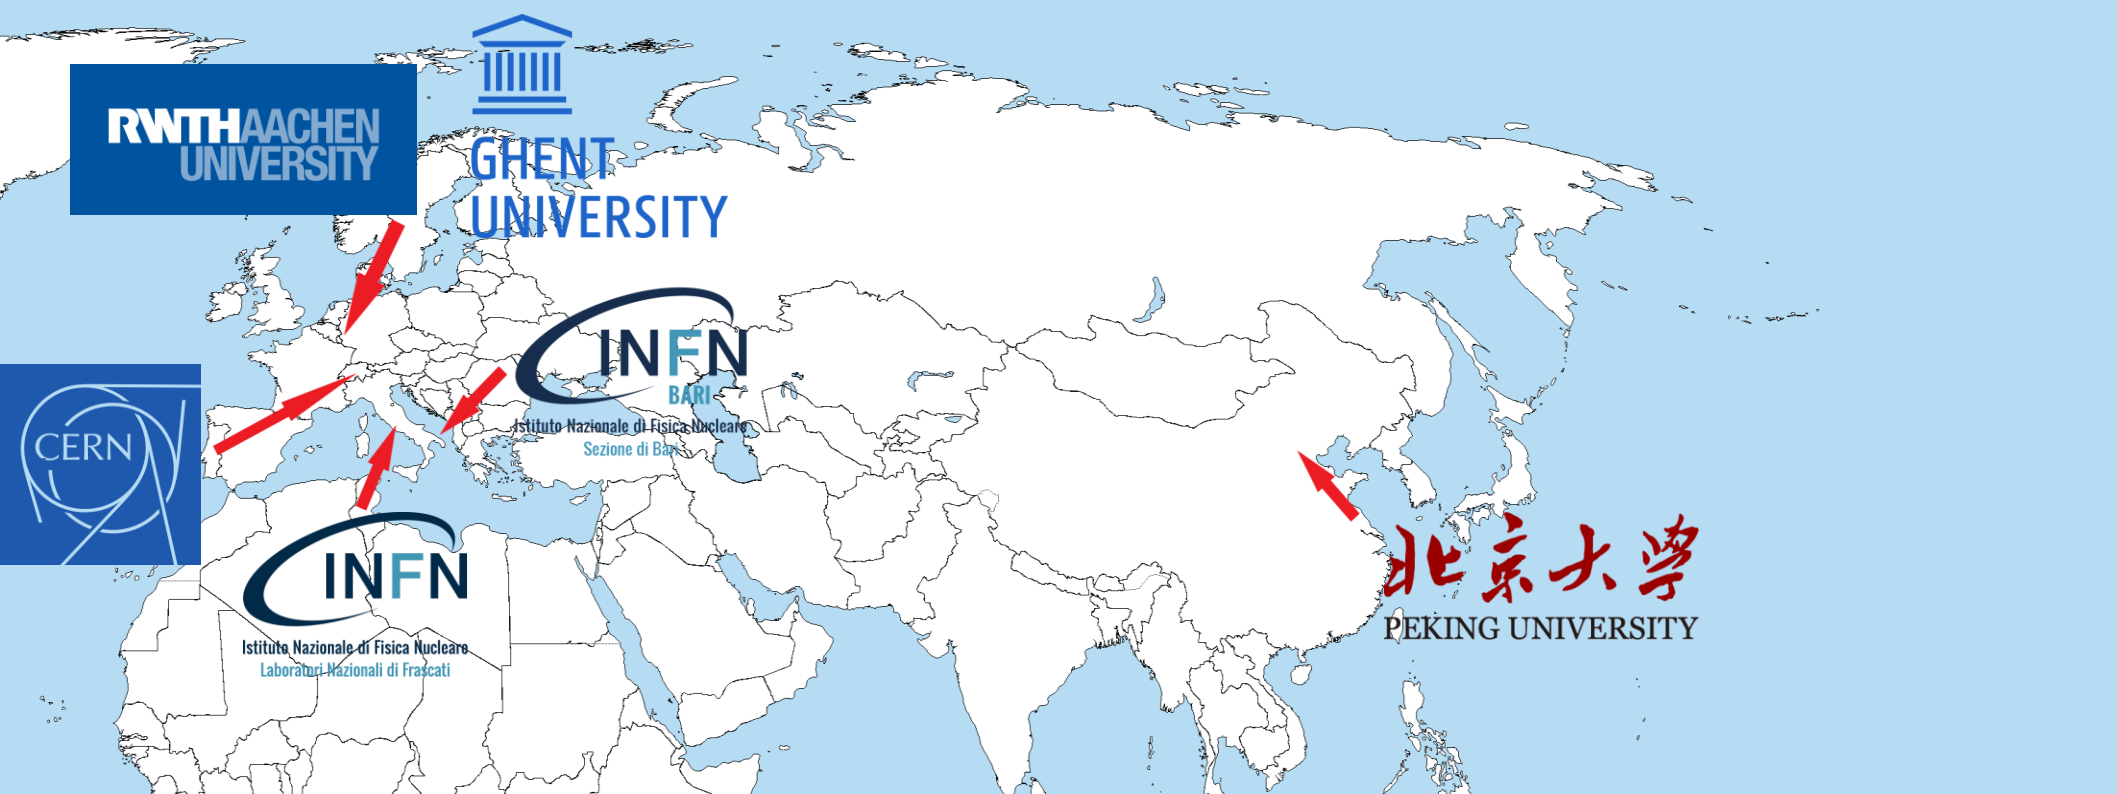
Distributed production across various institutions. All modules undergo quality control following predefined procedures, divided into 8 total phases.

- .QC1-2 CERN [Visual inspection and foils hv stability]
- .QC3-5 CERN and external production sites [Gas leak, circuit stability, gain and uniformity]
- .QC6-8 CERN [chamber stability test, connection test, cosmic test]

- .QC1: Foils visual inspection for: HV trace, SMD resistors, foils surface, PCB planarity
- .QC2: Foils HV stability control and leakage current.
- .Final impedance > 10 GΩ
- .Leakage current < 20 μA with HV between 100 - 600 V for 90 minutes in N₂
- .Leakage current < 2 μA with HV 600 V for 14 h in N₂

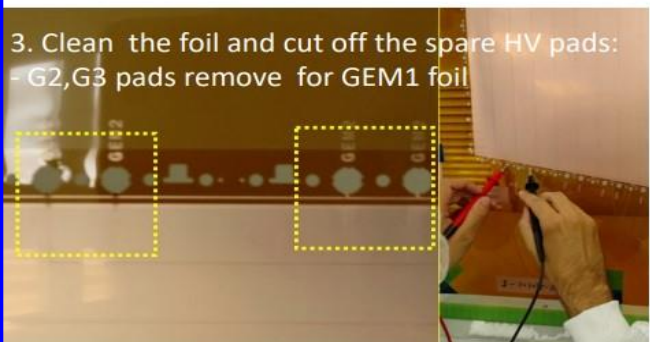
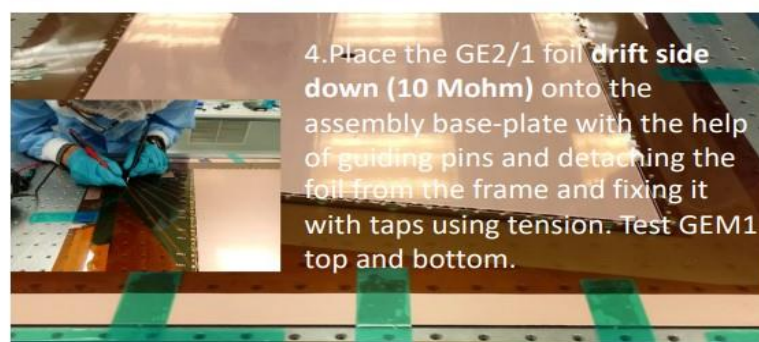
After QC2 is passed, foils are ready for module assembly, in three steps:

- .3 GEM foils stacking (1,6).
- .GEM stack moved on drift board, stretching to have uniform gaps between foils (7).
- .Closing with ROB (8).

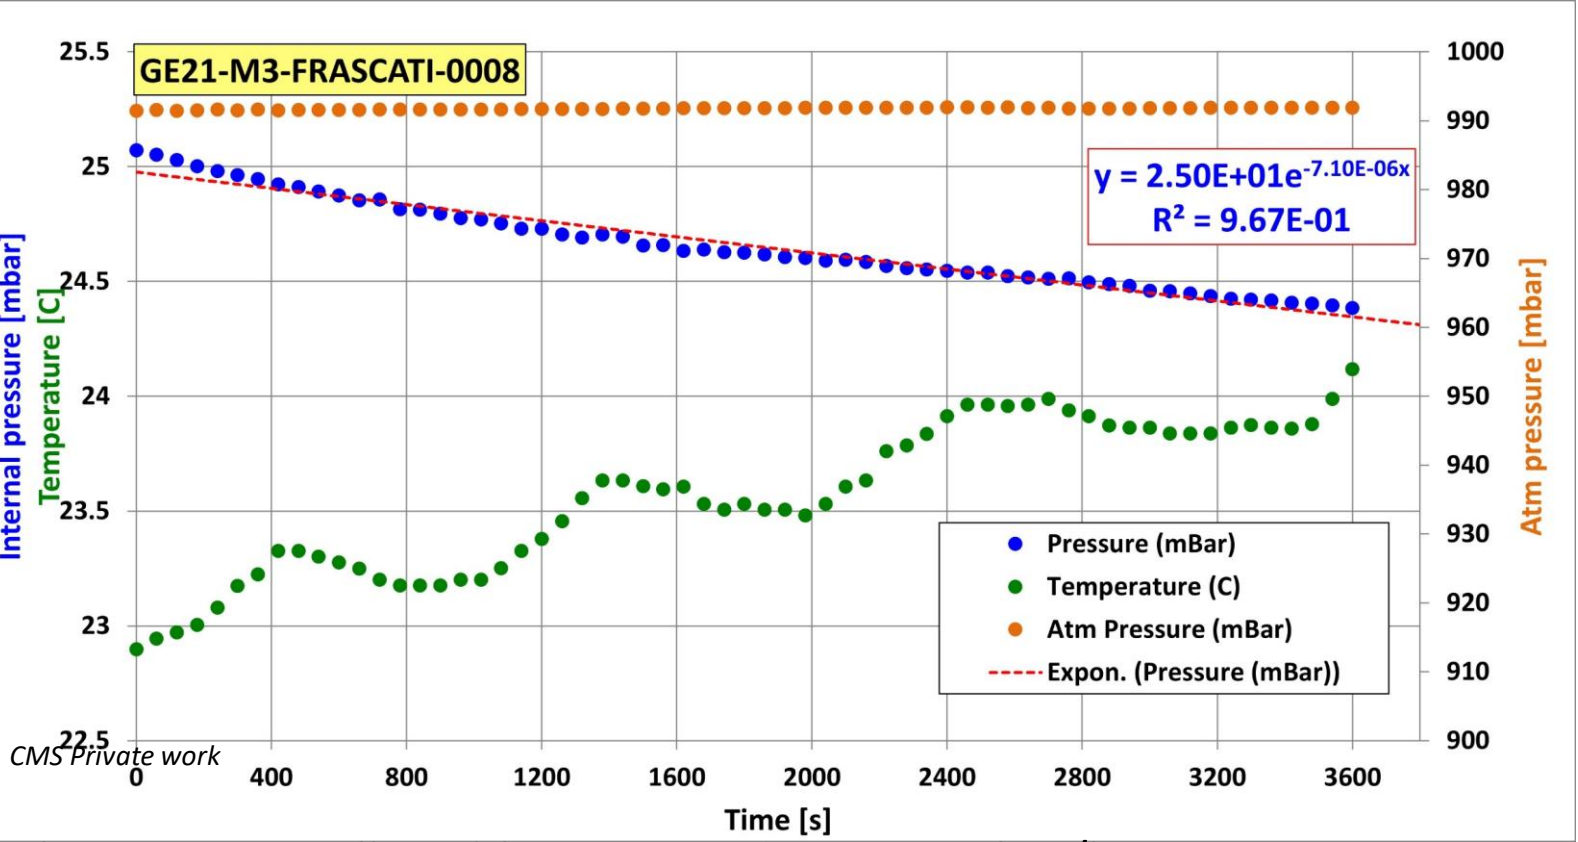
After assembly, the first test to be performed is the QC3 gas tightness check. The pressure drop inside the module is monitored as a function of time. Efficient gas tightness also prevents contamination from external source that may affect the detector performance (O₂, other electronegative elements and dust can compromise charge amplification and foils integrity).

Assuming constant detector volume during the test, time evolution of internal pressure is expressed by:

$$P_{int} = P_0 e^{-t/\tau}$$

The maximum allowable pressure drop is 7 mbar/h

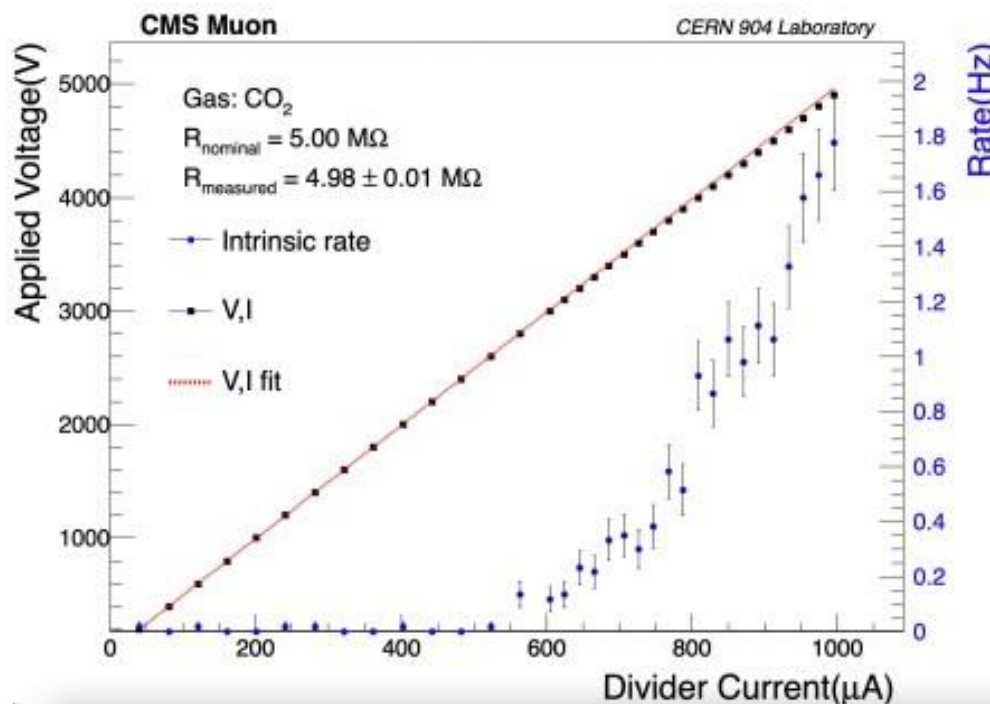
QC4 Result – I-V Linearity [4]

QC4 aims to establish the I-V characteristic of the detector to identify any malfunctions and defects in the HV circuit that powers the module.

The module is flushed with CO₂, powered up to 4900 V, and the current through the powering circuit is measured as a function of applied voltage. The test is considered successful if the I-V curve shows a linear behavior..

Test successful if **deviation less than 3%** .

Non-linearity would indicate a parasitic impedance, caused by a defect in the HV circuit or an issue with the GEM foils..
