# Characterization and Integration of Large Area SiPM Arrays at the NOA Facility

**By:** Federico Casadei,  
Samuel Habtemariam,  
Carmen Seoane,  
Sofia Paolilli Treonze,

# DarkSide-20k experiment

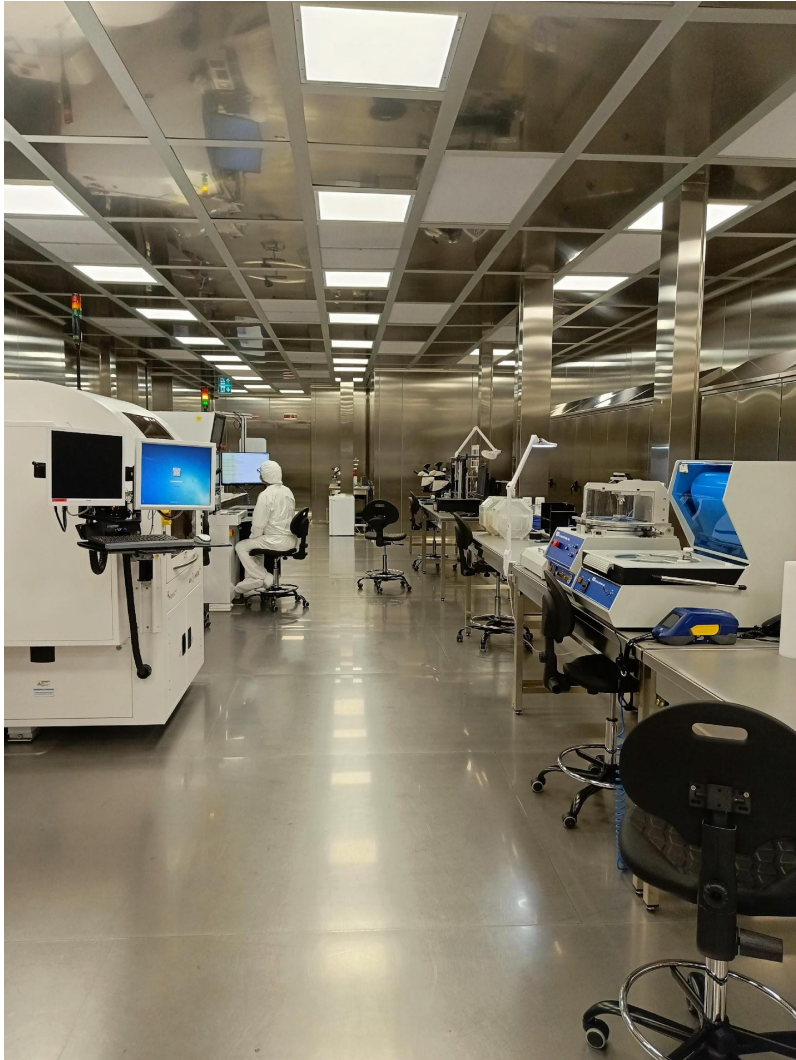
NOA is a clean room of ISO6 standard  
It became operational on February 2023  
NOA has two main areas:

- CR3 (350 m<sup>2</sup>) is devoted to the assembly of SiPMs, tiles, PDUs and respective tests
- CR2 (70 m<sup>2</sup>) devoted to integration of the optical planes

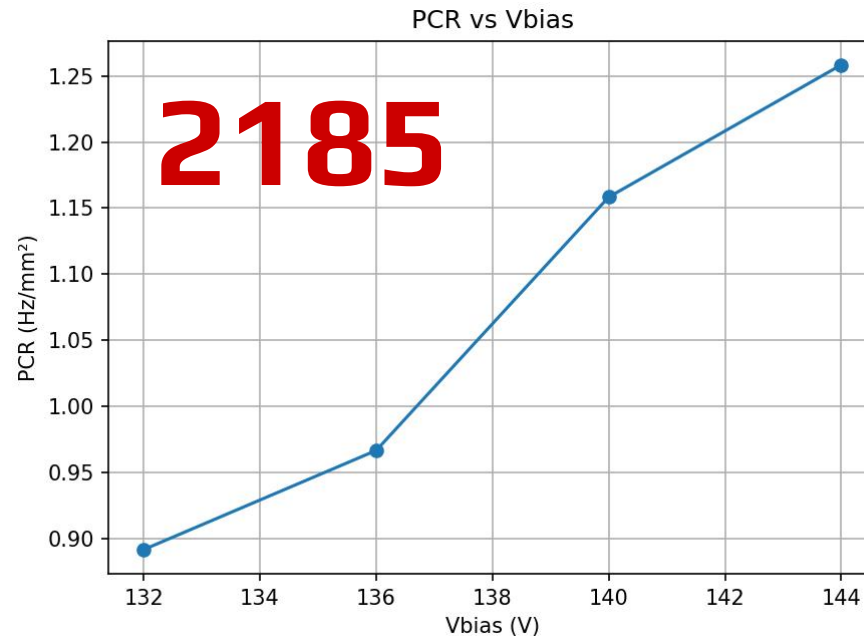
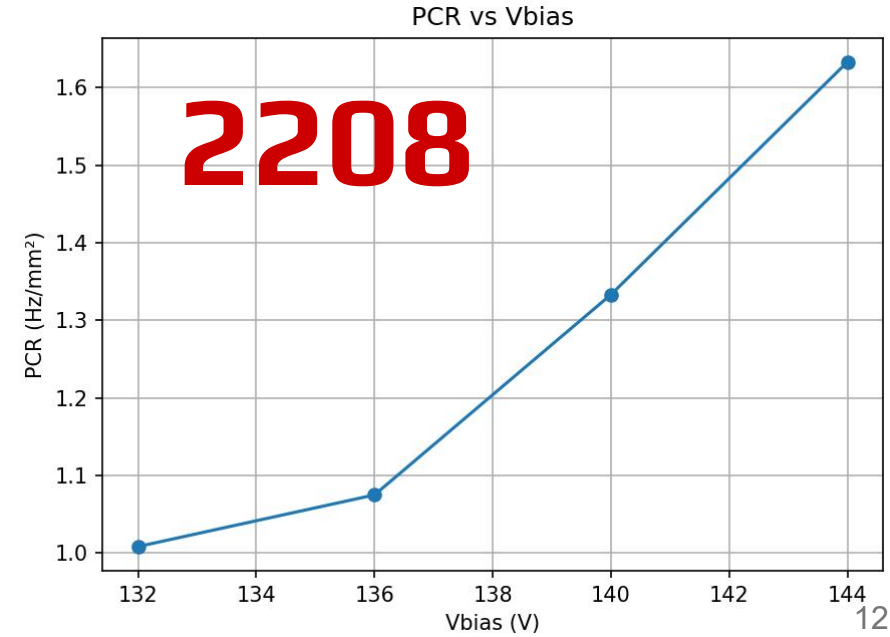
We checked the setup where the 2 high-PCR tiles were tested and both were measured at the same time in the same setup

We conclude there was a **light leak** in the setup

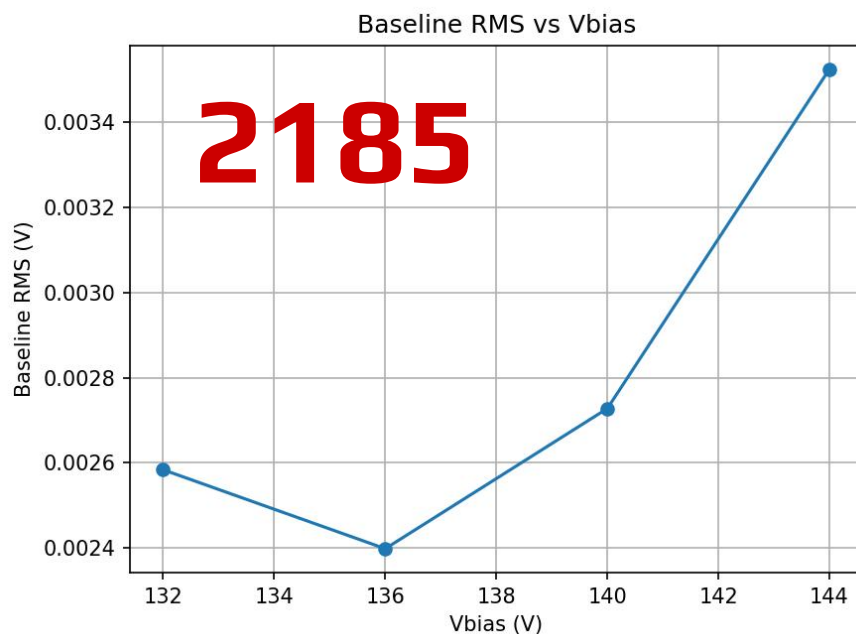
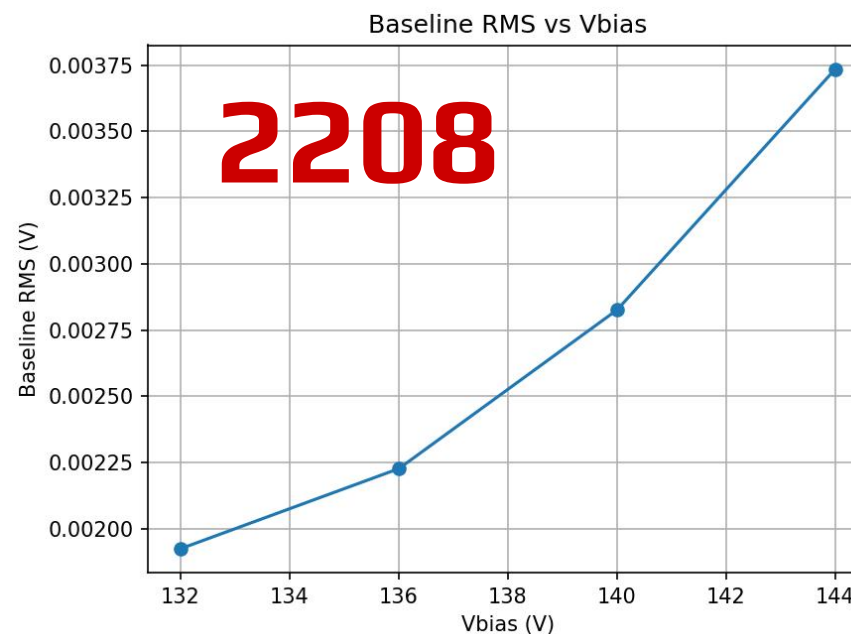
We conclude the RMS of the baseline is not a good estimator for the light leaks since there are only a few events of PCR

More analysis needs to be done and new observables have to be defined to be able to identify light leaks

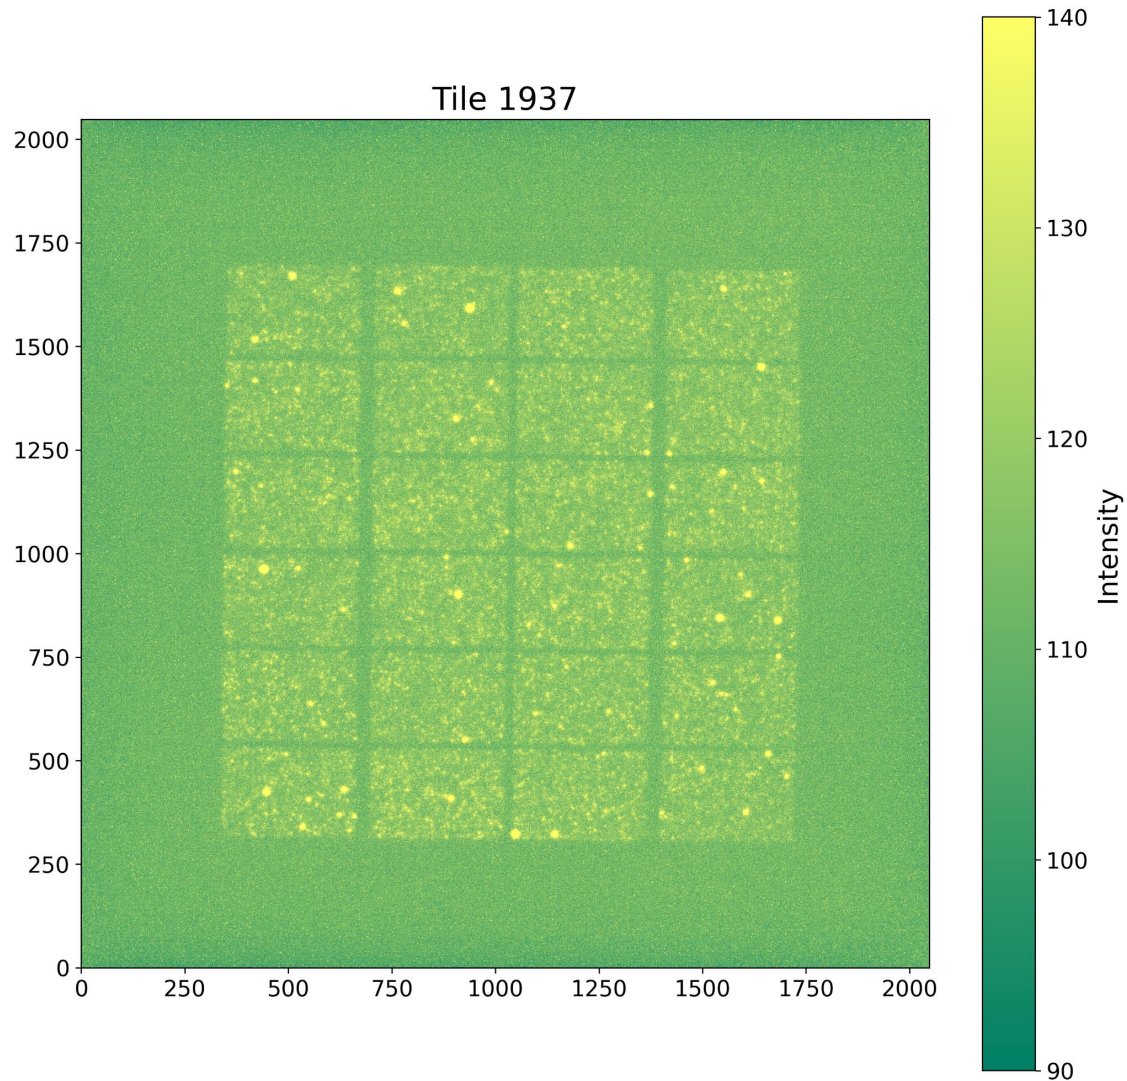
## Tile #1937

- CMOS image doesn't show any damaged SiPM
- You can recognise bad SiPMs because they appear darker

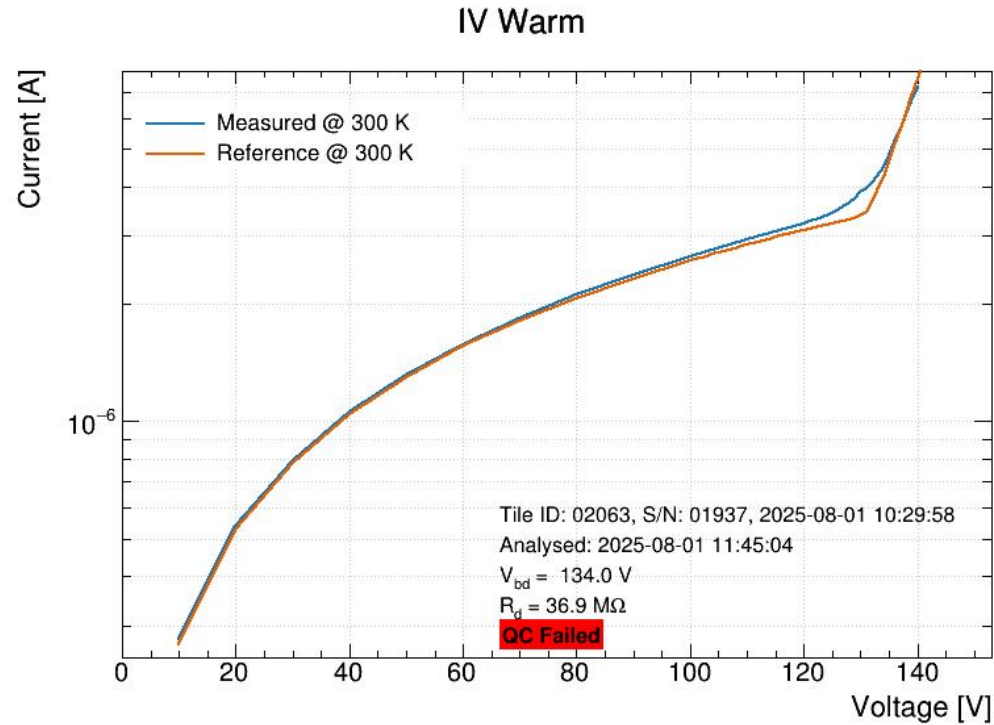
Even though from the CMOS image it seems that no SiPM is damaged, the IV Warm test failed because the measured breakdown voltage (blue line) is lower than the theoretical value (orange line, 132 V)

The other plots such as Noise Spectrum, Pulse Counting at 144V and 136V, and PCR curve are good.

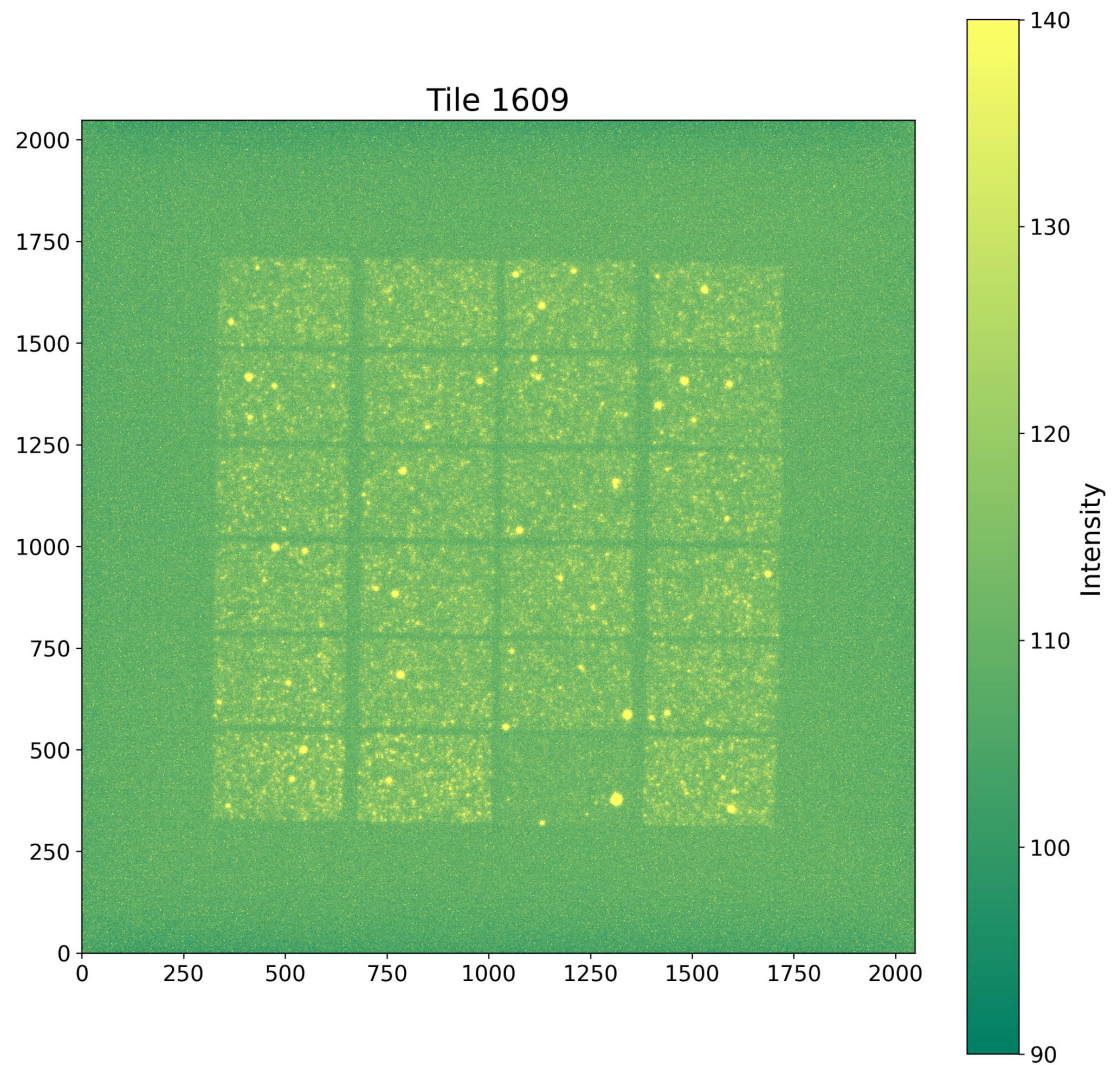
## Tile #1609

- The 3rd SiPM of the last row is darker so it is damaged

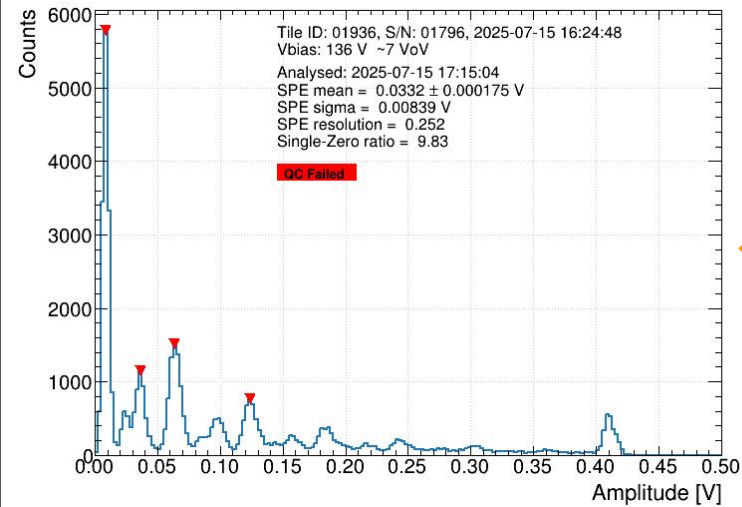
Pulse Counting at 136 V

The Pulse Counting test failed because, as you can see, this is not a proper finger plot.

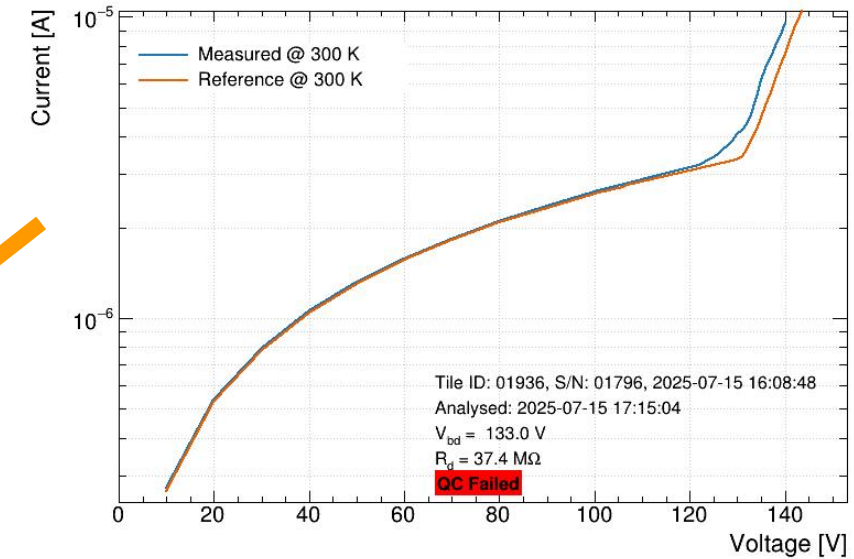
Regarding the IV Warm test, the measured breakdown voltage is lower than the theoretical value.

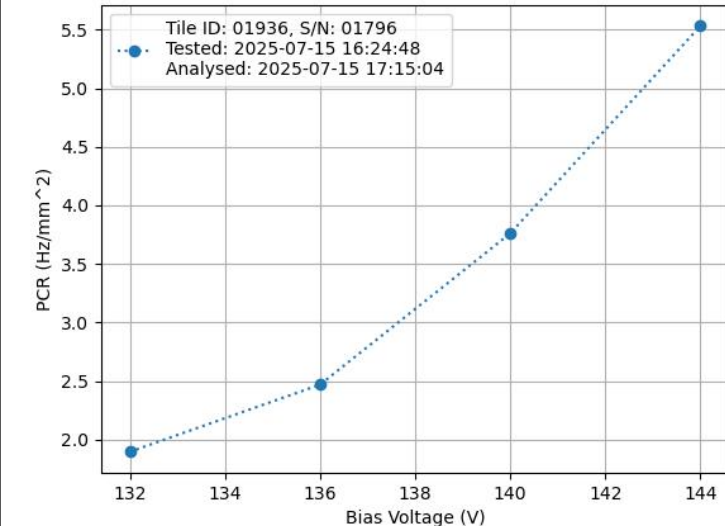
PCR vs Vbias

The maximum PCR value at 136V must be 0.3 while in our case it is 2.5

The maximum DCR value at 136V must be 0.1 while in our case it is 0.18

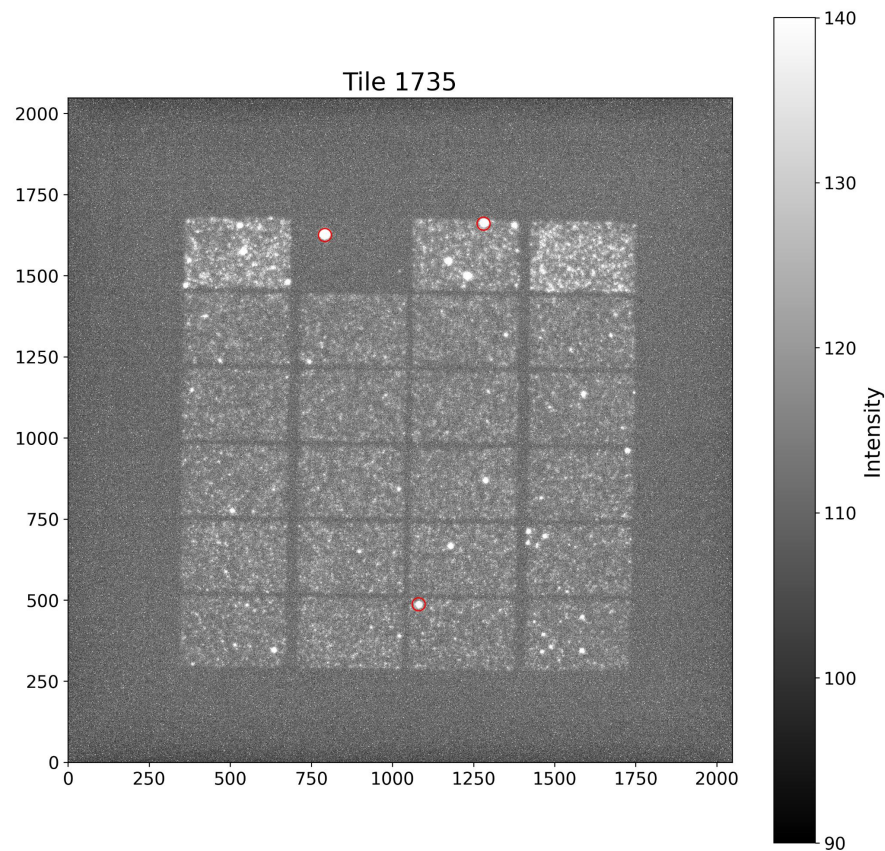
Example of peak finding algorithm applied on a damaged tile:

- a precise tuning would be required to obtain a reliable technique
- from rough analysis no dependence of DCR with respect to number and intensity of peaks has been found
- ML techniques could help, but training data would be required

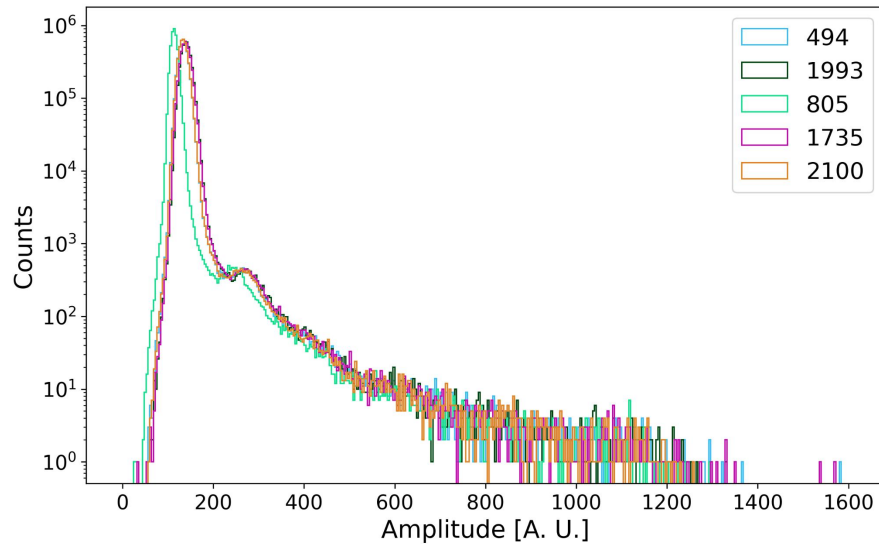
Amplitude distributions do not provide any separation

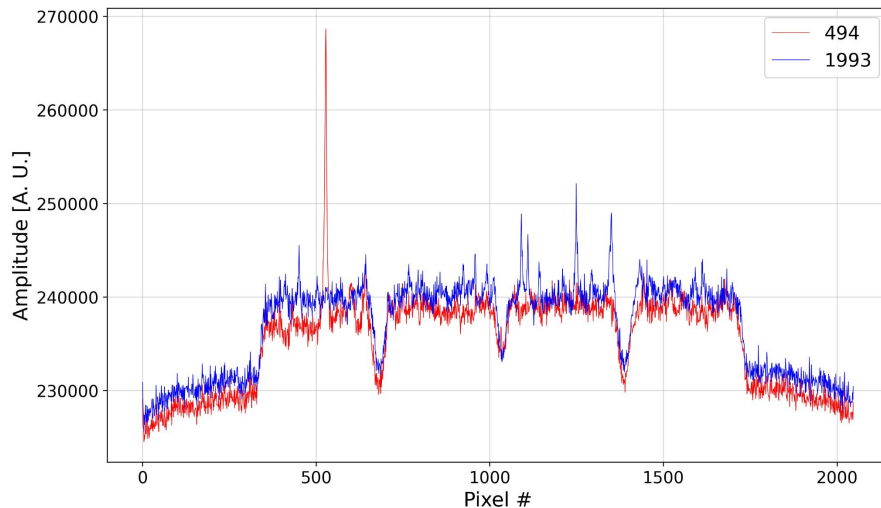
1D projections sometimes spot hidden spikes but they are not predictive on the DCR:

- 494 has low DCR
- 1993 has high DCR

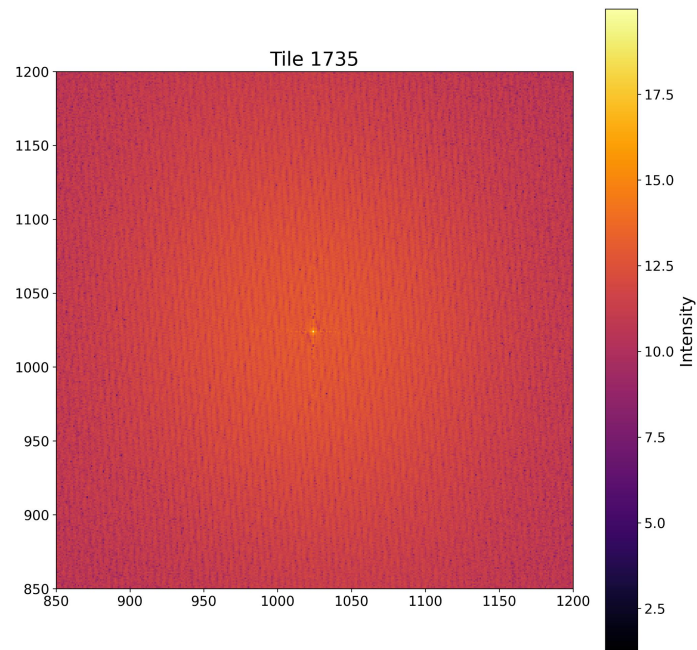
low DCR tile

A spatial Fourier analysis has also been attempted

- Some differences are visible in Fourier space
- Whether this can have an application is an open question

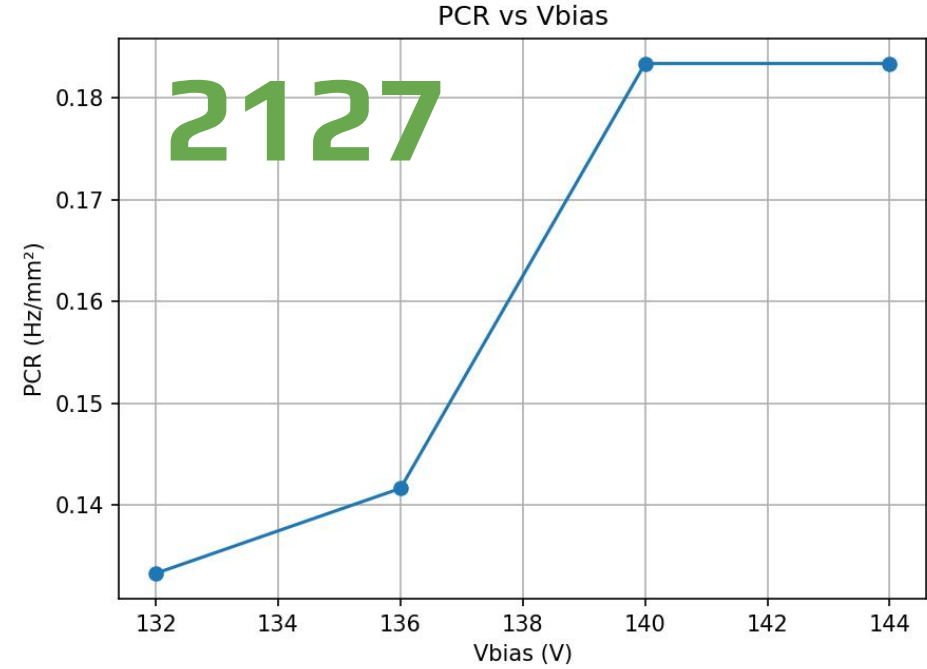
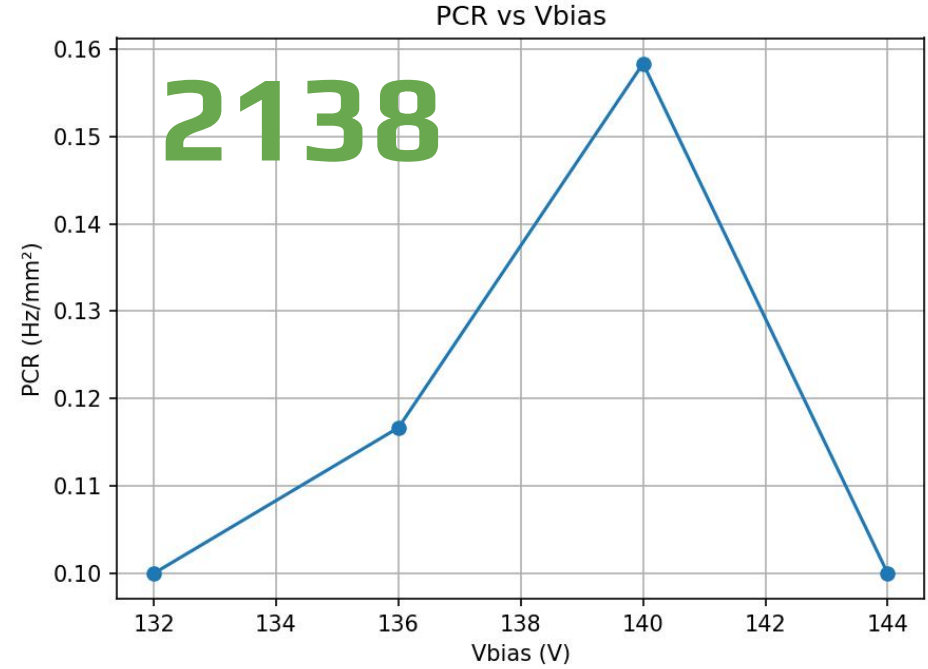
Good PCR tiles show values <0.3 Hz/mm<sup>2</sup>
