Preliminary tests performed on HRPPD #25

Fulvio, Jinky

13/02/2025

Updates on HRPPD N.25 activities

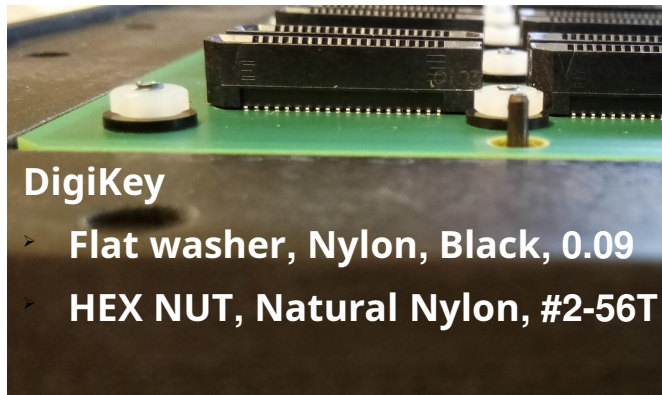
Assembling

Planarity O (100 μ m)
~100 μ m bump – top to bottom

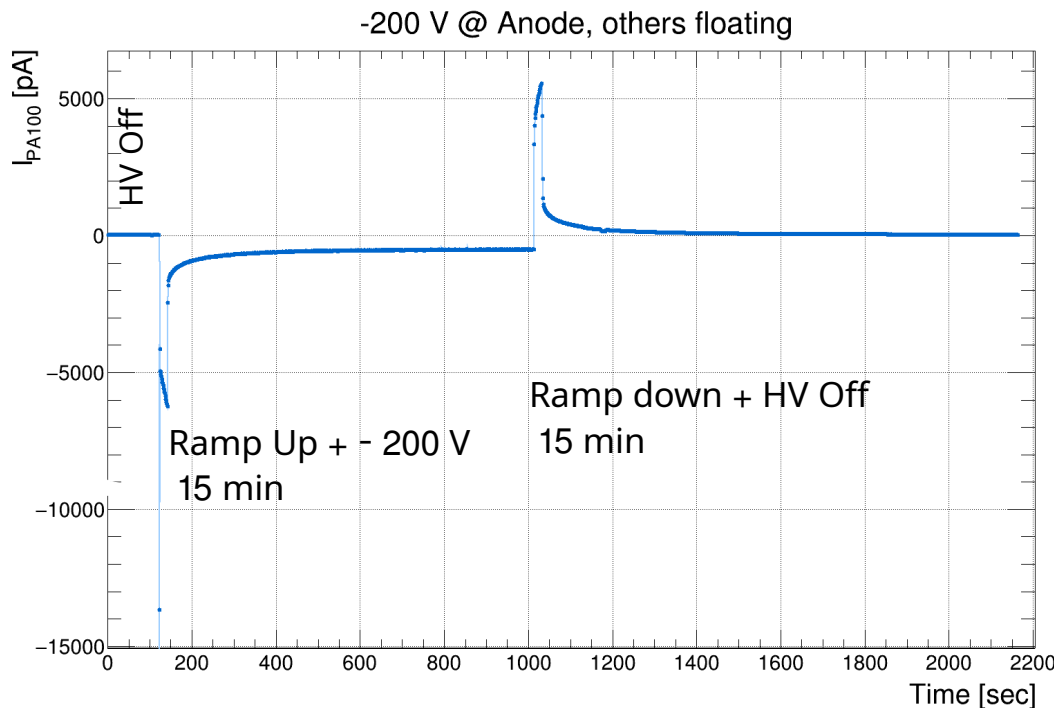
HV_A [V]	I_PA100 [pA]
-10	-20
-20	-40
-100	-250
-200	-520

$R_{A,iso} \sim 350-400 \text{ G}\Omega$

Ohmic?

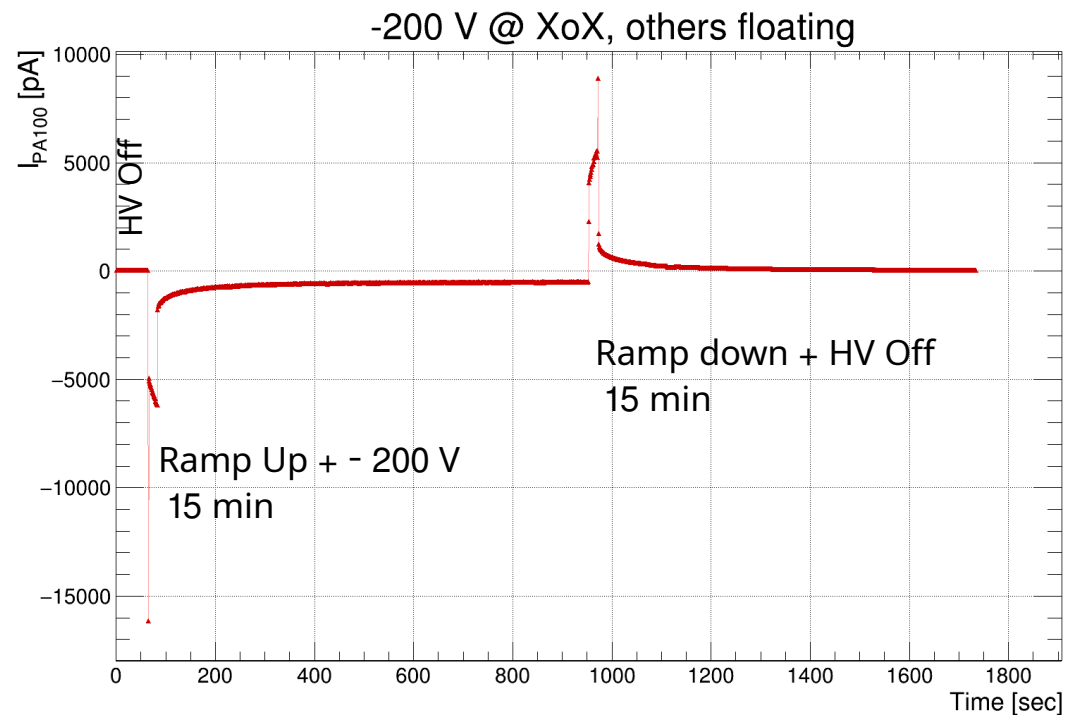
Isolation tests

$$R_{X_0X, iso} \sim 380 \text{ G}\Omega$$

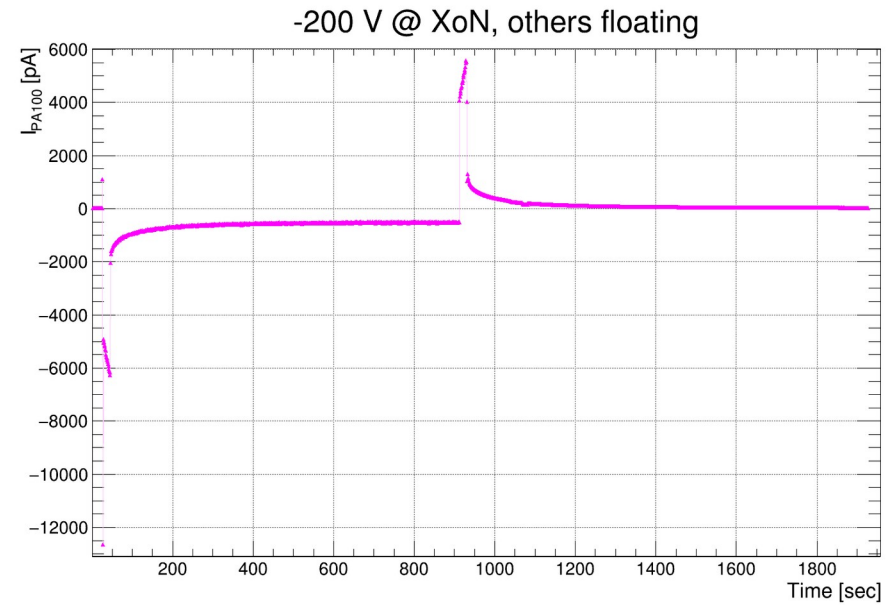
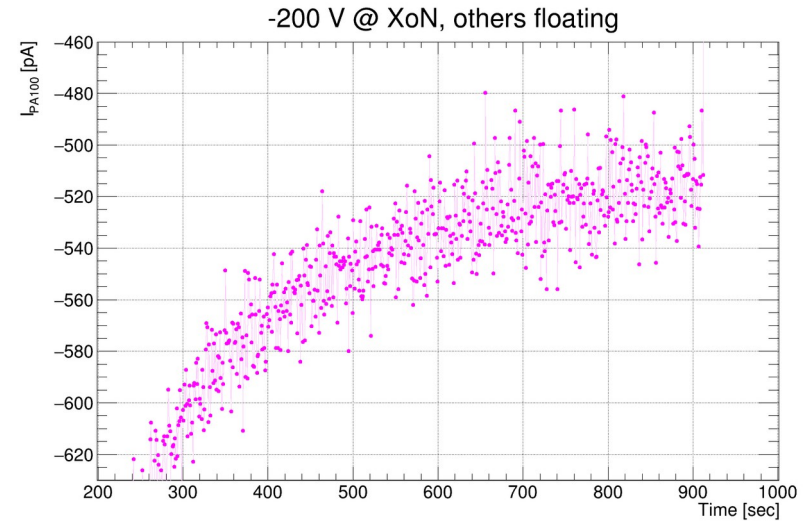
Isolation tests

$$R_{X_0N, iso} \sim 390 \text{ G}\Omega$$

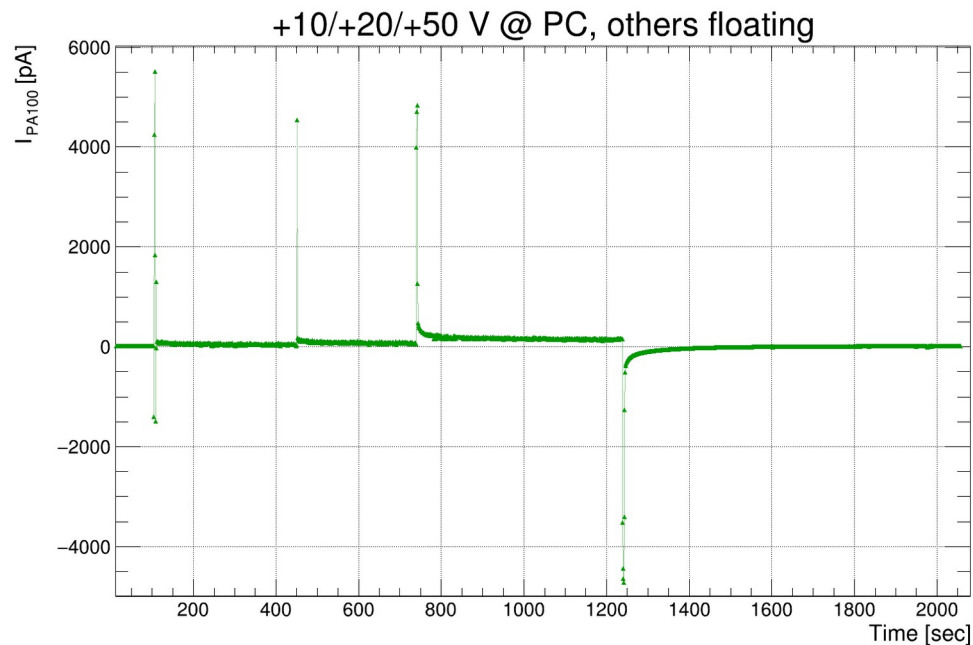
Isolation tests

$$R_{PC, iso} \sim 330 \text{ G}\Omega$$

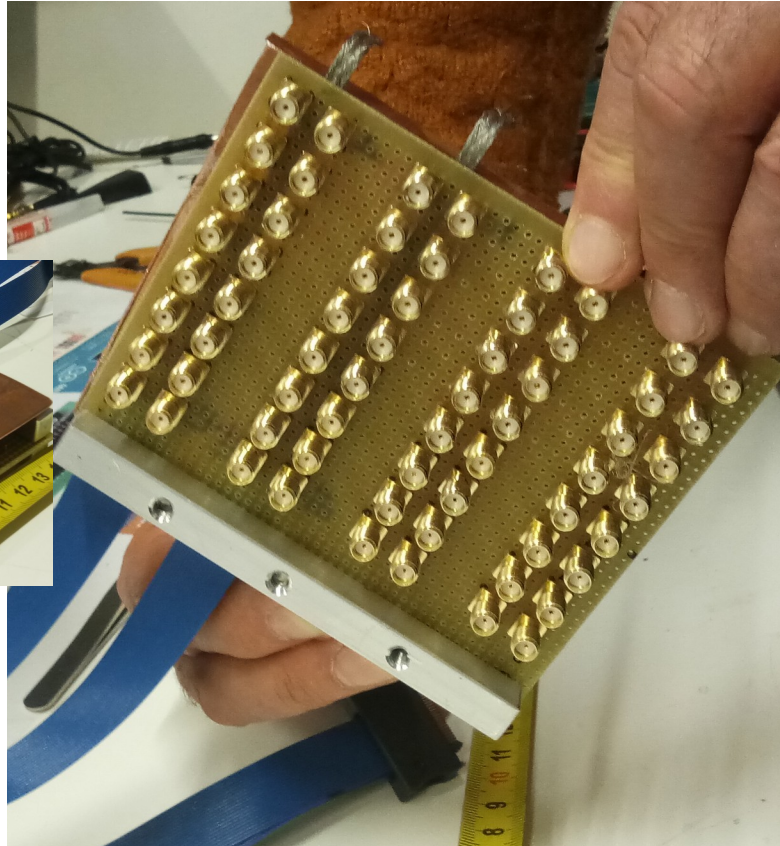
Mauro's bread board - updates

- Reading of **64 pads** from a group using 4 flat cables.
- Grounding of 32 Pads together.

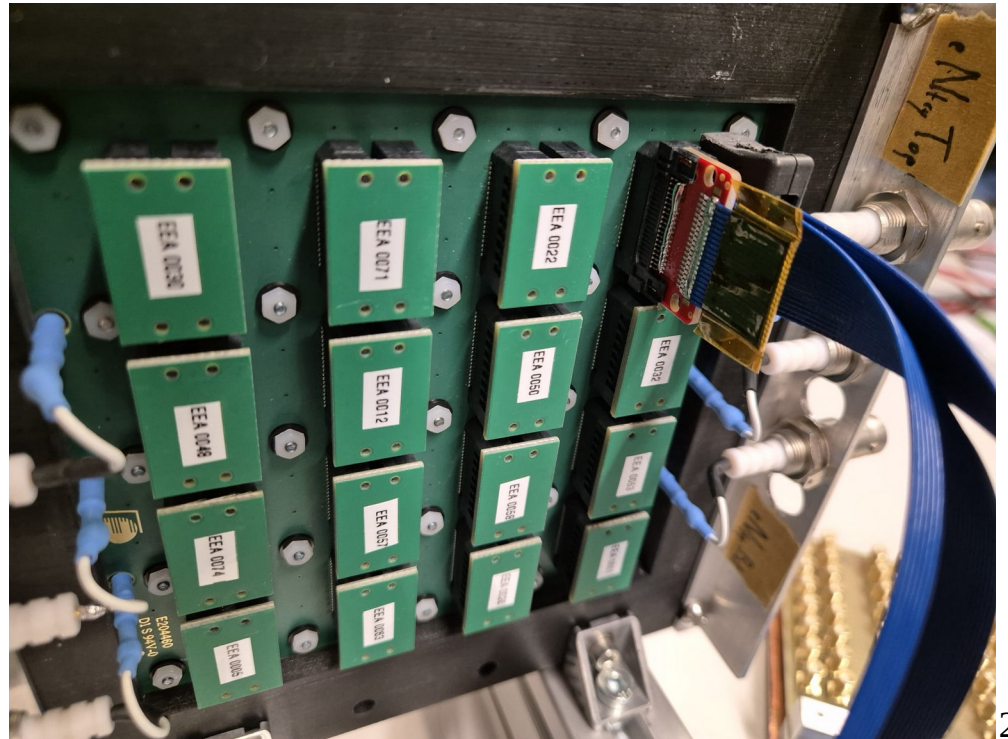
μ -Coax cables plugged in

- Reading Group D0 top 32 pads (near NoN connector)
- Labeling done

By the way, from the photos, it looks like it is possible to solder resistors on the connector - where coaxial cables are connected to the pins. Perhaps not all 32 channels, but some number of them.
