CMS SILICON TRACKER OPERATION

Silvia Taroni
University of Zurich
on behalf of the CMS Collaboration

RD13
Florence, 3rd - 5th July 2013

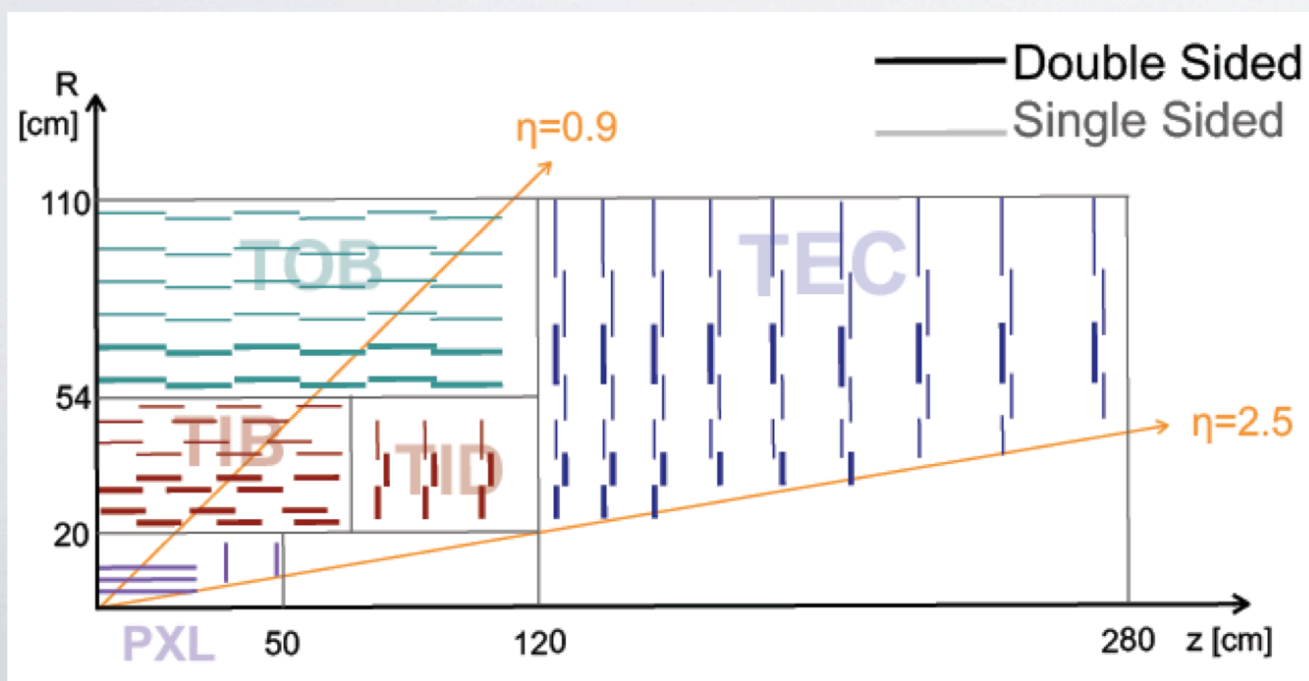
PIXEL

n⁺-in-n silicon sensor

- 100 μm x 150 μm
- 52x80 pixel read by one ROC

Pixel Barrel (BPix):

3 layers (56 cm long) placed at $r = 4.3, 7.2, 11.0$ cm
48M pixels, 11520 ROCs, 1120 readout links

Pixel Endcap (FPix):

4 disks placed at $z = \pm 34.5, \pm 46.5$ cm
inner (outer) radius = 6 (15) cm
18M pixels, 4320 ROCs, 192 readout links

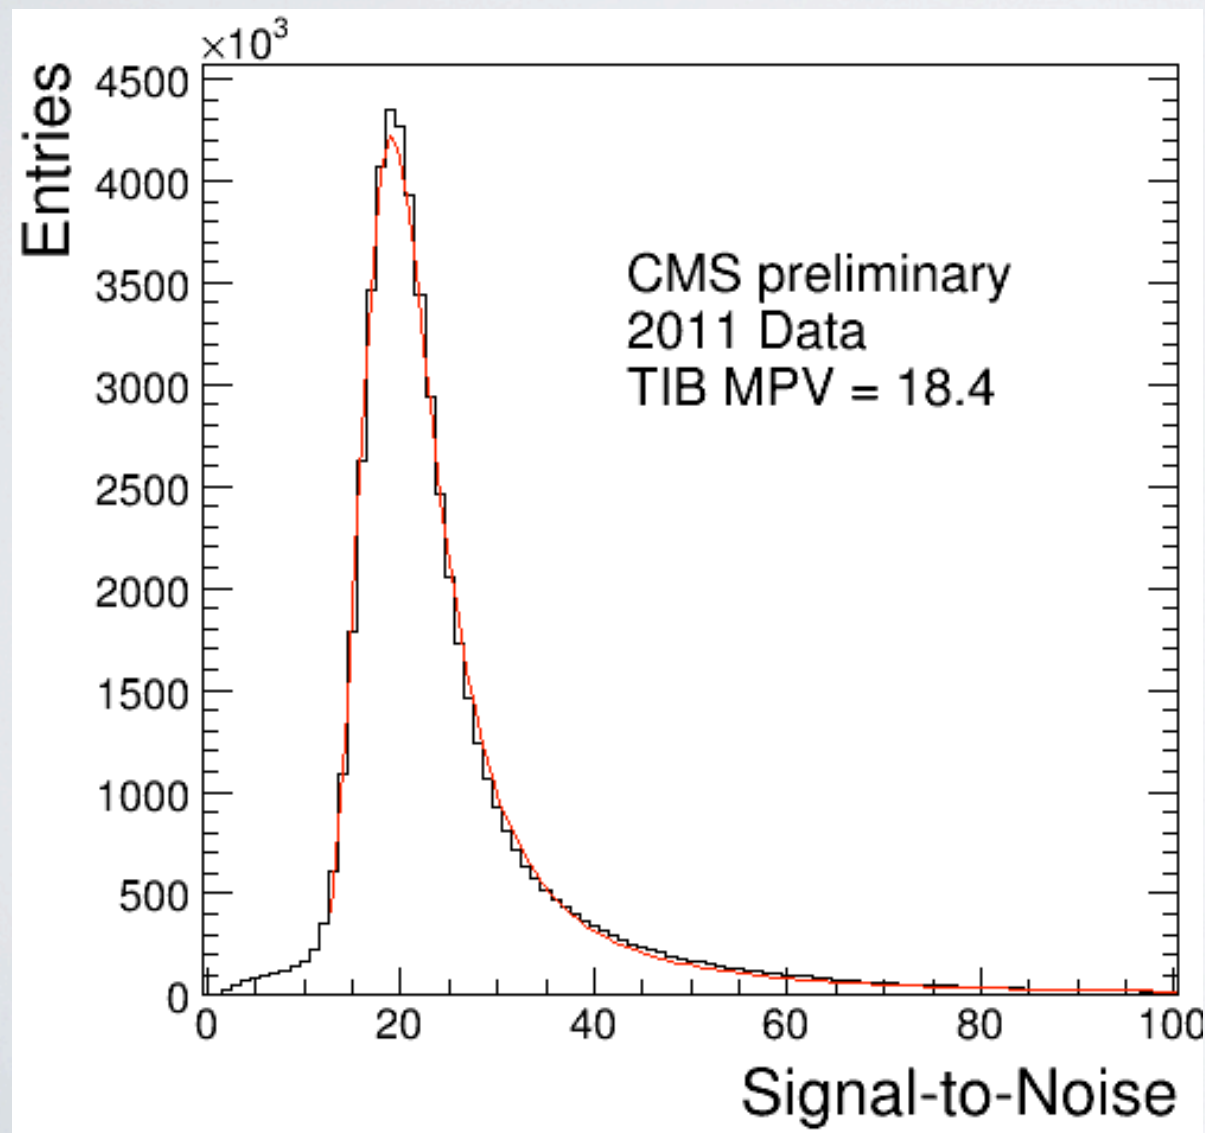
- Clusters on track only, charge corrected for track angle.
- Distributions nicely follow Landau distributions convoluted with Gaussian resolution.
 - MPV thin sensors (TIB): ~ 18
 - MPV thick and long sensors (TOB): ~ 22

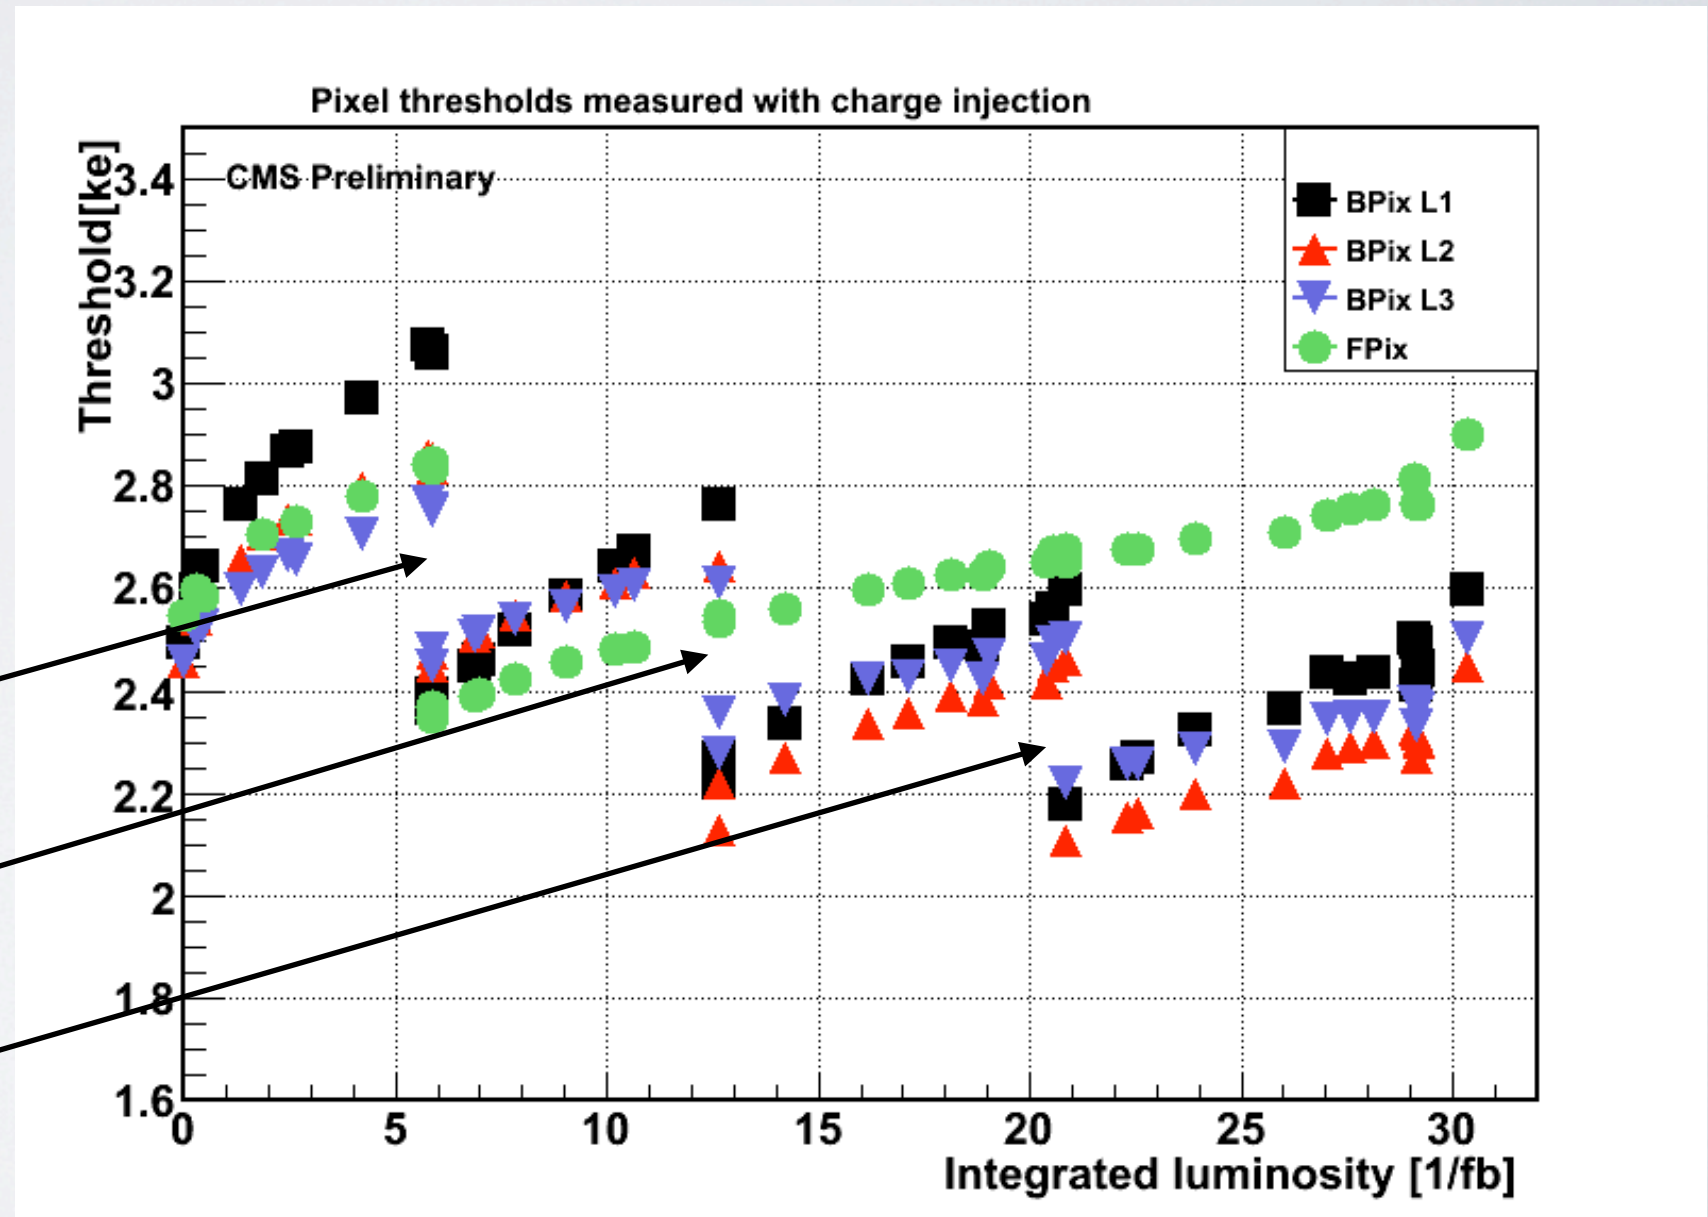
- Pixel thresholds depend on the integrated luminosity
- Threshold optimization during technical stops

End of 2011 run

June 2012 technical stop

September 2012 technical stop

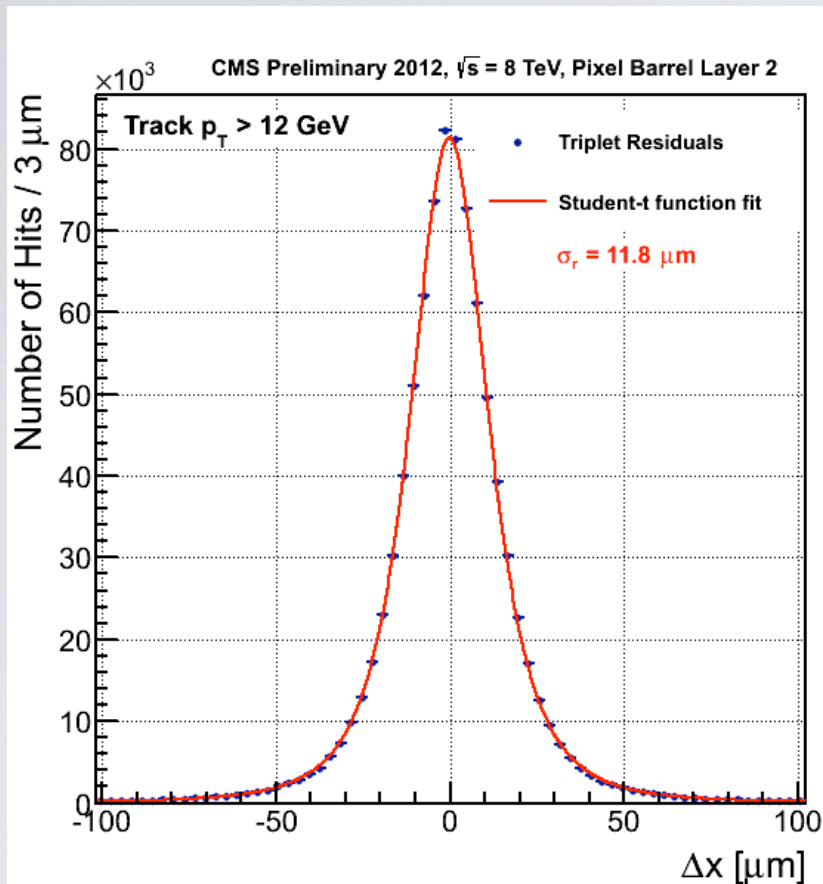
z direction resolution
in barrel pixels

pixel triplet
resolution
transverse plane

intrinsic resolution of pixel
detector (barrel, layer2),
from pixel triplets

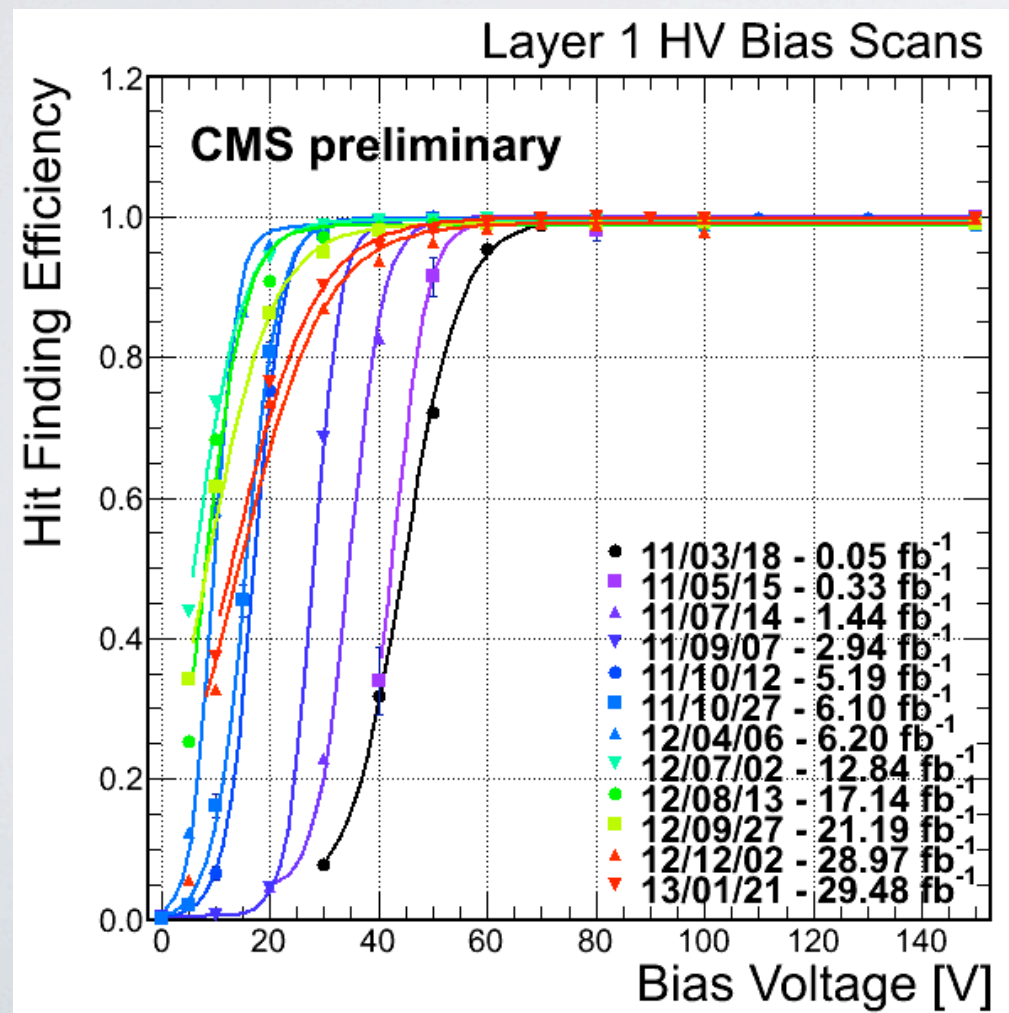
- Detection efficiency and charge collection efficiency vs bias voltage measurement have been measured regularly
- Layer 1 and layer 2 are type inverted.

Nominal Voltage
150V for BPIX
300V for FPIX

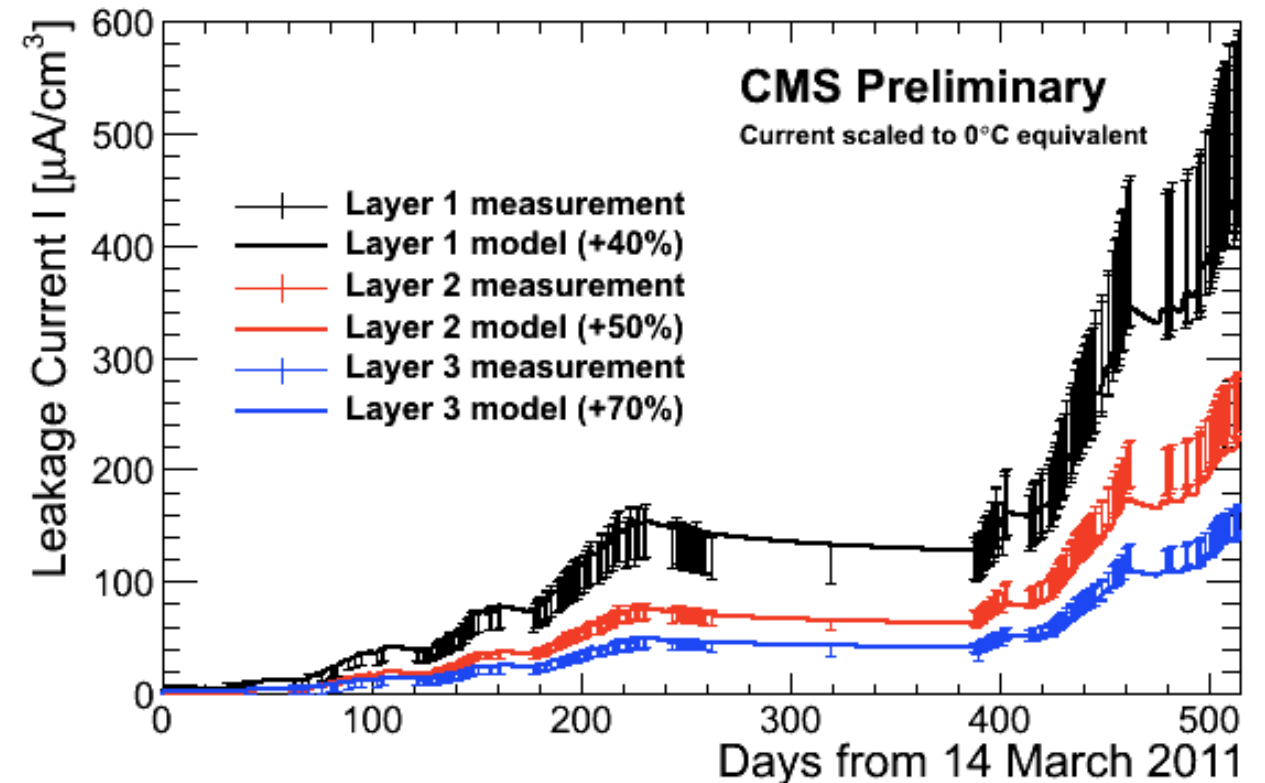
- Leakage current expected to increase linearly with fluence
 - Due to bulk silicon damage
 - Partial recovery due to annealing
- Good shape agreement with models (fluka)
- Normalization low by 40-70%

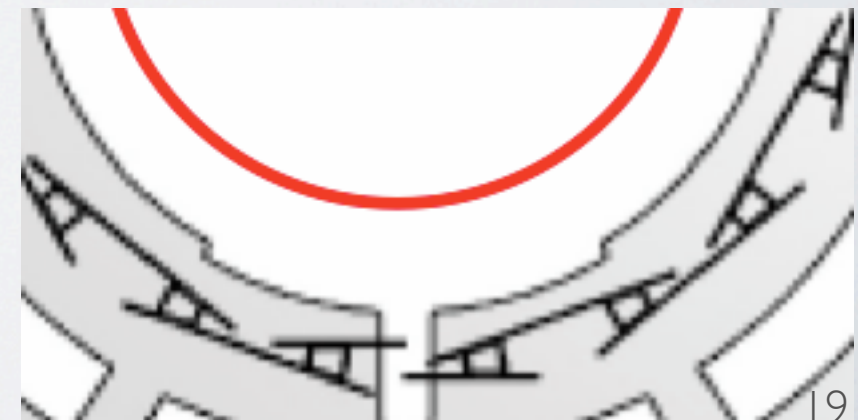
- An azimuthal dependence is observed
- LHC Beam Spot is not at the center of Pixel Detector
 - W.r.t pixel, LHC beam spot $(x,y) = (-2.4\text{mm}, 3.9\text{mm}) \rightarrow \varphi \sim 2.12$
- 30% effect on potential Layer 1 lifetime
 - new (better) position after LSI
- Geometric issues also impact data rates \rightarrow where readout issues emerge

Can also see impact of staggered geometry
