Aging and outgassing studies for GEM detectors in the LHC high-rate environment

MPGD2015

Jeremie Merlin

On Behalf of the CMS GEM collaboration*

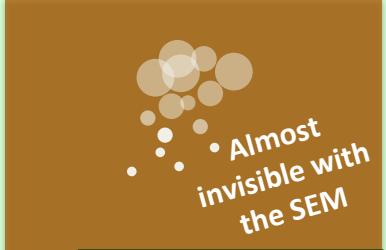
White dots/ stains

- Long-term effect ?
(classical aging ?)
- Instantaneous effect ?
(discharges during incident)

→ we suspect PU Cellpack as the culprit for deposits observed in GE1/1-IV-CERN001 after GIF test

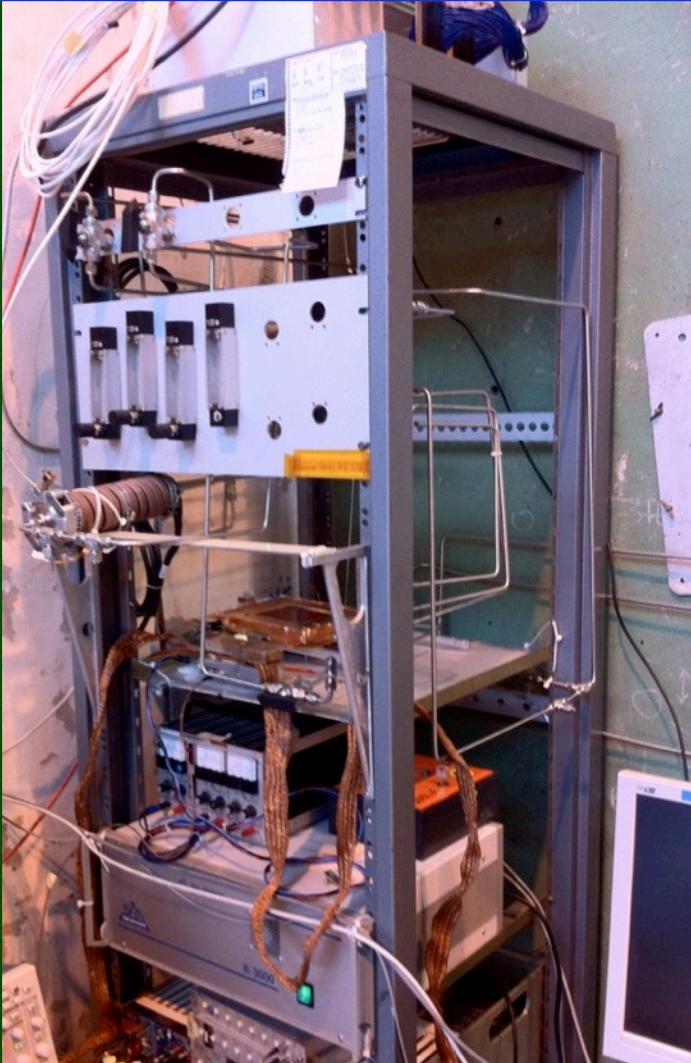
GIF (CERN / Meyrin)

GIF – 2013

1 outgassing channel
1 SWPC+GEM 10x10
PLC
Gas Chromatograph
→ 3 materials tested

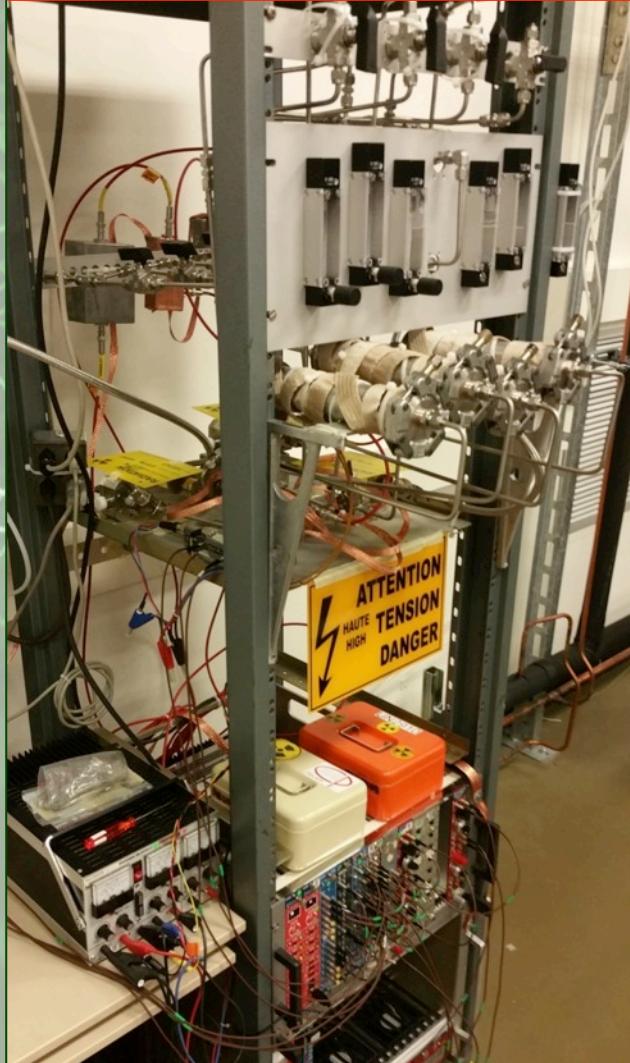
TIF (CERN / Meyrin)

TIF – Today

4 outgassing channels
3 SWPCs
PLC
→ 6 materials tested

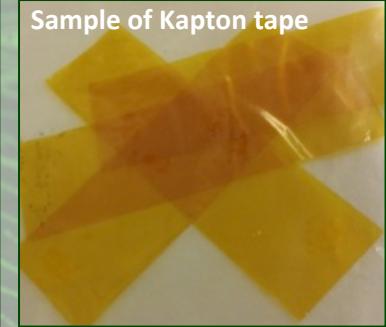
Materials and samples:

- Clean metallic supports
- 10x the amount present in GE1/1s
- Max. surface in contact with gas

→ 4 weeks of purity check of entire system before inserting samples in the setup

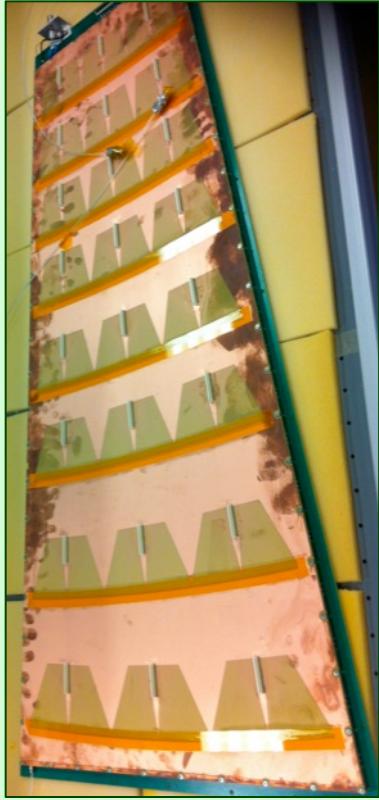
GE1/1- prototype IV:

- Size : 99x(22-45) cm²
- Gap configuration : 3/1/2/1
- 24 readout sectors (3072 channels)
- No Glue/No Spacers

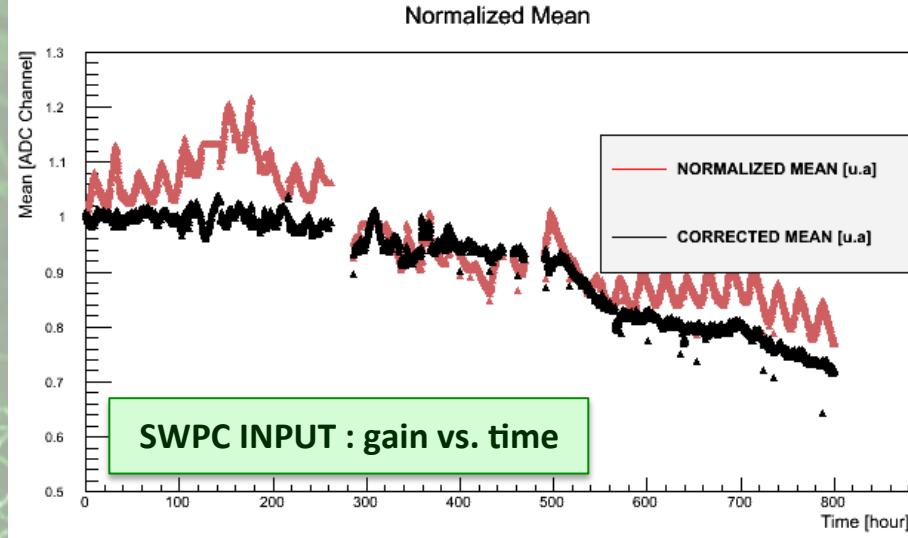
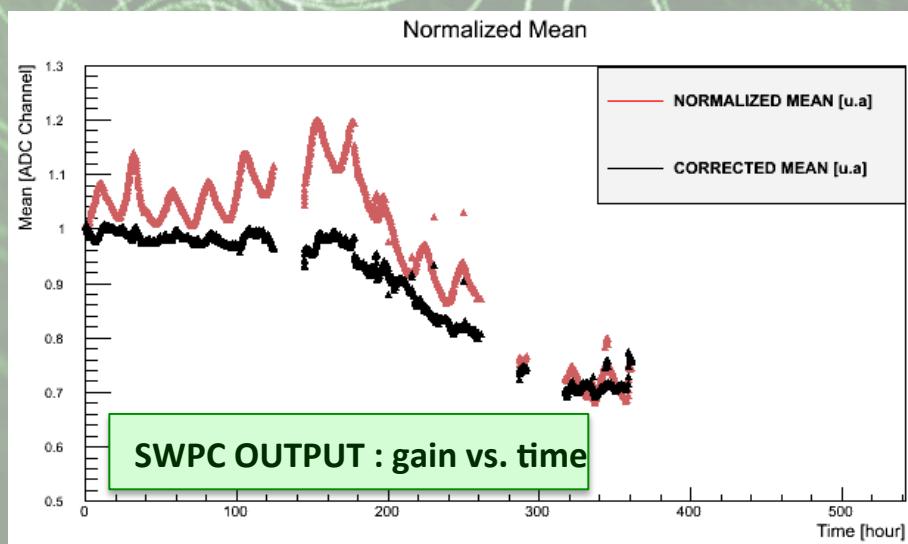
- Significant gain drop observed in reference SWPCs (input and output of GE11)
- Presence of C, O, F, S, Ca and K on the aged wires

- > No aging during the gas line check
- > Faster aging on output SWPC
- > gas flow rate < 1 L/h

Fast gain drop with the SWPCs but NO aging was observed with the GEM
