Pixel, tracking e b-tagging 2017

A. ROSSI

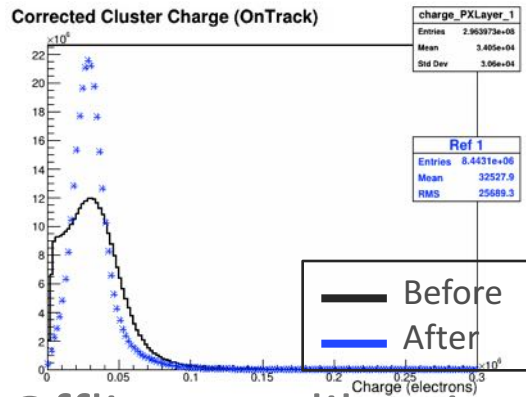
- HV increase recover steady signal loss

- Offline recalibration + Bug fix (ReReco)

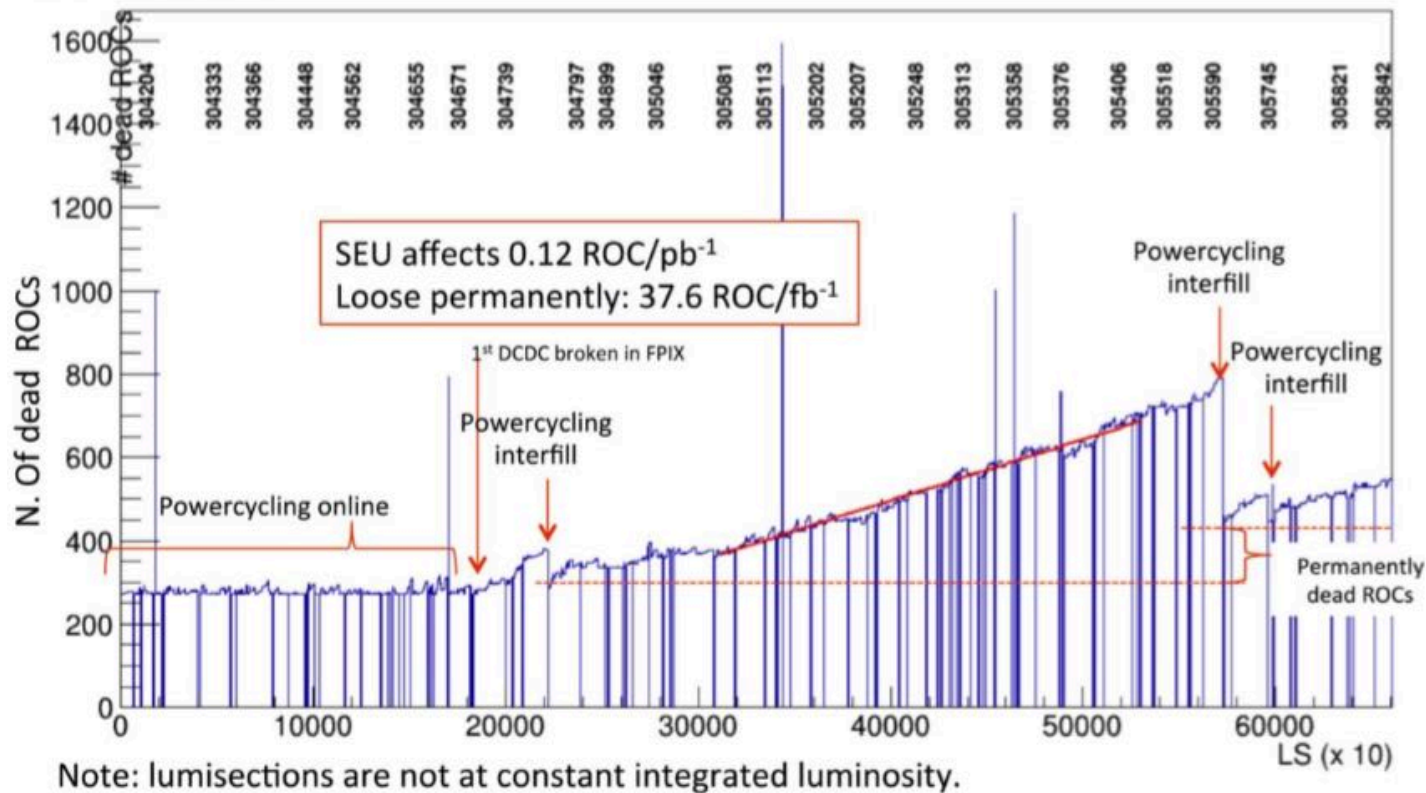
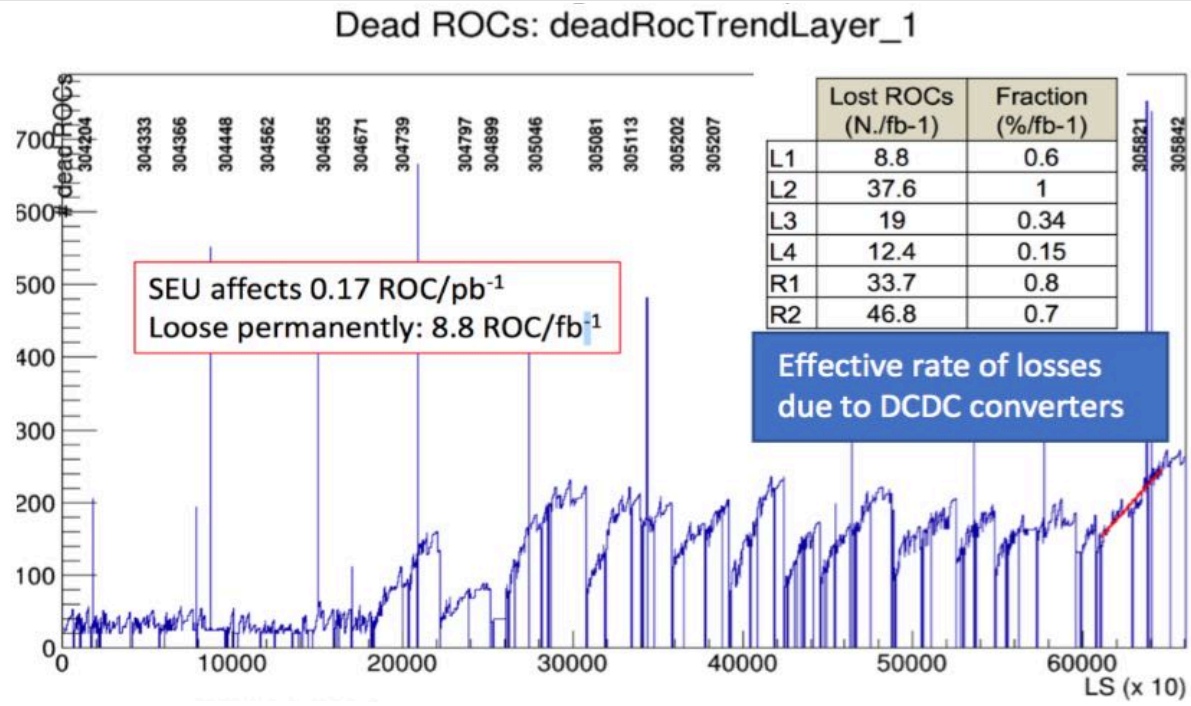
Bpix Layer 2

- 55 DCDC converter failures
 - **Few of them restart to work (spontaneously)**
 - 5 Analog, 4 Digital
 - 3 unstable
 - 2 provide limited analog current

- Inactive channels build up because of “stuck TBM” and no automatic power cycle
- Interfill power cycles recover them but can break DCDC converters
 - DCDC failure proportional to luminosity

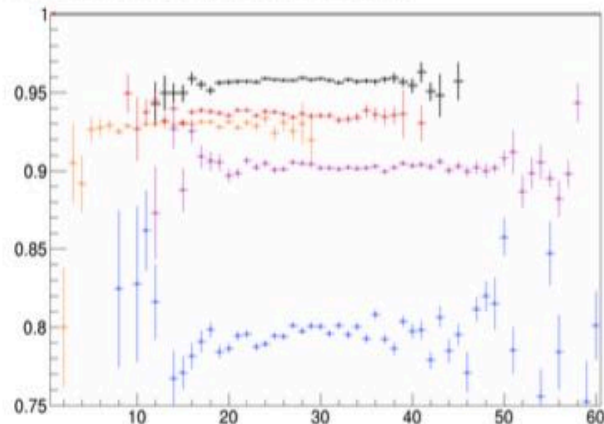
PXB Layer1 Efficiency vs GoodNumVertices

- Layer 2-4 and Fpix good MC matching and as expected resolution
- L1 ~50% worse than expected
 - Reproduced by MCv2 with increased threshold
 - Present challenge

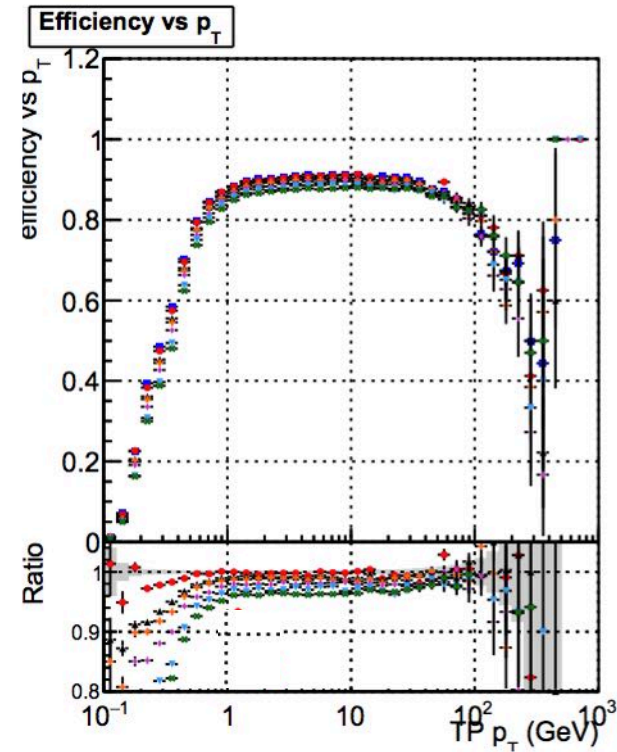
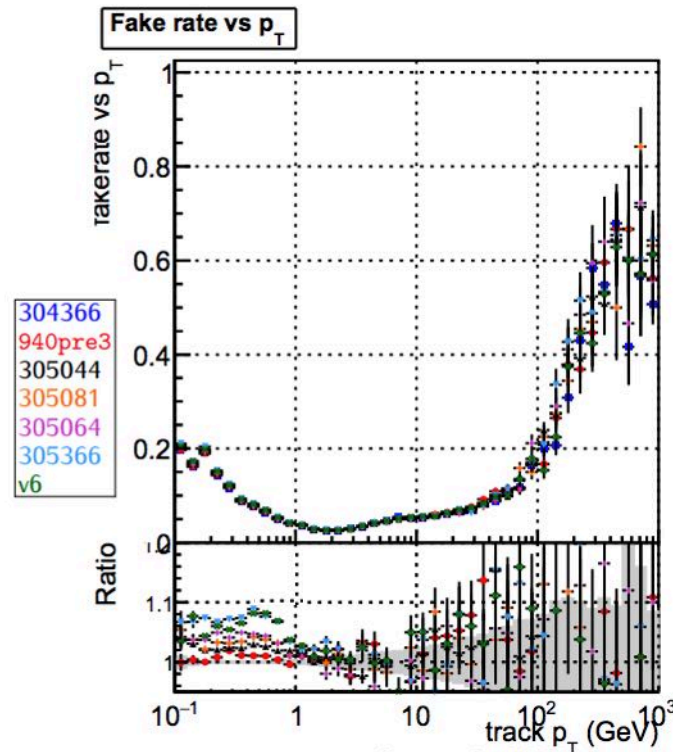
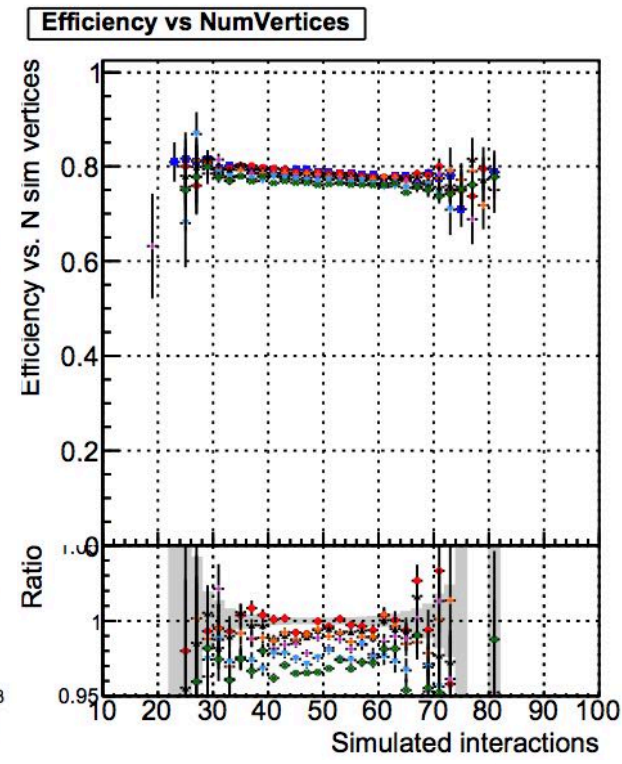
- Overall efficiency decrease by up to 4% with a increase on fake rate up to 3%
- Vertex efficiency decreases by up to 3 %
- Also IP resolution and Vertex resolution are affected

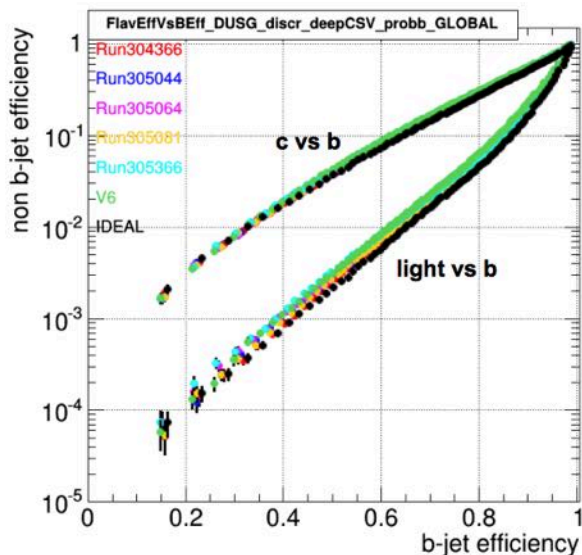
- Impact of DCDC issue on b-tagging efficiency is present
 - Some region on ϕ more affected

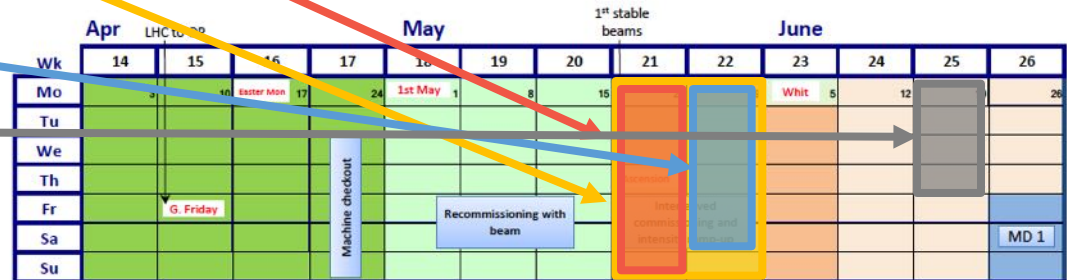
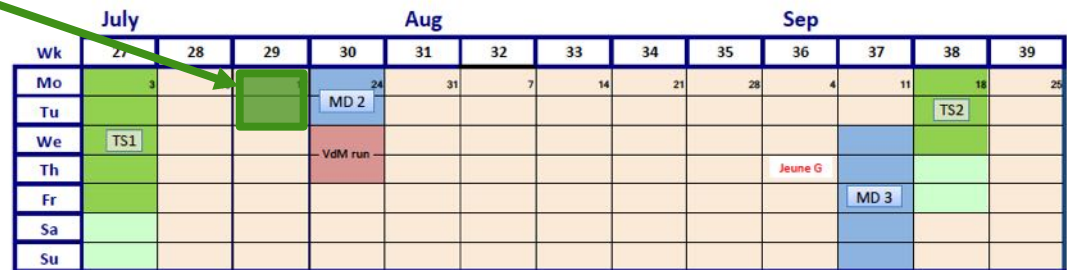
Final BPIX L1-L2 timing

- Last timing scan performed at the end of October (150b fill)
 - Setting confirmed

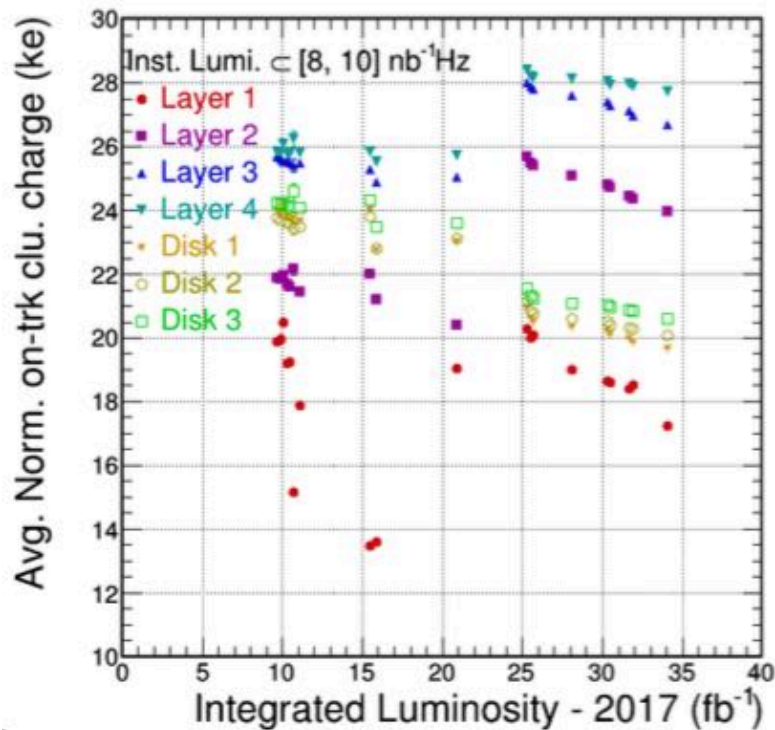
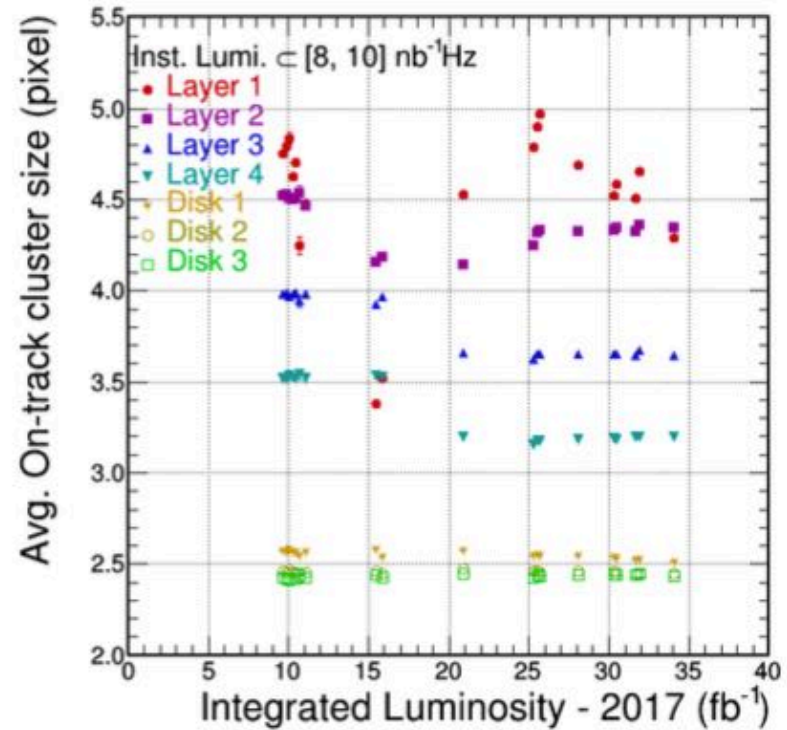
- Charge Collection
 - Loss of charge collection efficiency probably due to radiation damage

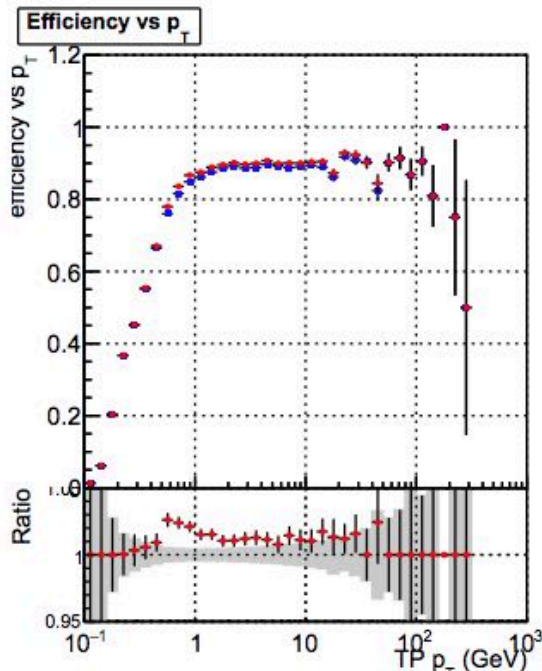
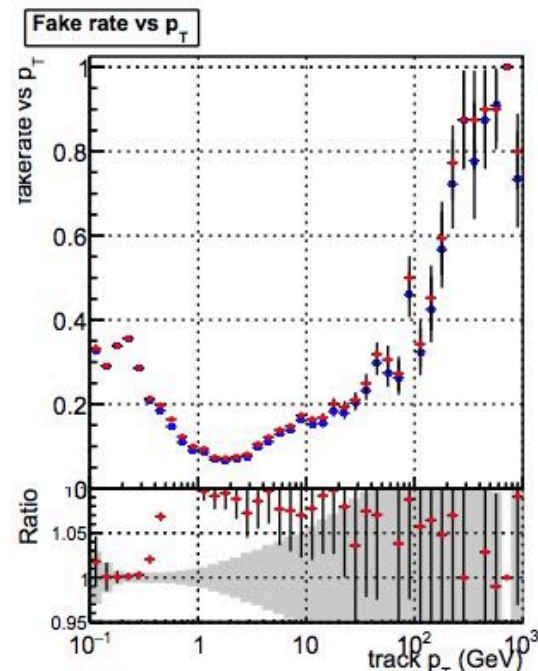
- Preliminary test to automated PixelPair mitigation
 - PixelPair originally used to cover BPix-FPix transition region covered only by 3 layers and the region with inactive areas in BPix layers 2 and 3

- Noticeable improvement
 - Big part of the PixelPair improvement goes to reduction of strip seeds
