Performance and Operation of the CMS Phase 1 Pixel Detector

Lea Caminada on behalf of the CMS Collaboration

The CMS Phase 1 Pixel Detector

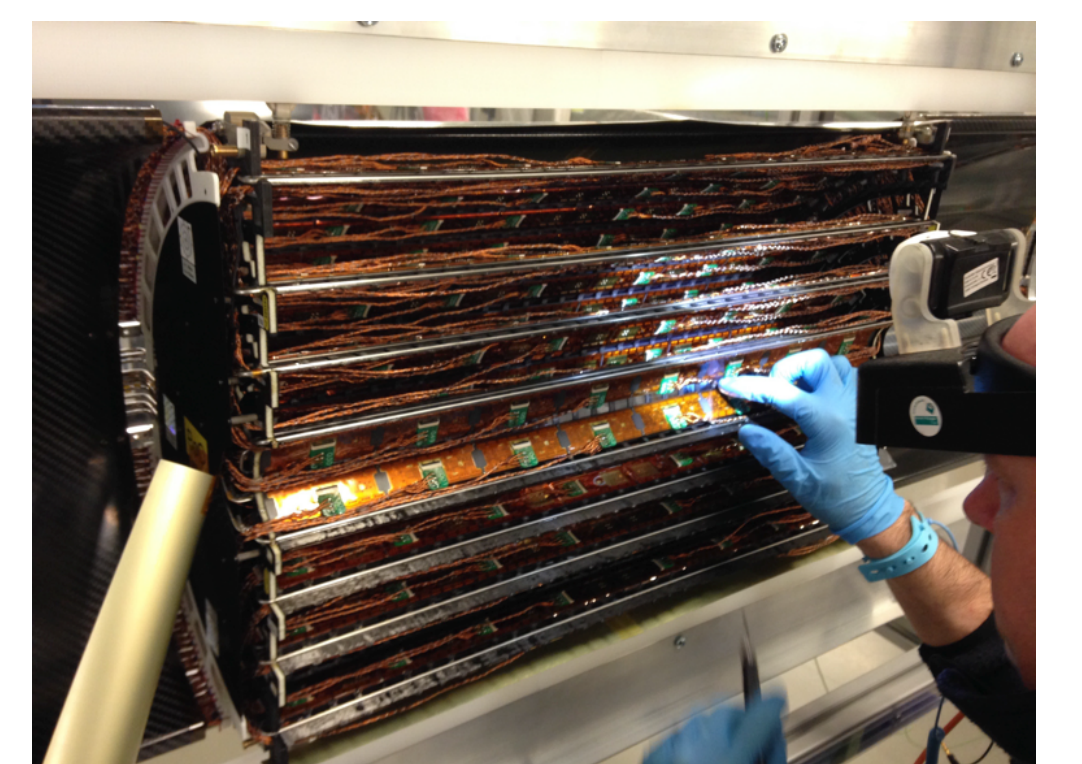
DCDC converter issue

- 1184 DCDC converters used for powering
- Components started failing during last two months of operation (67 converters)
- Detector extracted for repair at the end of 2017
- Failure traced to FEAST2 chip, cause still under investigation

+ Testing and calibrations
