Conductive polymer and TPB tests at Carleton

Marcin Kuźniak and Jeff Mason
mkuzniak@physics.carleton.ca

Carleton University
Ottawa, Canada

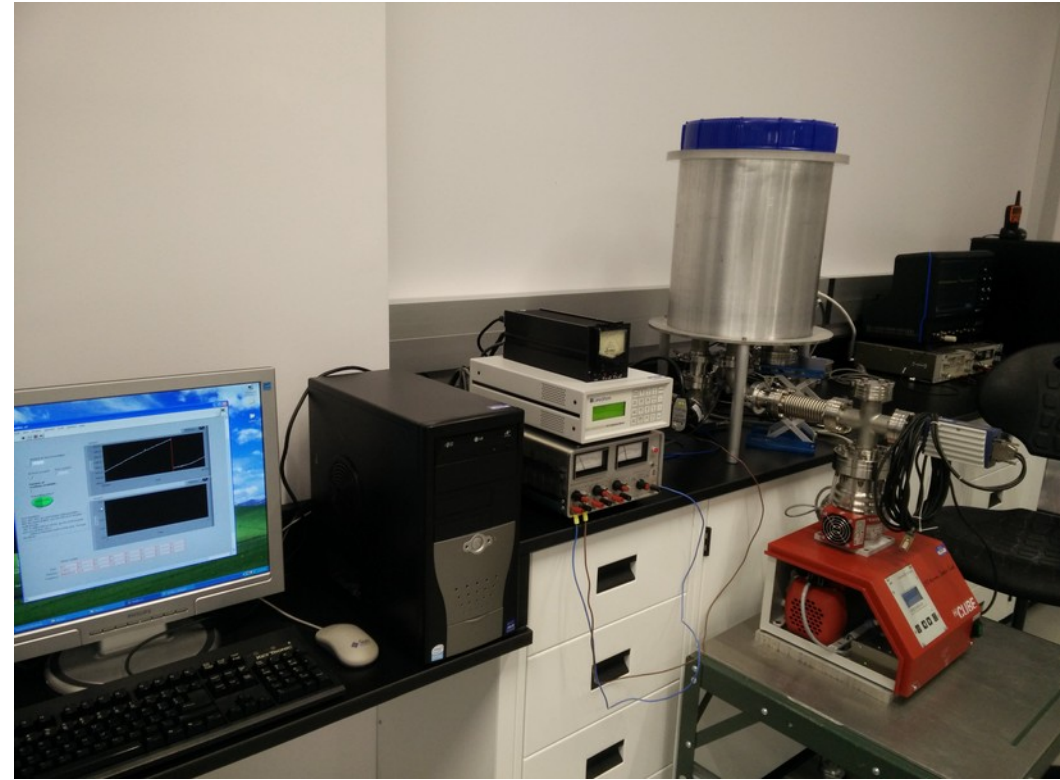
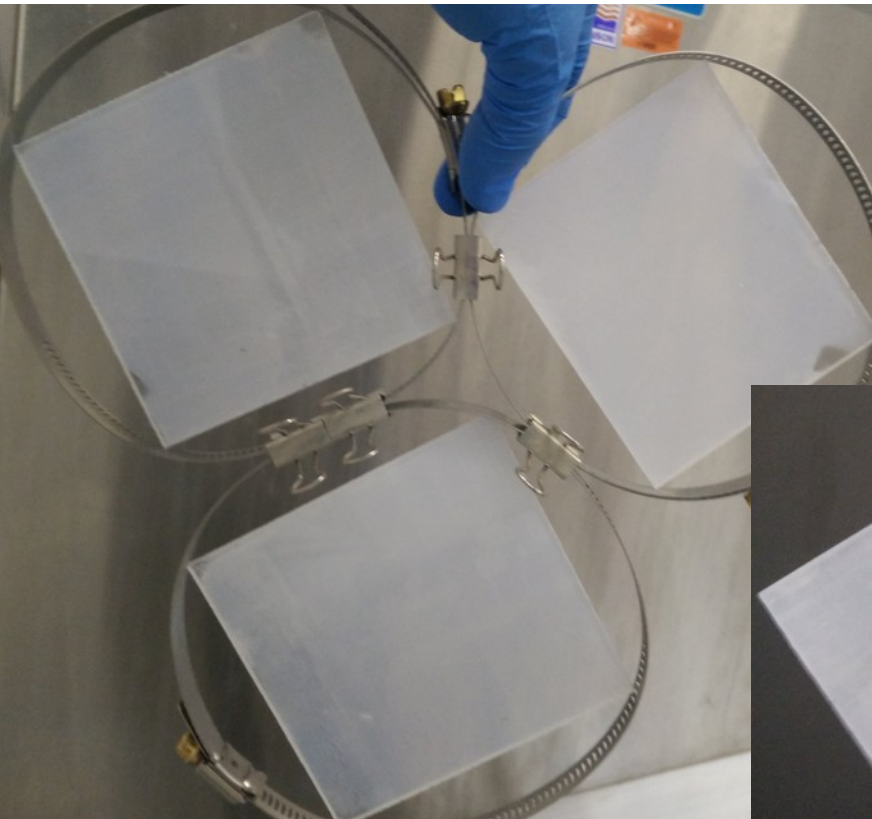
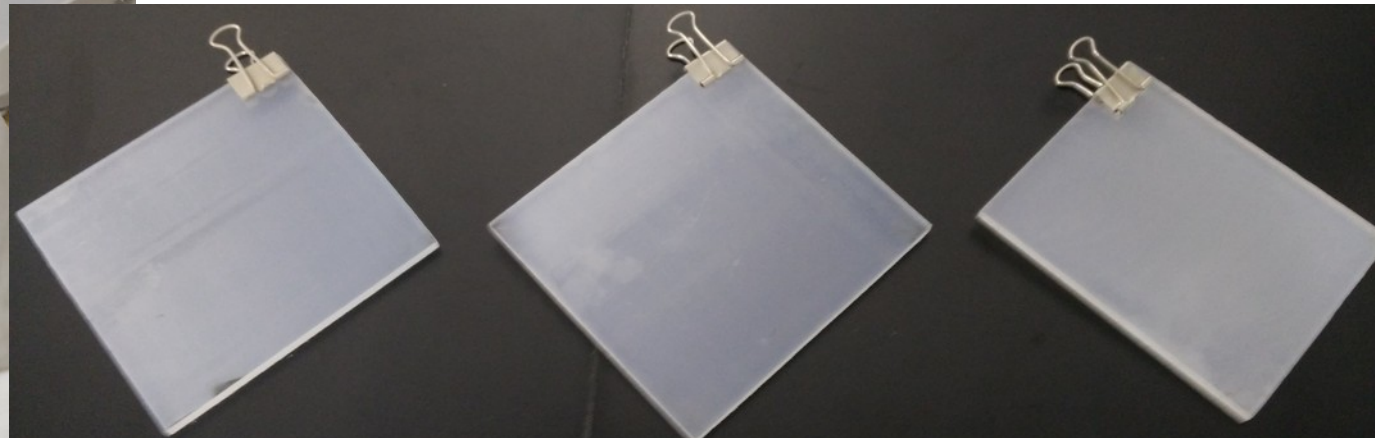
TPB deposition II

- Deposition started at $p=1.2e-4$ mbar. (Can go lower if needed)
- Deposited 3 microns of TPB over ~4h
- Deposition rate approx. 2 A/s
- Manually operated to maintain constant and low deposition rate
- All three coatings look very good!

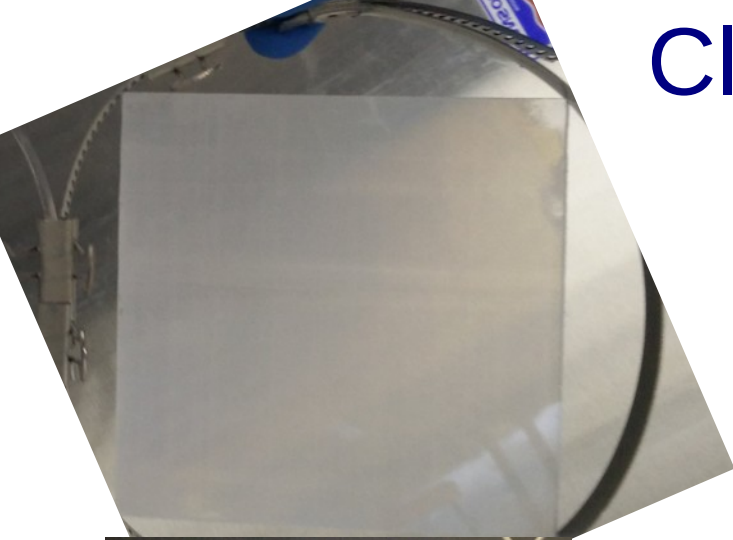
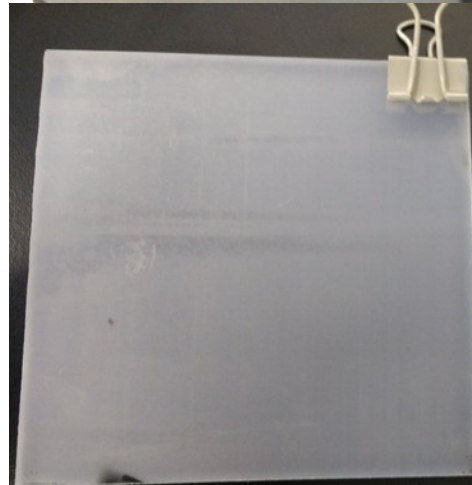
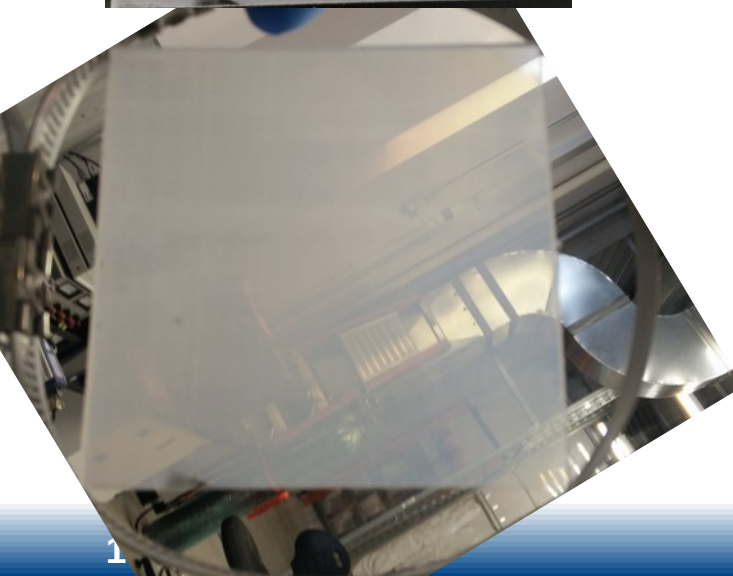
Closer examination

Signs of deterioration in one corner of one Clevios sample

- This is the thicker of two Clevios coatings
- This is the thicker side of the TPB coating
- This is also the edge of the sheet, where I fear Clevios could have been too diluted or pressure on the coating rod uneven
- Chance of mechanical damage through contact with neighbouring sample?
