# Beam Monitor update

FOOT performance meeting  
05/02/20

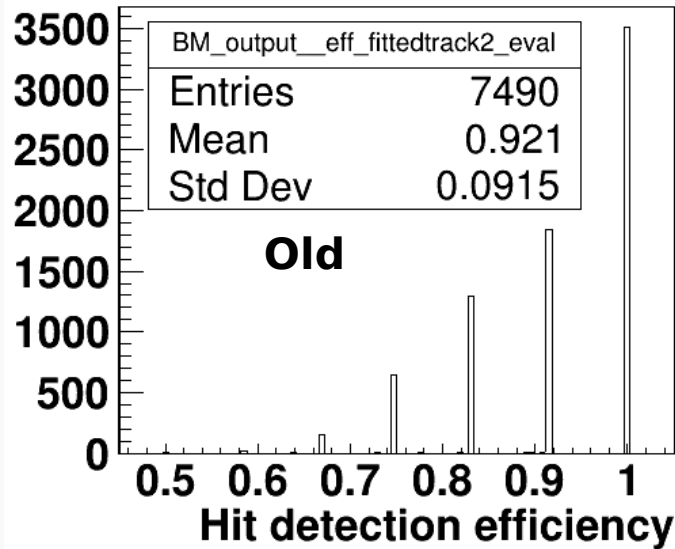
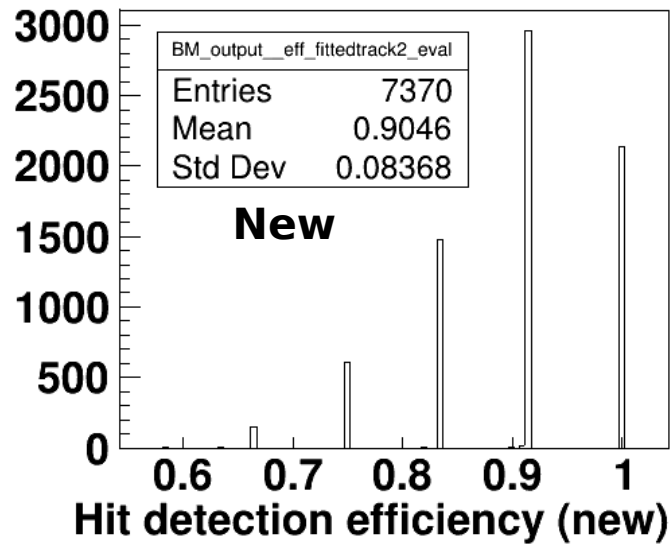
- The hit detection efficiency is similar to the past: all the other cells are working good
- The track reconstruction does not seem to be affected by the dead cell
- With the software improvements, we will reconstruct better than the last year
- Even with a spread beam, apparently there isn't any hole in the track reco.

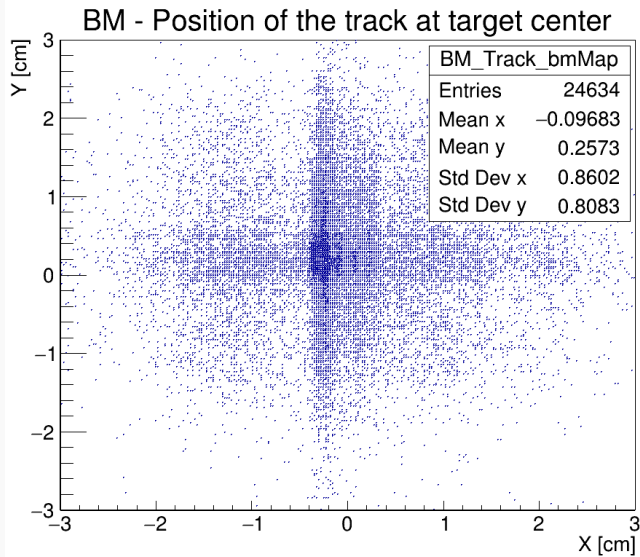
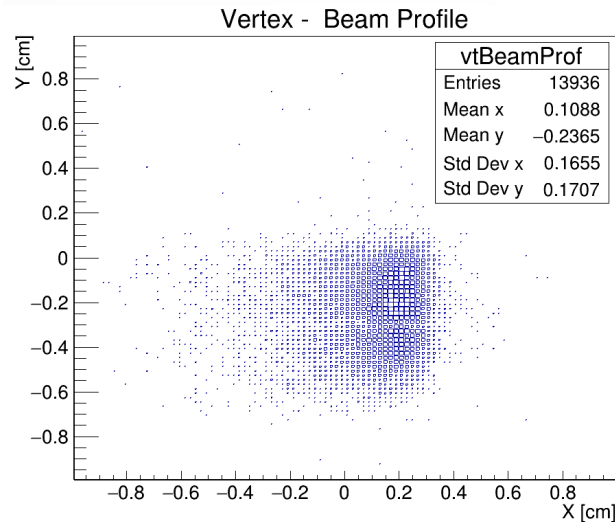
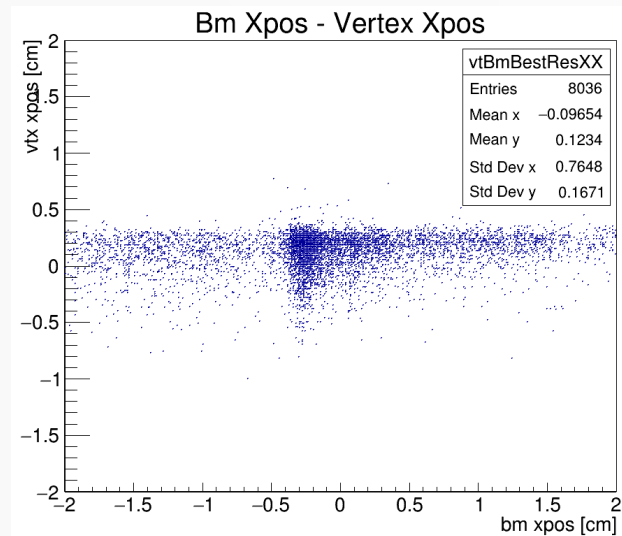
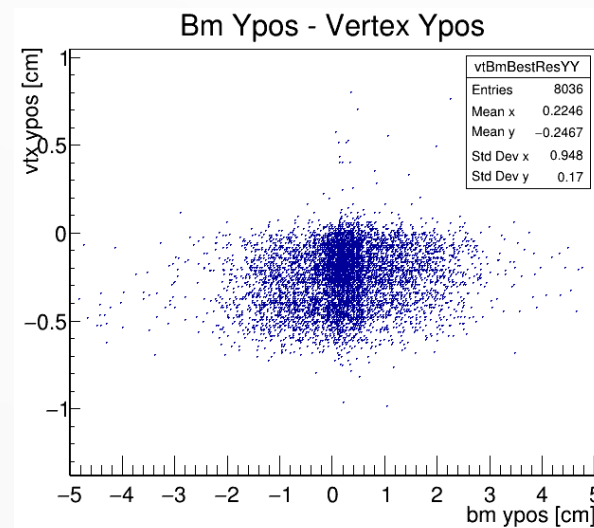
- Starting analysis on the 2211.july.dat run (no target, in principle vtx synchronized)
- BM tracks affected by the T0 shift
- Apparently No BM-VTX correlation
- Possible causes:
  - BM reco suffers too much for the T0 shift
  - VTX reco has something wrong
  - VTX events not synchronized due to event builder or hardware prob.

- GSI electronic setup: try to resolve the causes of the BM-VTX loss of correlations (use the TW hits position)
- Check the BM rejecting power on the events in which the projectile has fragmented on the ST or in the BM itself.
- Check the BM resolution and its impact on the inverse kinematic approach.
- ...
