Visual investigation of possible degradation in GEM foil under test

S. Chatterjee*, A. Sen, S. Das, S. K. Ghosh, S. Biswas

Department of Physics, Bose Institute, Kolkata, India

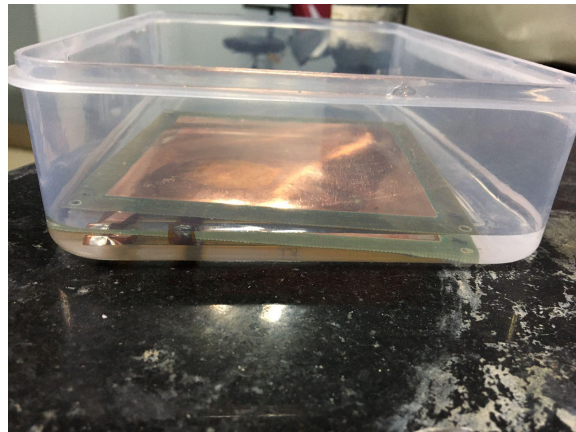
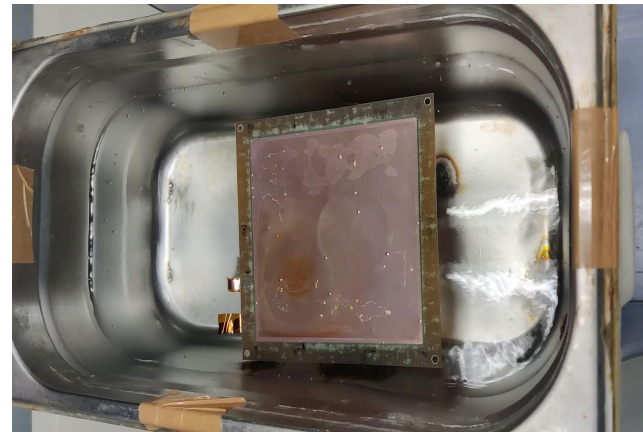
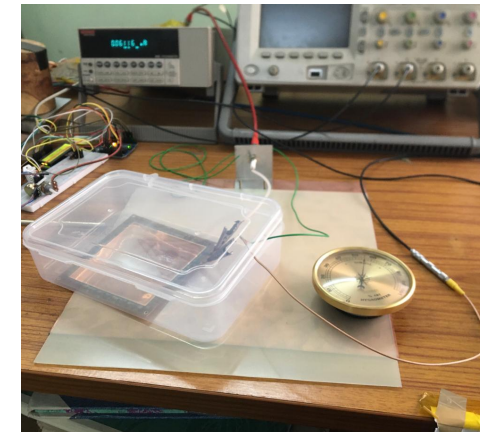
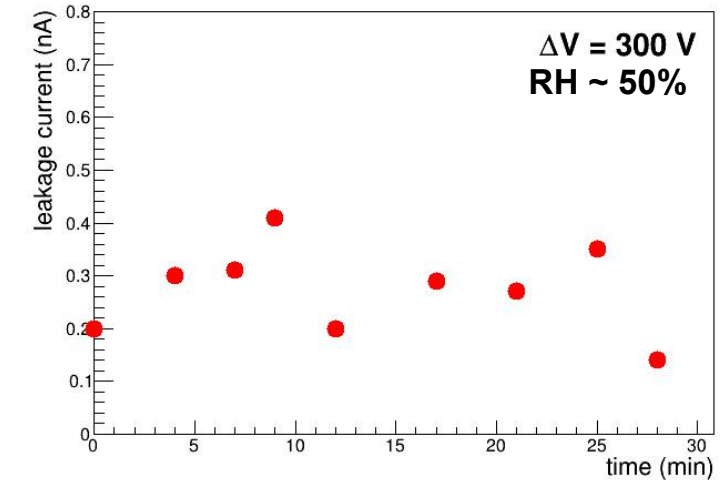
- During the long-term study of a Single Mask triple GEM chamber, the 3rd GEM foil of the chamber is found to be damaged
- The measured resistance is found to be $\sim 40 \text{ k}\Omega$
- Optical inspection of the GEM foil reveal imperfections in the GEM foil
- The short paths in the GEM foil are removed by using an ultrasonic ($\sim 20 \text{ kHz}$) bath with millipore water
 - The foil is kept in the ultrasonic bath for ~ 5 minutes
 - The foil is dried for ~ 30 minutes under continuous heat flow and after that the resistance of the foil was found to be high
- The leakage current of the GEM foil is measured and found to be reasonable (at $\Delta V \sim 300 \text{ V}$, RH $\sim 50\%$; $\sim 0.3 \text{ nA}$)
