L3 Tests

Ilaria and Riccardo
on behalf of the working group

BESIII Italia
Marzo 2021

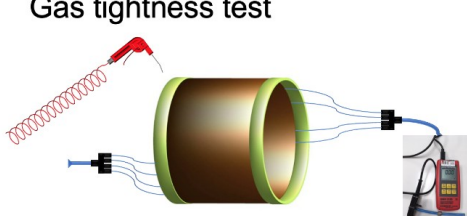
Gas tightness test: close a finished CGEM layer on a differential pressure meter, and blow N₂ on the surface. If the N₂ flow enters a hole, the instrument shows a sudden increase ($\approx 0.1-1$ mbar) of the detector internal pressure wrt the atmospheric one.

The first test showed a leakage

- glue sealing
- Following test showed no leakage

- Durante i test di validazione si inizia ad evidenziare una **notevole perdita di gas** (non presente all'uscita della camera pulita) di circa **30%**

- perdite nei fori di spina (1,2)
 - man mano che si chiudono fori se ne trovano altri più piccoli non evidenziabili prima, nel contorno degli anelli (3), [essendo più stretti di L2 e L1, fanno meno tenuta gas nella zona in cui gli elettrodi sono incollati sugli anelli]

- il gas filtra attraverso i fori di spina e trova strada all'interno dell'anello esterno dell'anodo
- si controlla ogni volta la perdita totale flussando con N₂, flussimetri massivi in ingresso e misuratore di flusso in uscita

- si arriva ad un **perdita finale dell'8%** ritenuta tollerabile ✓

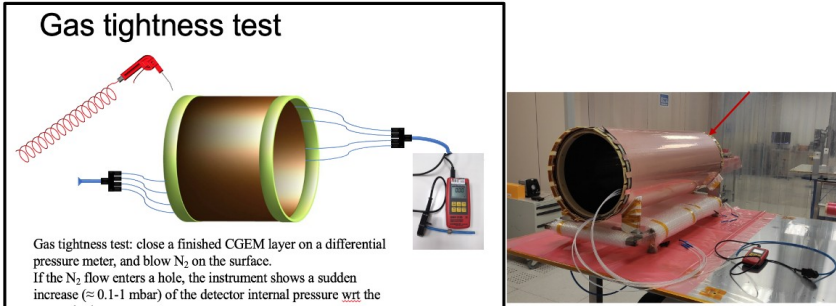
The first test showed a leakage

- glue sealing
- Following test showed no leakage

- Durante i test di validazione si inizia ad evidenziare una **notevole perdita di gas** (non presente all'uscita della camera pulita) di circa **30%**

- perdite nei fori di spina (1,2)
 - man mano che si chiudono fori se ne trovano altri più piccoli non evidenziabili prima, nel contorno degli anelli (3), [essendo più stretti di L2 e L1, fanno meno tenuta gas nella zona in cui gli elettrodi sono incollati sugli anelli]

- il gas filtra attraverso i fori di spina e trova strada all'interno dell'anello esterno dell'anodo
- si controlla ogni volta la perdita totale flussando con N₂, flussimetri massivi in ingresso e misuratore di flusso in uscita

- si arriva ad un **perdita finale dell'8%** ritenuta tollerabile ✓

L3 suffered a hit before gluing

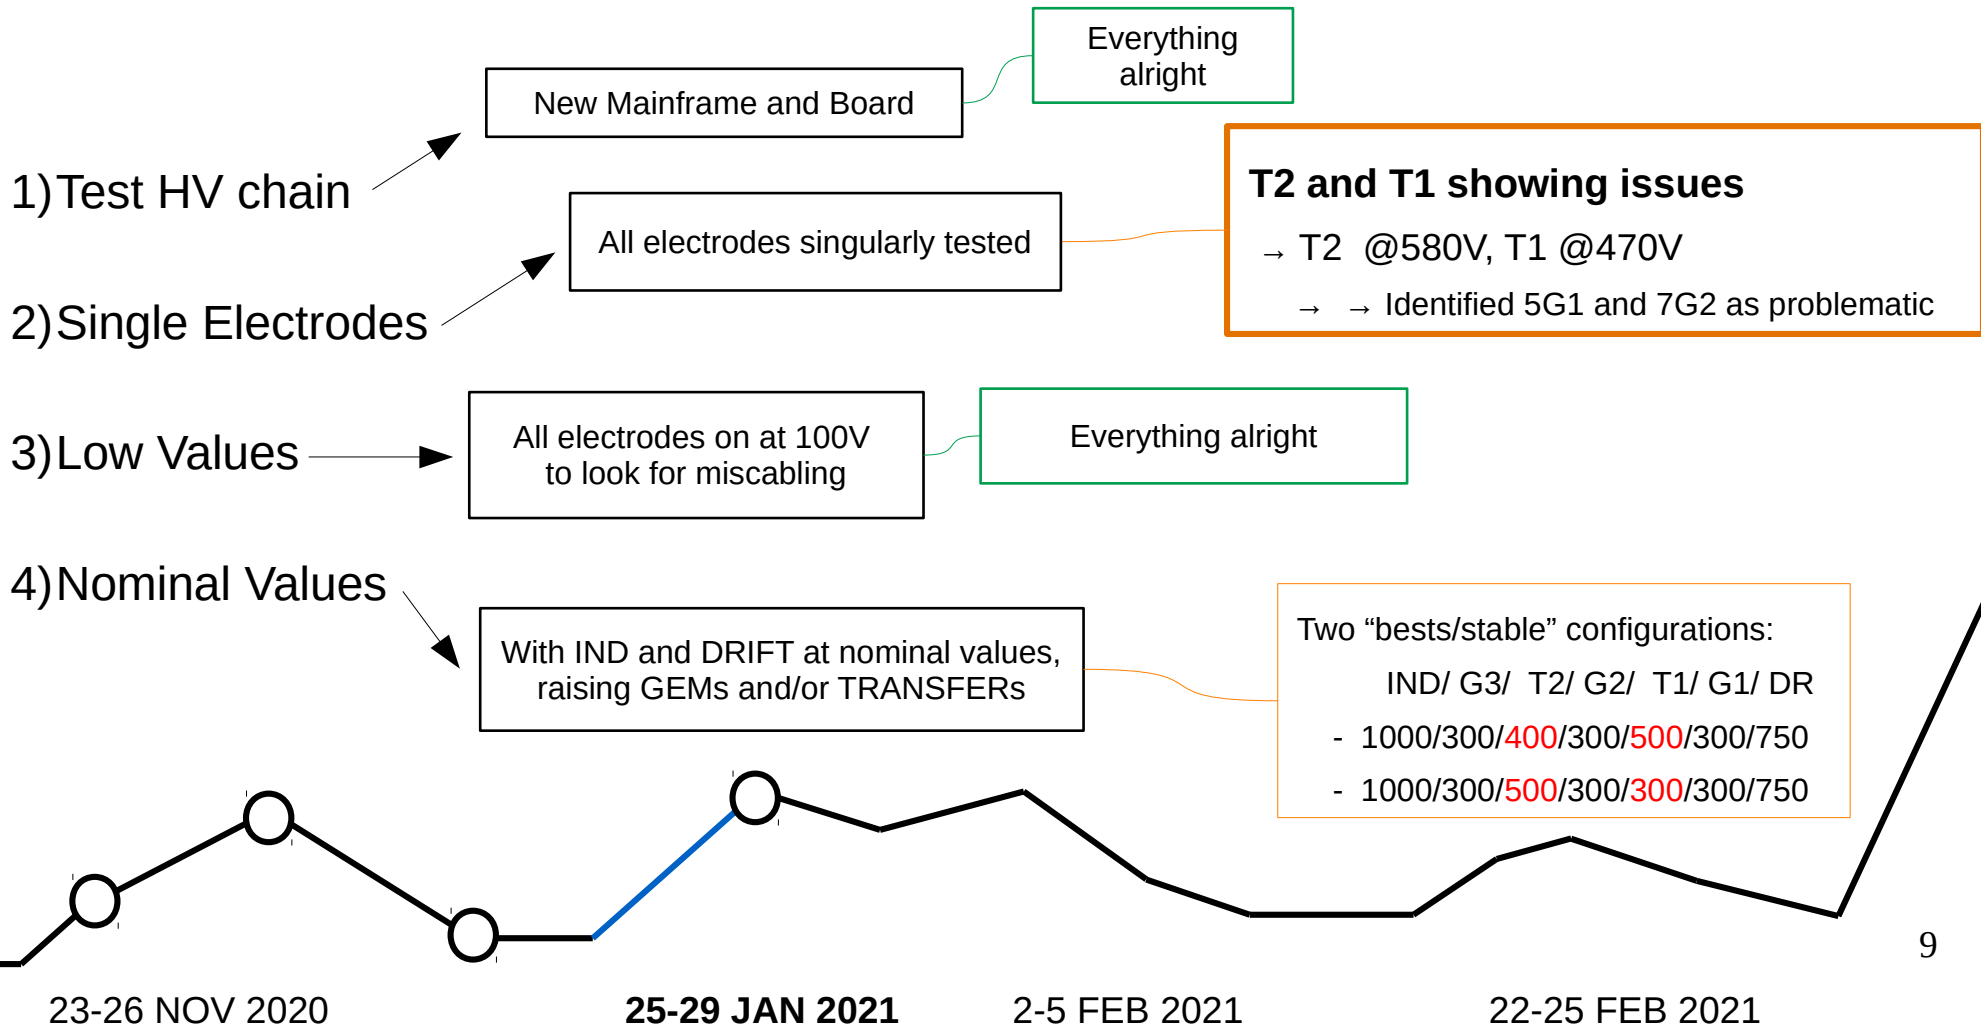
T ~ 13-25°C
H ~ 23-40%

Everything alright

All electrodes singularly tested

T2 and T1 showing issues
→ T2 @580V, T1 @470V
→ → Identified 5G1 and 7G2 as problematic

Two "bests/stable" configurations:
IND/ G3/ T2/ G2/ T1/ G1/ DR
- 1000/300/400/300/500/300/750
- 1000/300/500/300/300/300/750
