# Shift report

01-07/04

Liliana Congedo and Alessandra Pastore

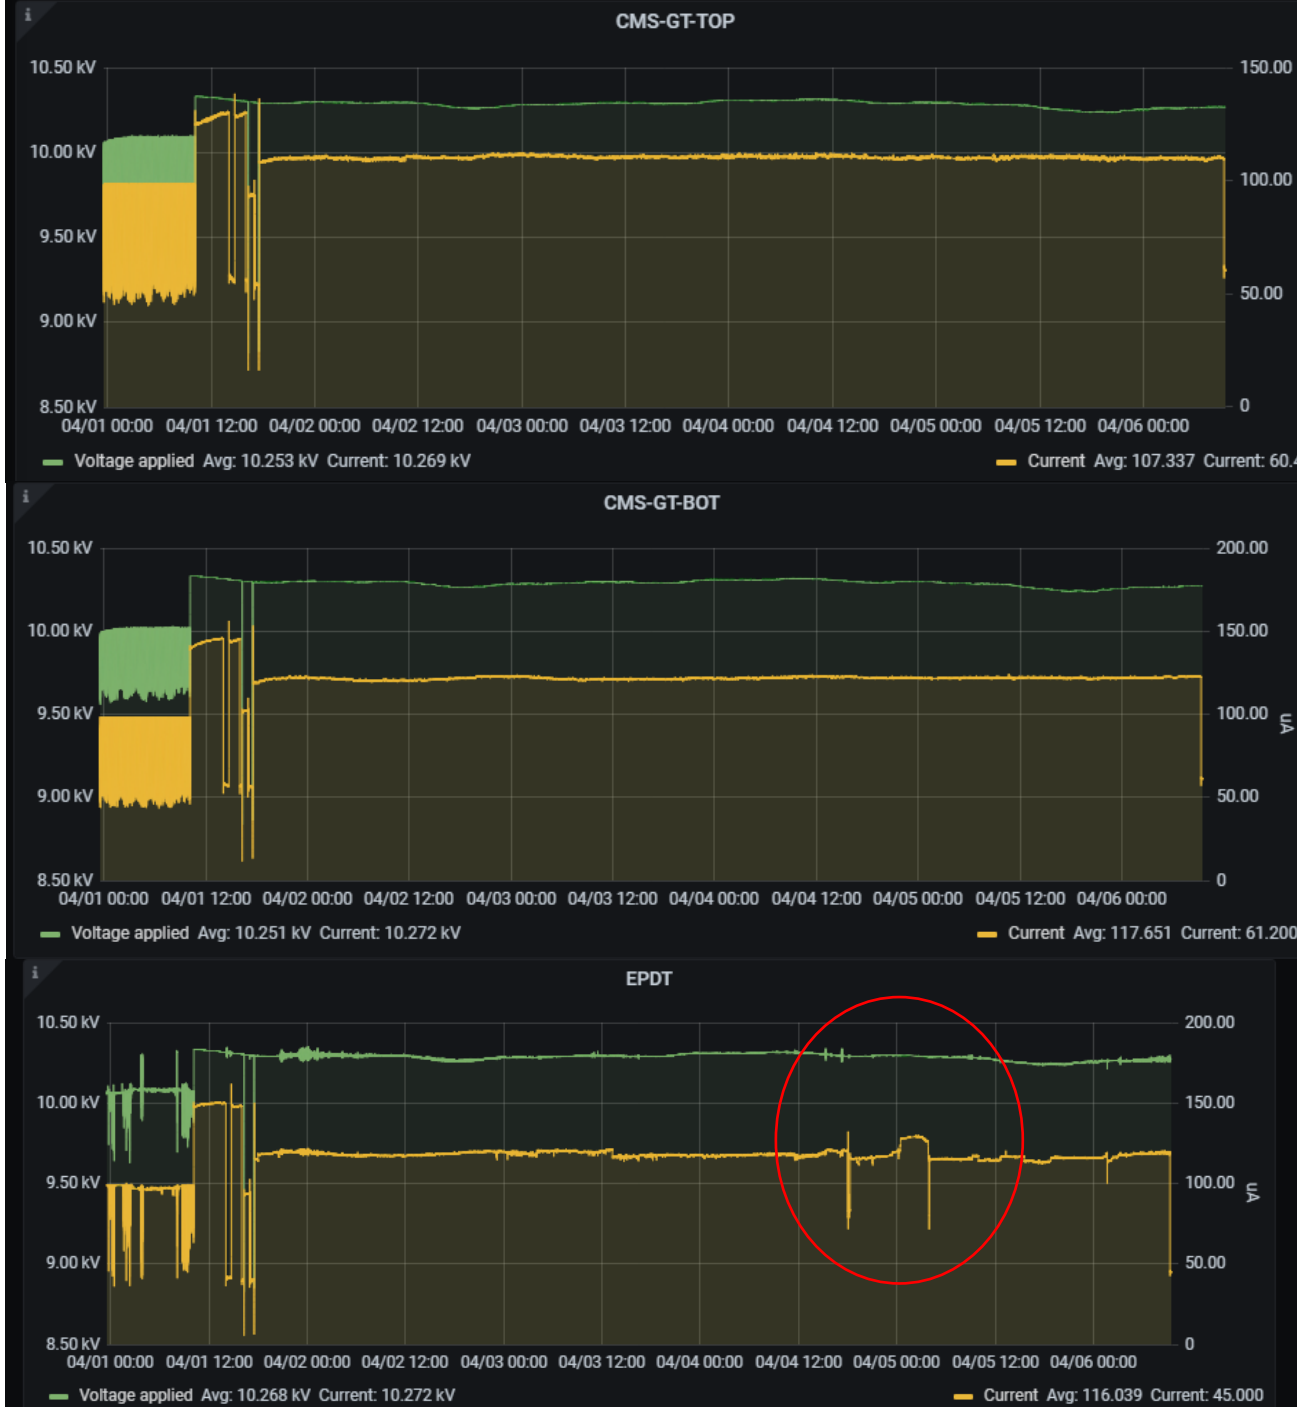
# Weekly stability run: currents

Some current spikes (up to about 50 microA) happened for EPDT. HV was correspondingly fluctuating of about 100 V. The source and attenuation factor were stable. The CMS chambers current fluctuations were about 2uA.

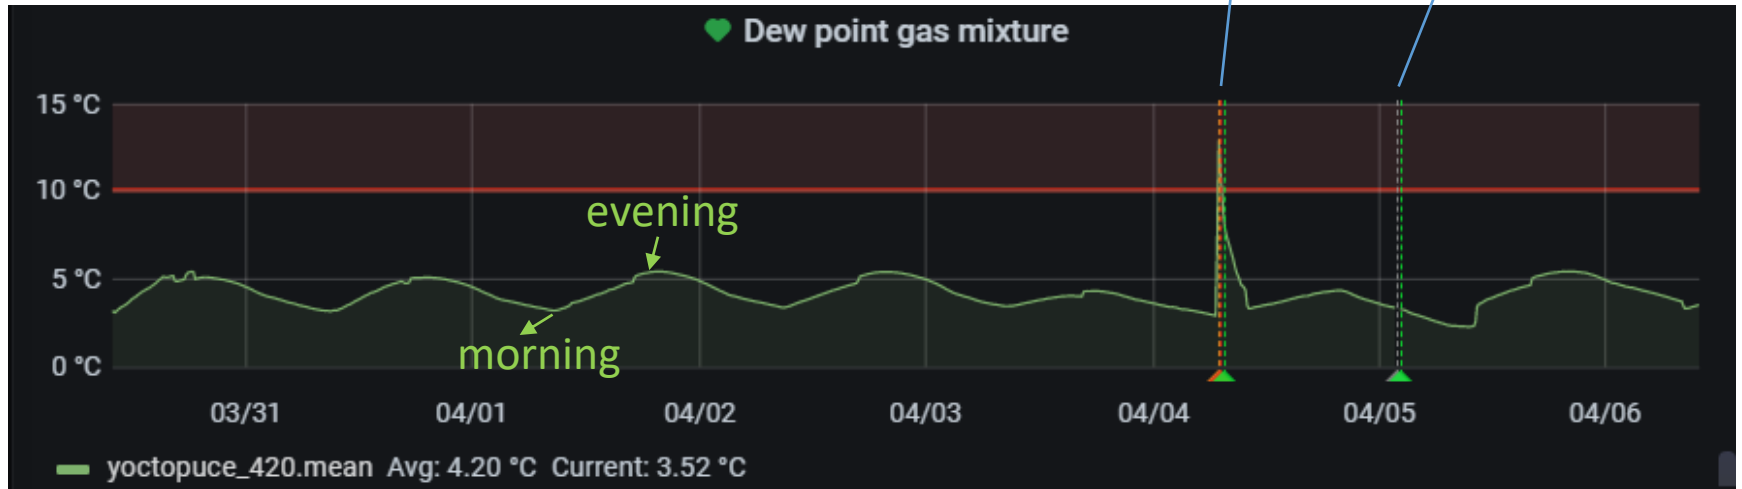
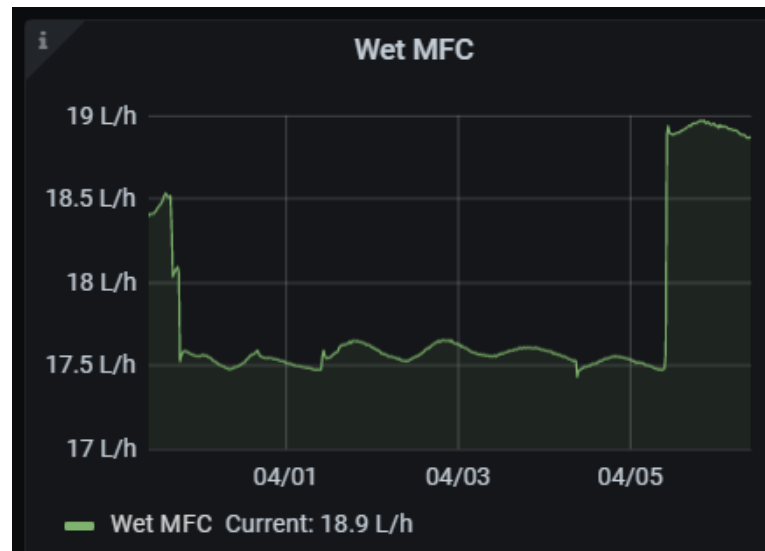
## Dew Point

- Run config has been updated;
- The source/attenuation status was stable. Correspondingly, CMS chambers current fluctuations were up to a few  $\mu\text{A}$  while some current spikes (up to about 50  $\mu\text{A}$ ) happened for EPDT;
- Dew point oscillated between  $\sim 3^\circ\text{C}$  and  $\sim 5^\circ\text{C}$ , with a Sunday peak (above  $10^\circ\text{C}$ );
- Now the source is off and an HV scan could be performed if everyone agrees.
