### **Observations of Spontaneous Field Emission Occurrence with Subsequent Cavity Performance Degradation – or,**

### "What Just Happened?"

Joe Ozelis

TTC Meeting, 28 February - 2 March, 2011, Milan

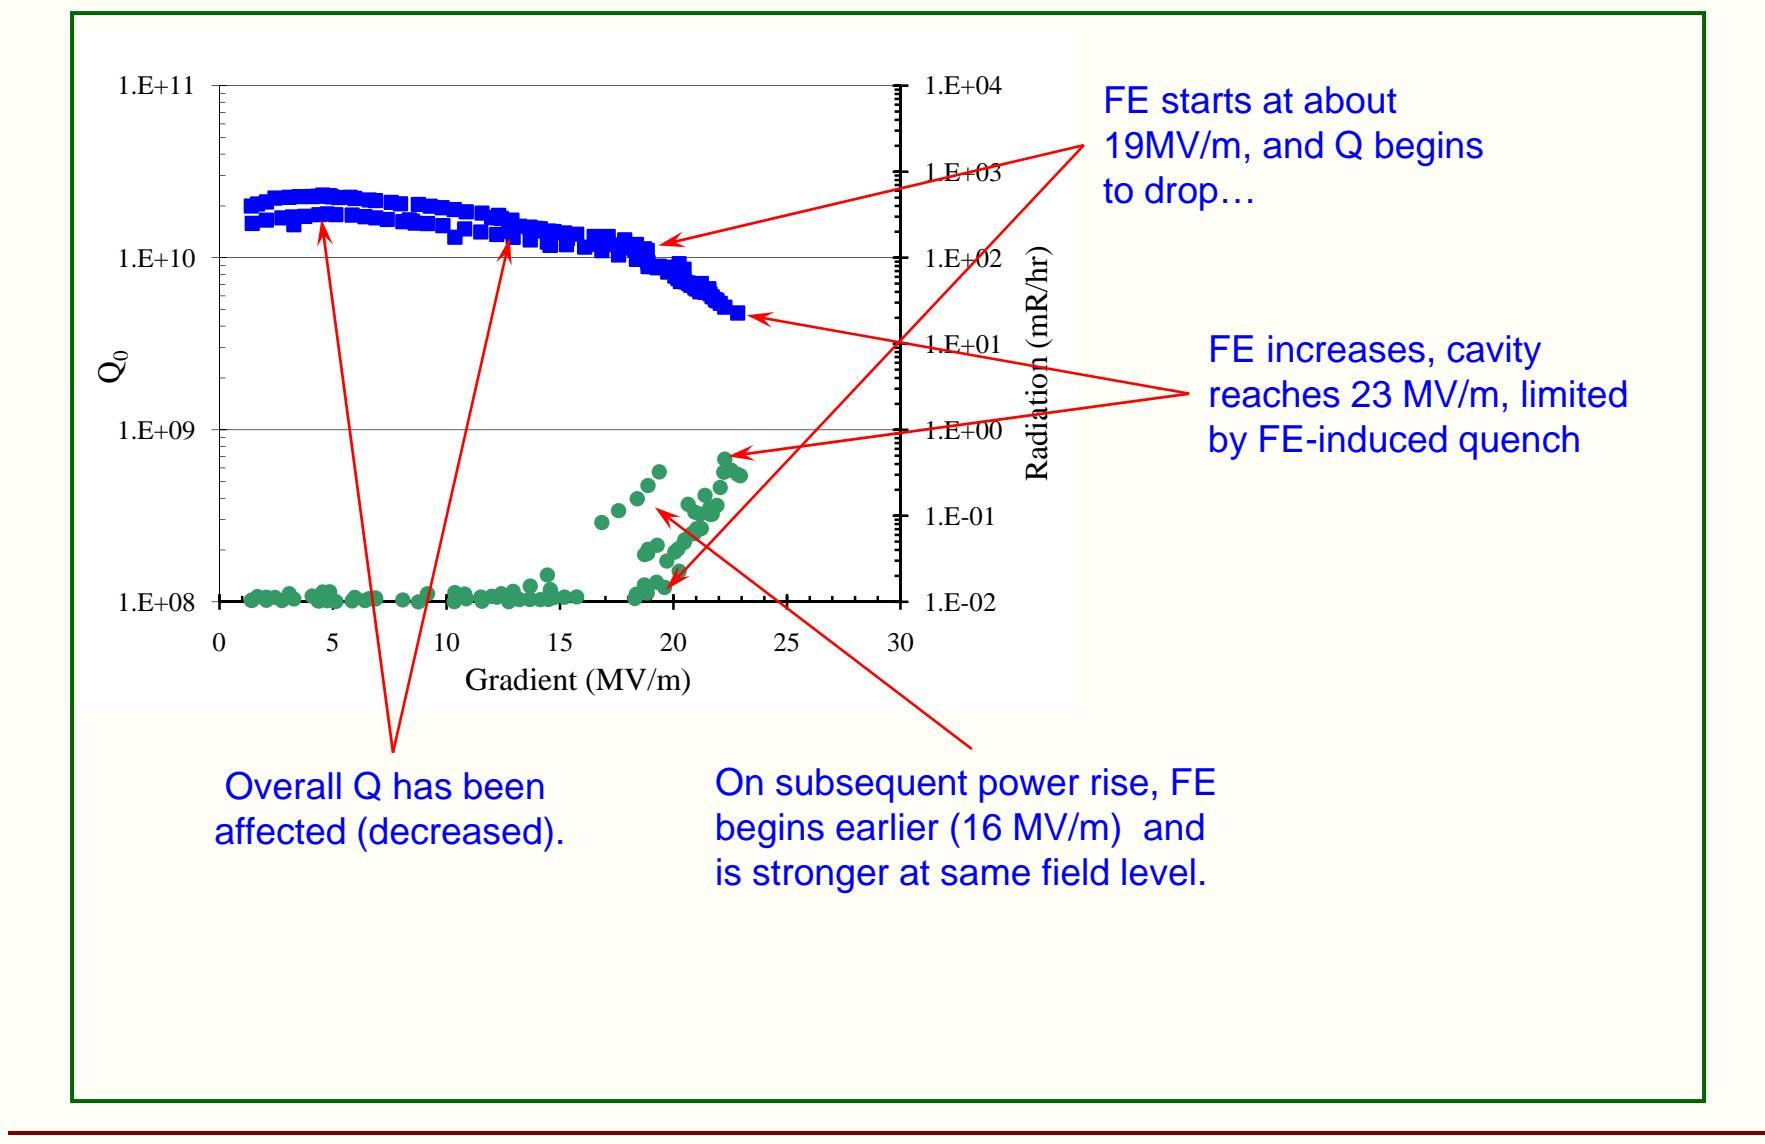
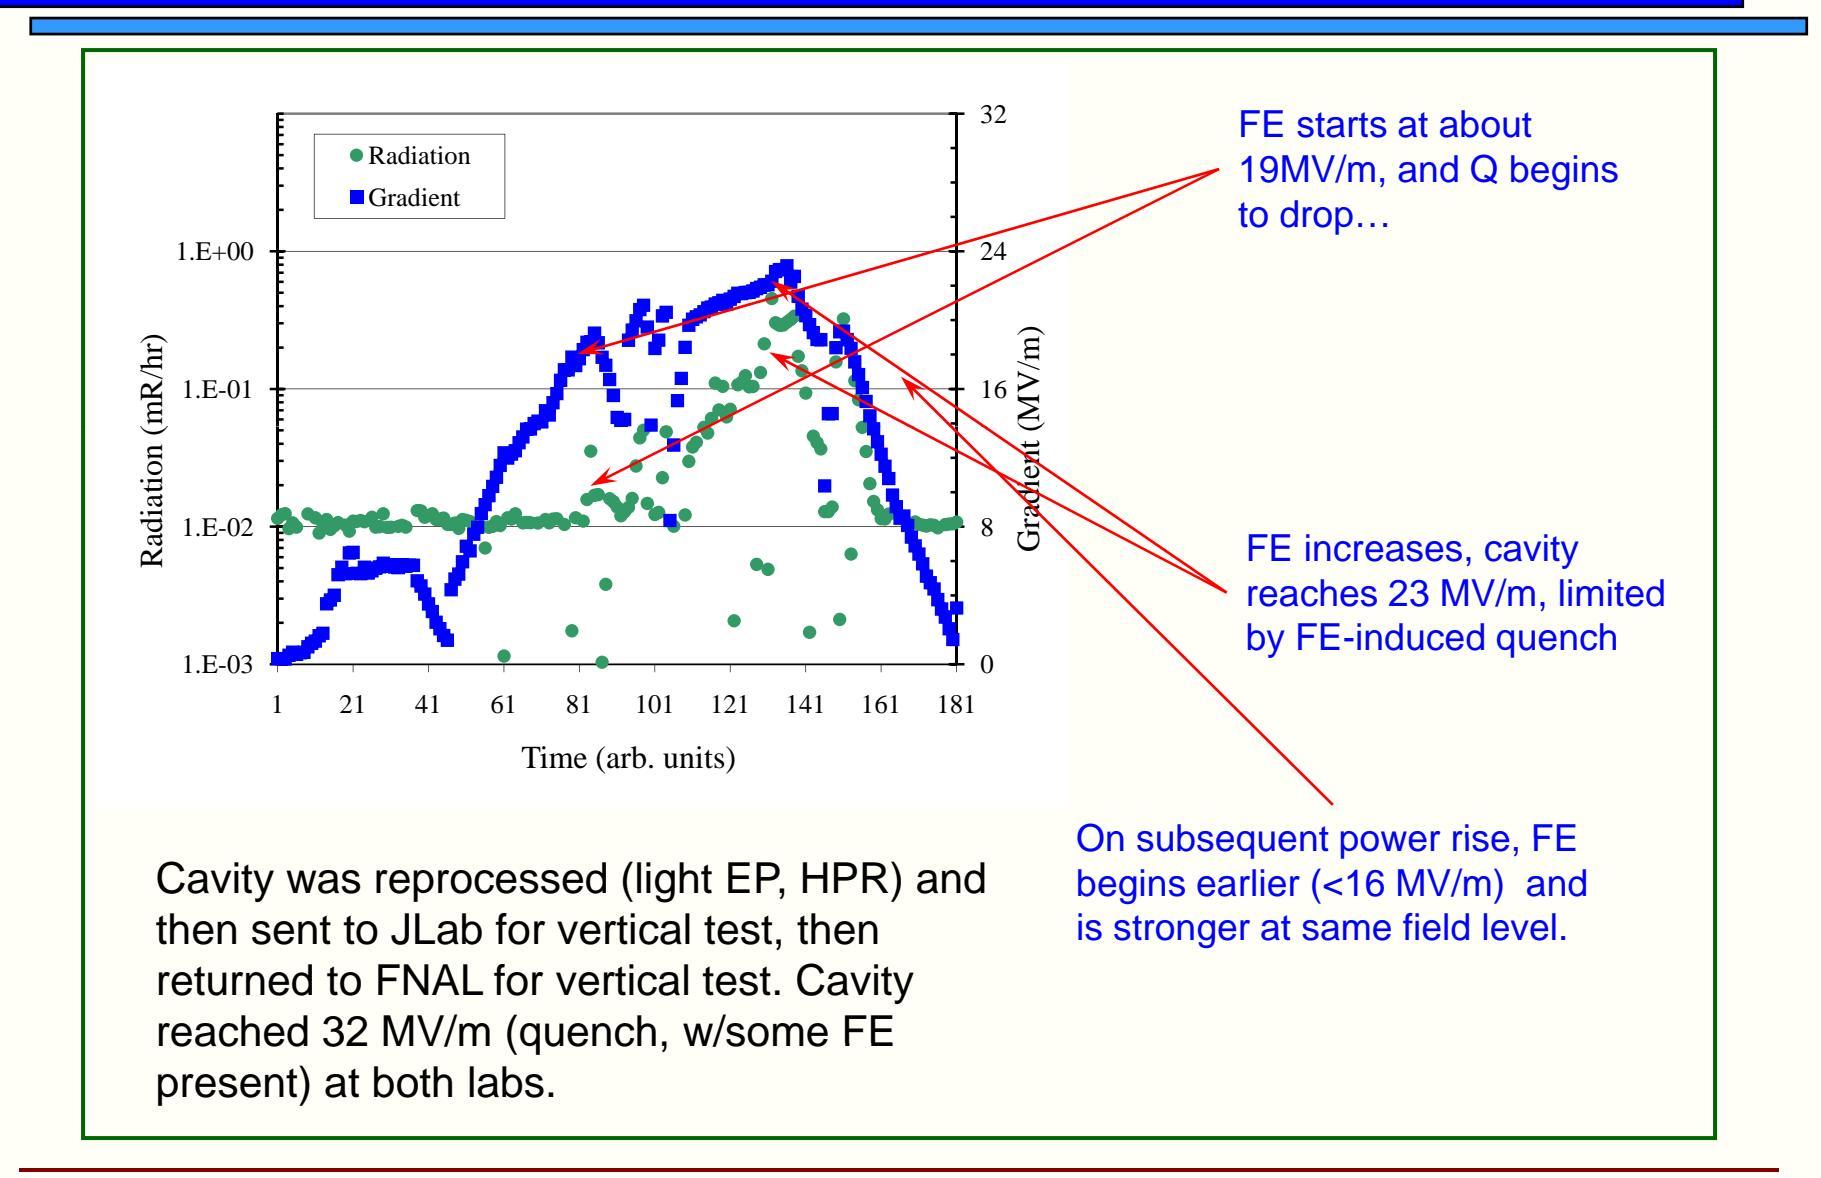
Cavity was subsequently damaged (dent in cell #9), repaired (cell #9 de-tuned by ~20%), and re-tested. Quench limited (FE) to 30MV/m.

The cavity was then given additional HPR and re-tested... quench limited to 34MV/m, with some FE. No more "events".

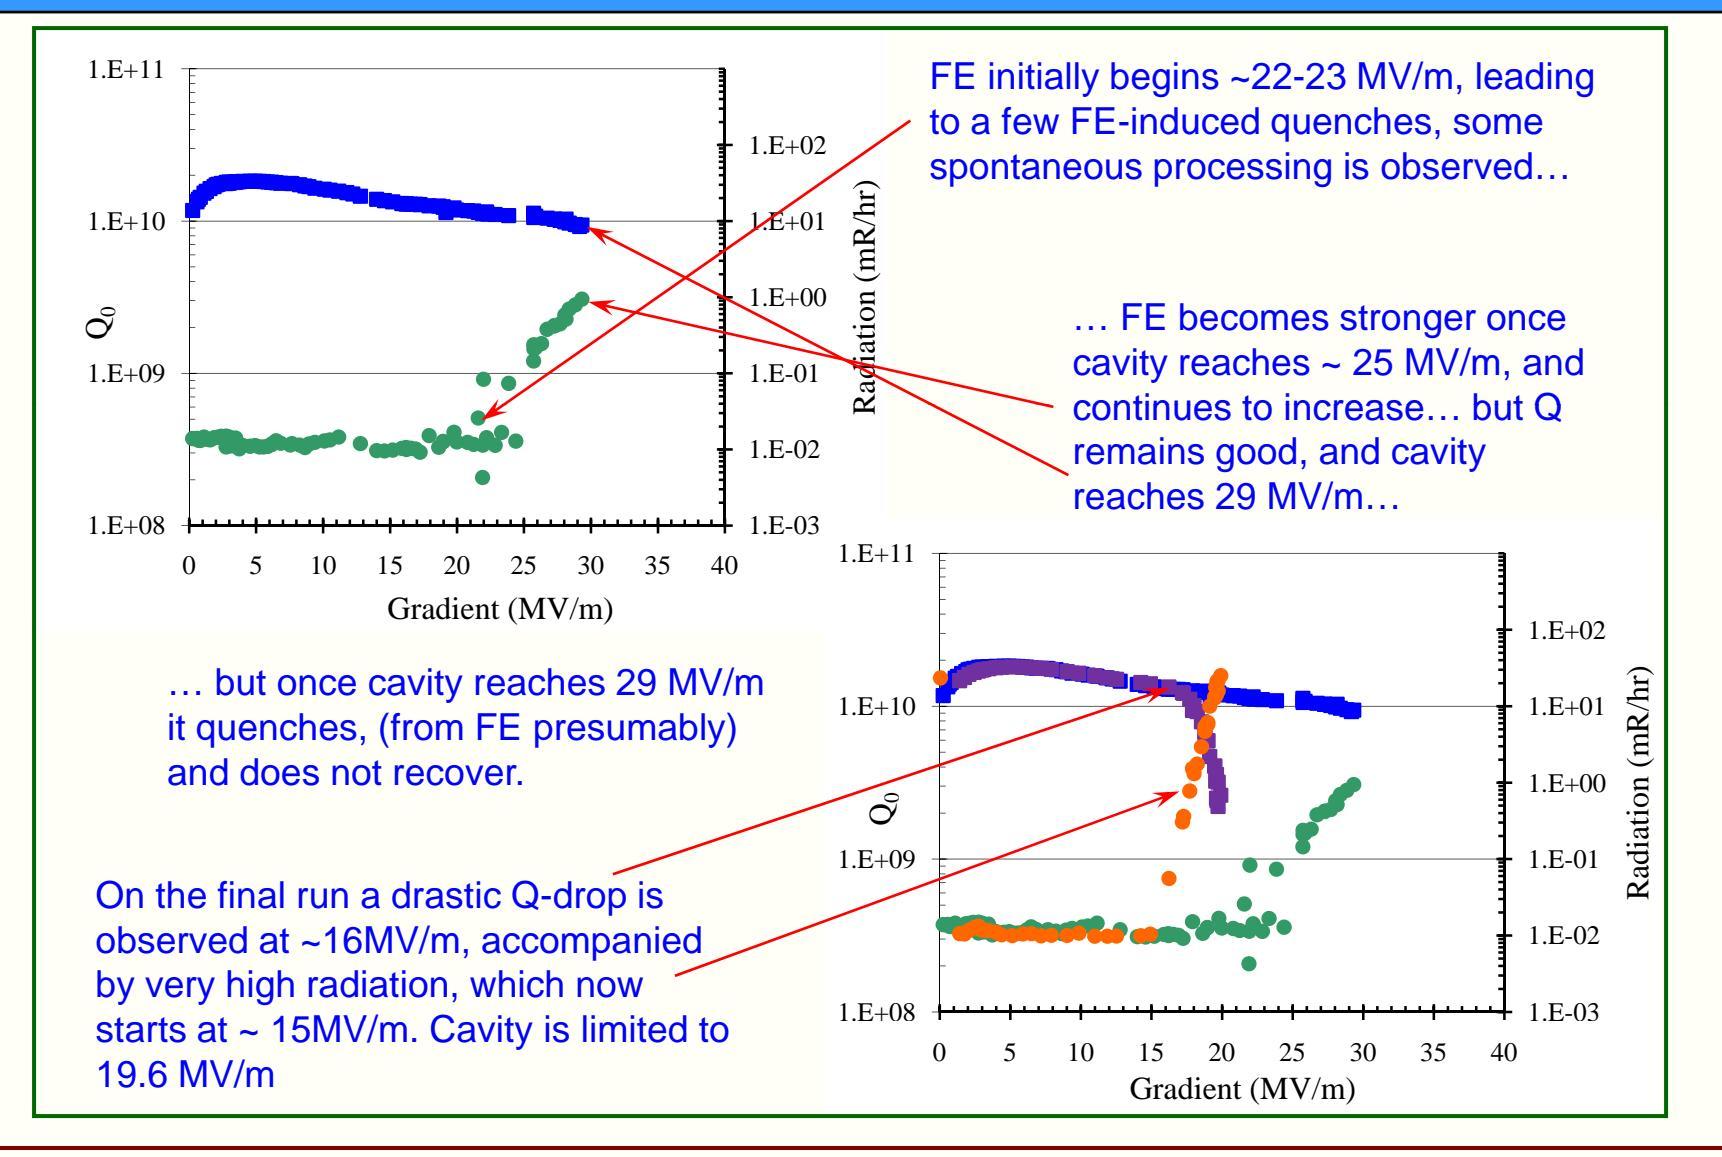
Optical inspections of TB9RI026 revealed a huge "crater" on the iris between cells 8/9, which got larger as EP was carried out.
