CERN
CH1211 Geneva 23
Switzerland

EDMS NO.
2802473

Microscopic examination of triple-GEM detector after installation and operation on LHCb with CF₄-based gas mixture

Previous studies in 2004 showed that after operation with CF₄-based gas mixture, the copper surface of a triple-GEM detector was etched due to bad gas flow rate conditions [1]. The aim of the current study is to inspect by microscopic means different layers of a triple-GEM detector after its operation in LHCb also with CF₄-based gas mixture.

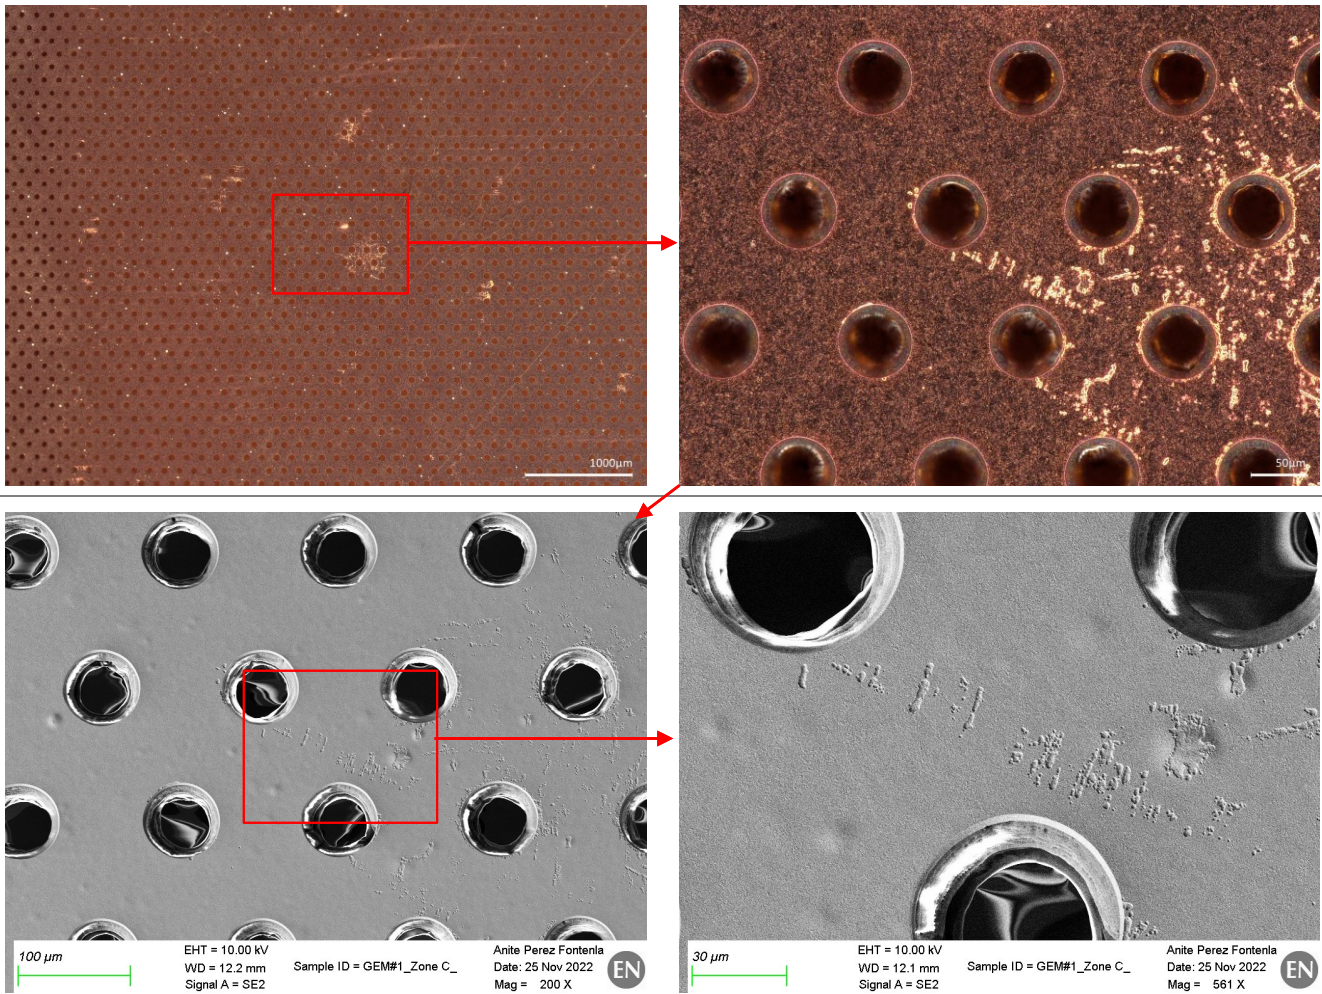
Figure 7 - OM and SEM images of the GEM#1 aspect on zone C

Microscopic observation on zone B and C confirmed the presence of a residue visible on the Cu surface. Representative images are included in Figure 15 and Figure 16 respectively. The chemical analysis of the deposit confirmed the same composition as observed in zone A with
