The Infrastructure Team

AGATA@LNL

Identified issues and adopted solutions

AGATA Week, October 19, 2023

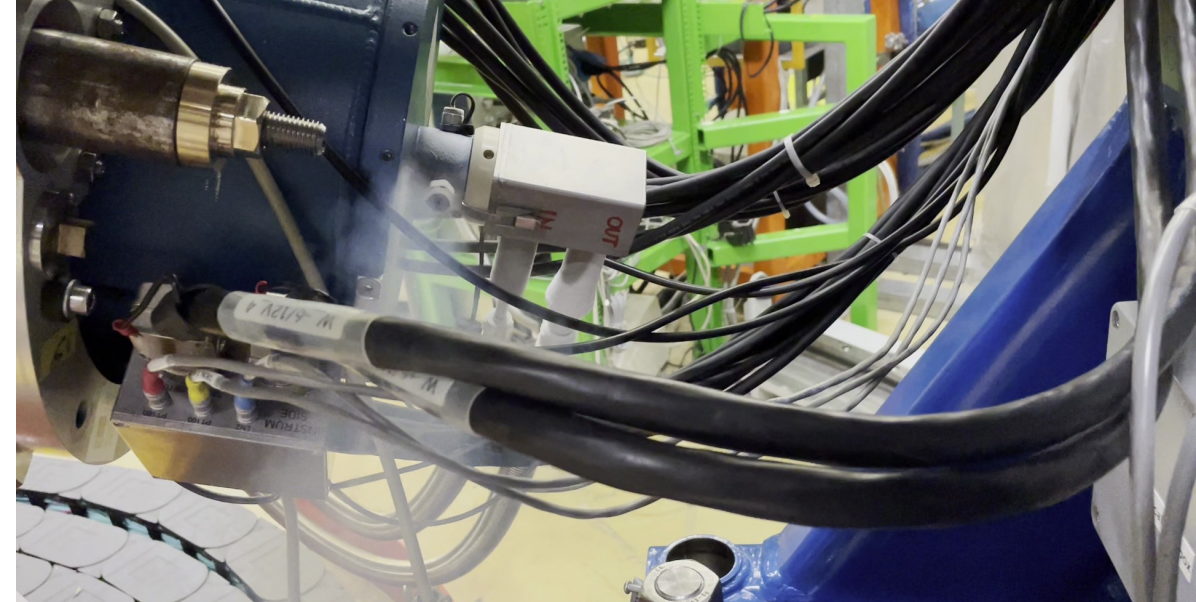
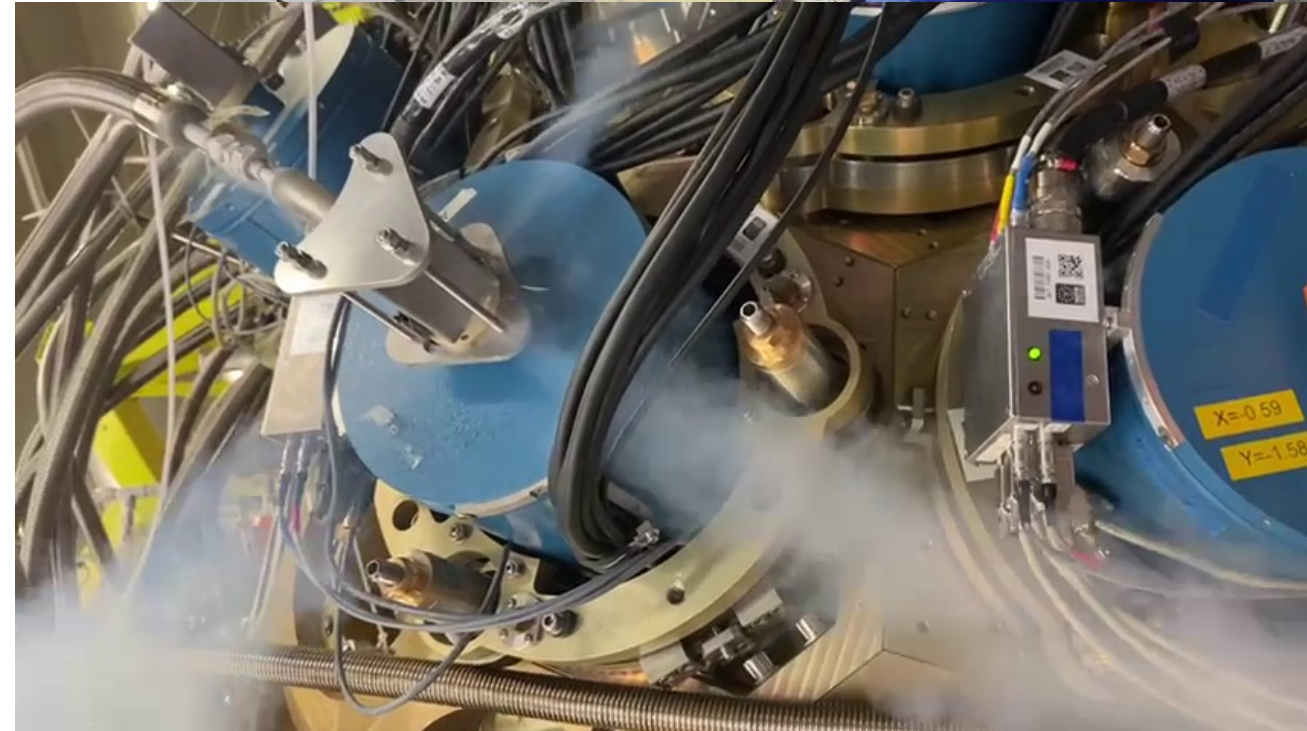
Detector bayonet

Limited flexibility

Mechanical fragility

Precise alignment and reduced strain on cryostat collar

New insert to improve mechanical stability

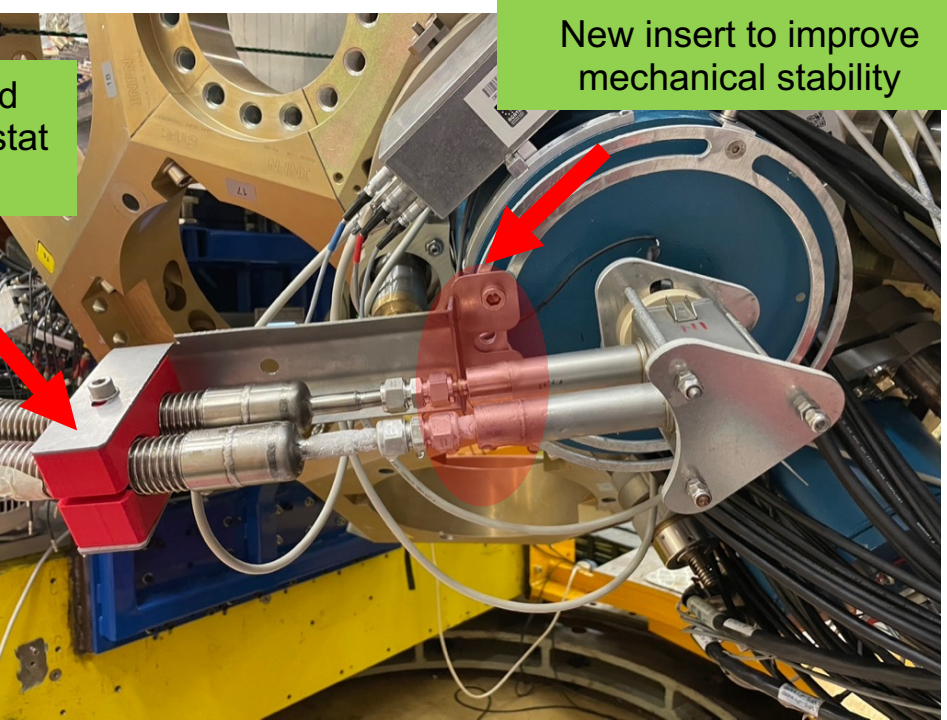
Polystyrene insulation

- Humidity

Additional isolation around the bayonets and improved air circulation

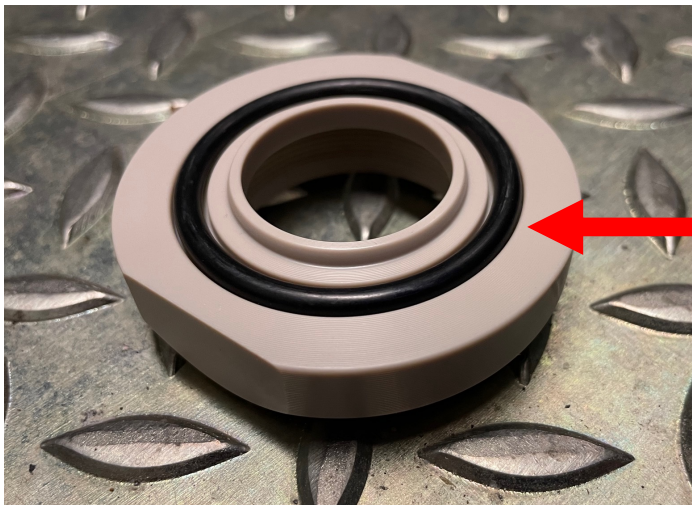
Modified adapter

- Very thin bayonet O-ring

Improved alignment ring

Standard fixing key

Additional O-ring

Adapter replaced on 10 installed detectors

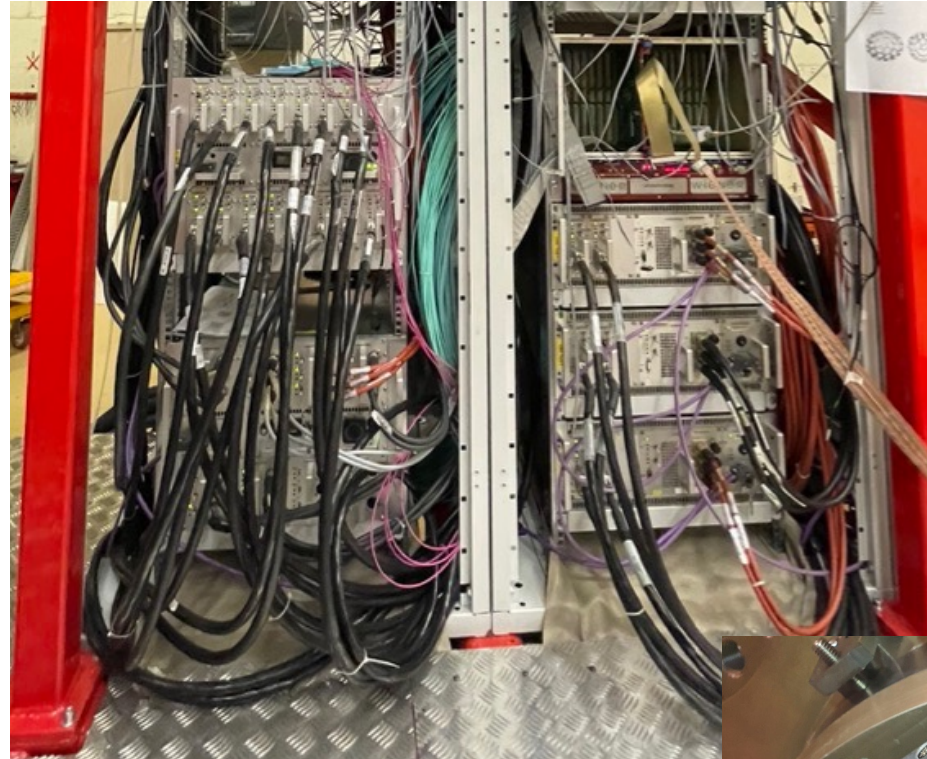
- LVPS: **burning component** (smell) in the new 6/12 V LVPS crate (ch. 4). The smell disappeared after ON/OFF cycle. All channels are working as expected

- LVPS PLC/GUI: Unexpected **general 6/12 V LV OFF**. Lost GUI control. Recovered control switching to manual mode.
- LVPS: the **PROFIBUS module** of the new 6/12V PS is **not working**. Diagnosis @ Saclay: hardware failure due to design problems. Problem fixed by AXIS and module sent to LNL. Preventive maintenance of 48V PB module. Fixed and installed at LNL in September. Now ok. Lengthy test procedure: purchased test LVPS unit purchased by GANIL
