Istituto Nazionale di Fisica Nucleare
Sezione di Bologna

Status rivelatore TOF, richieste 2024 e programma manutenzione straordinaria

A. Alici, P. Antonioli

Riunione con INFN referee - Roma, 20-21 Luglio 2023

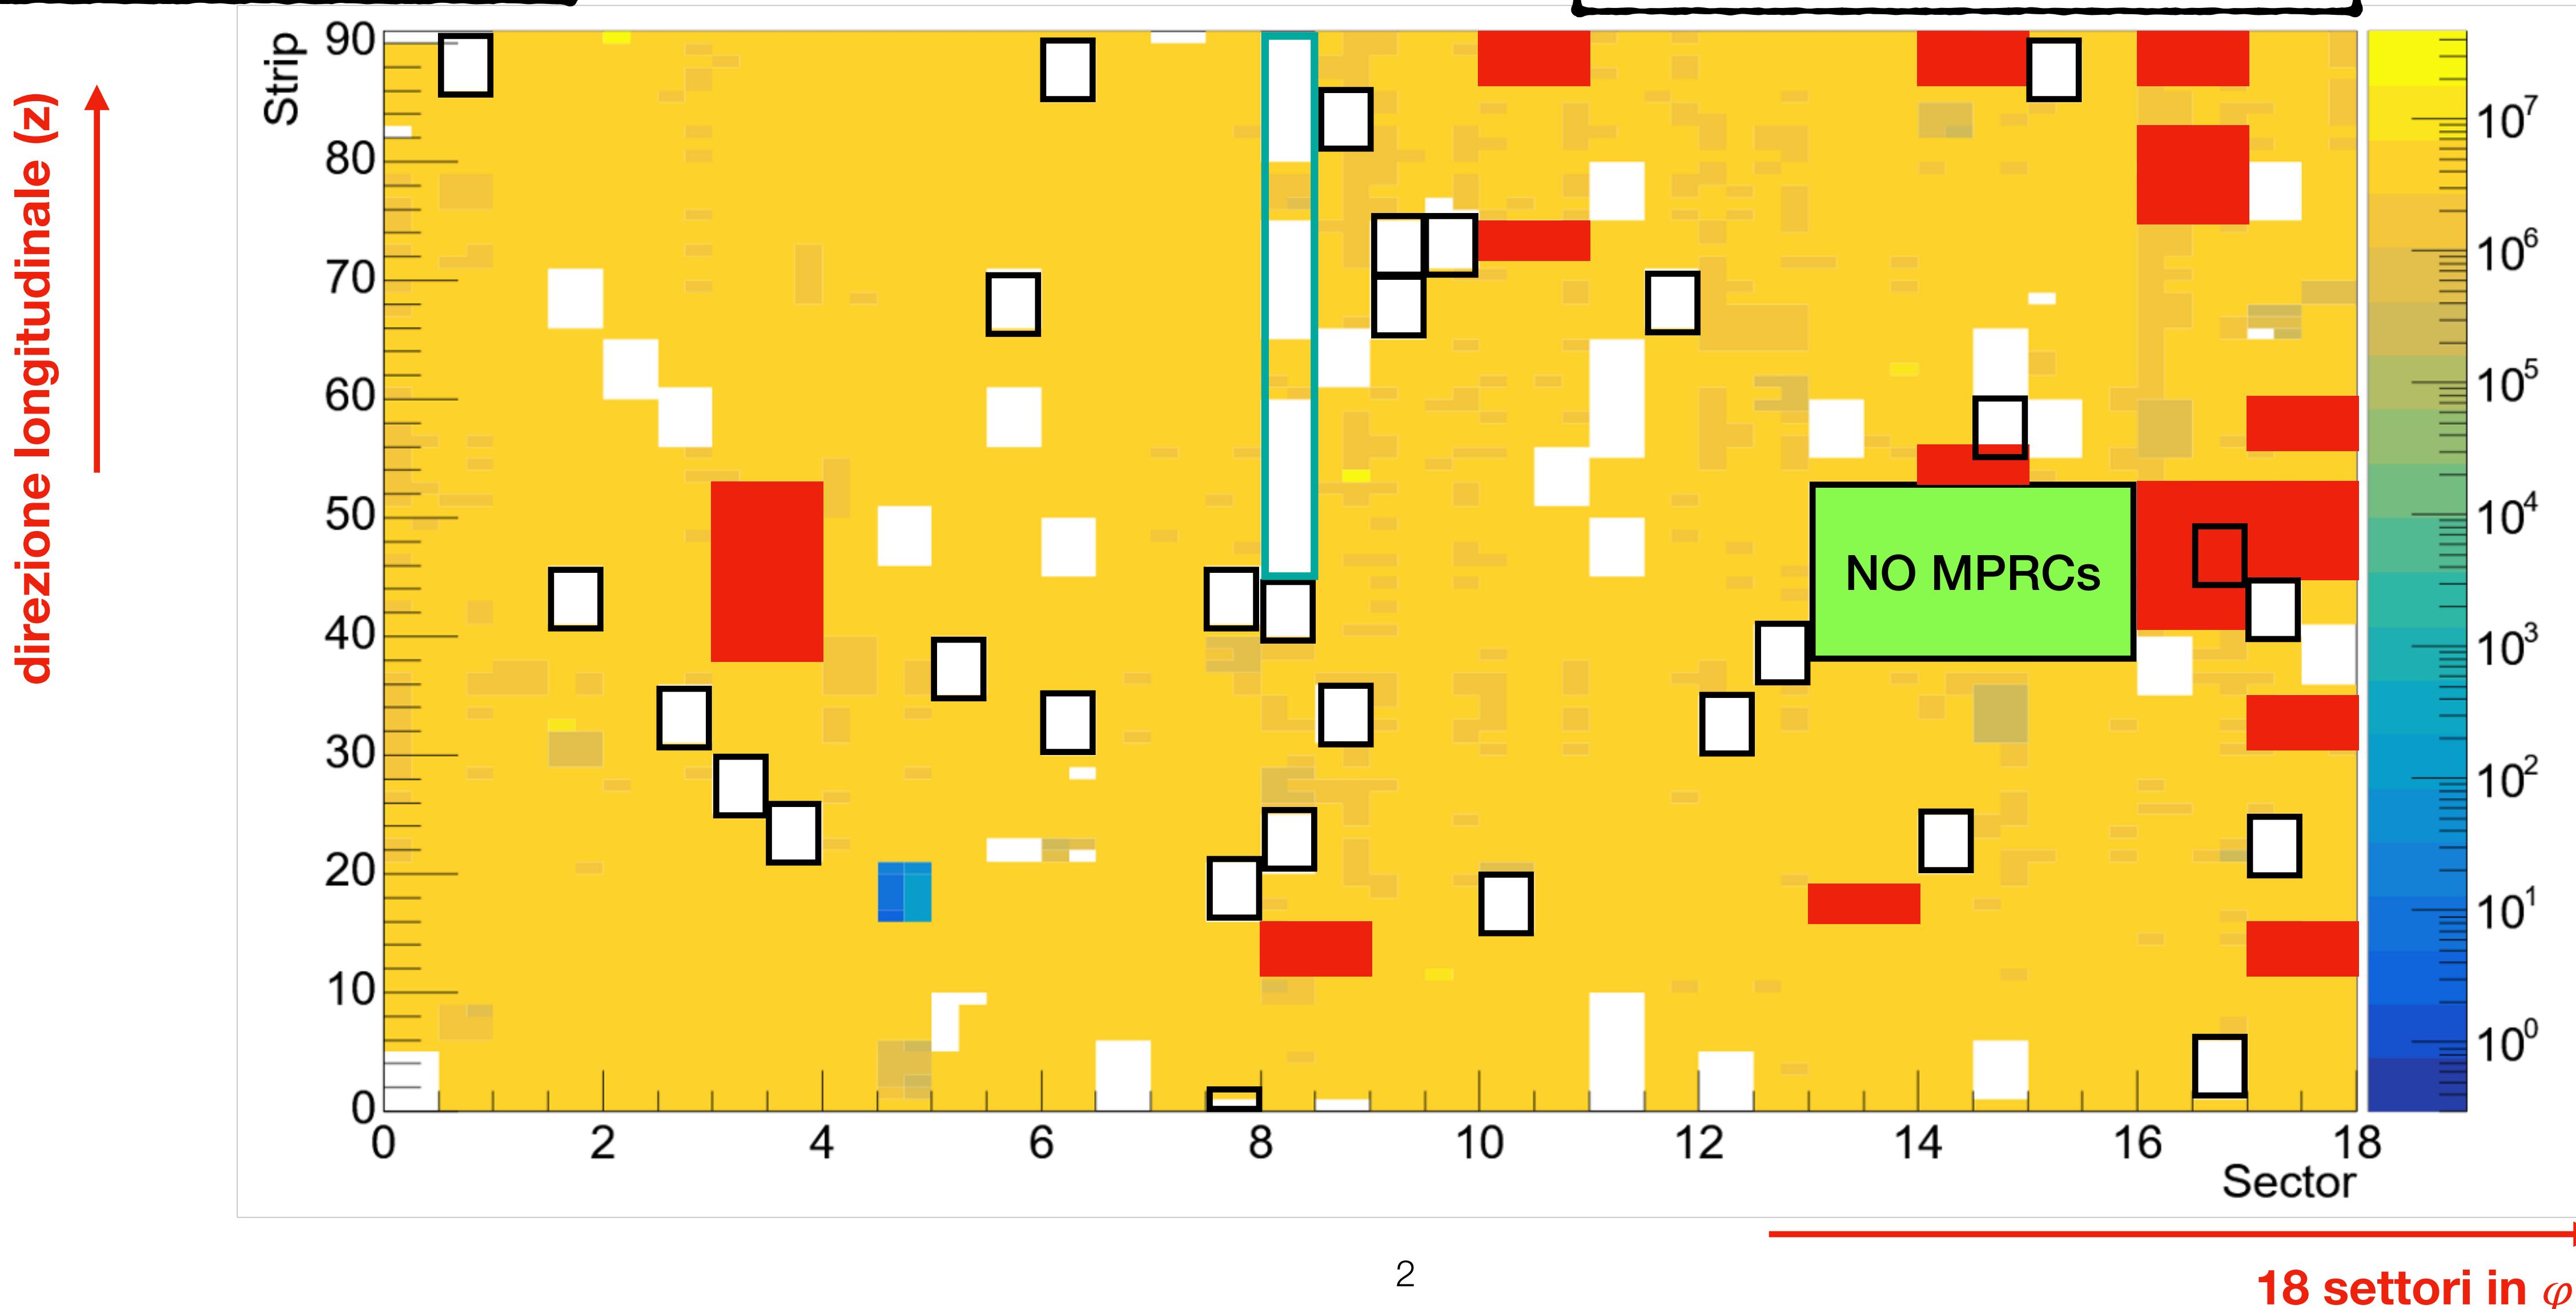
TOF Active Channel Map before YETS

Sources of inefficiency:
HV: 4.5%
TRM: 8.6%
Cooling: 1%

TOF total acceptance ~ 85.9%

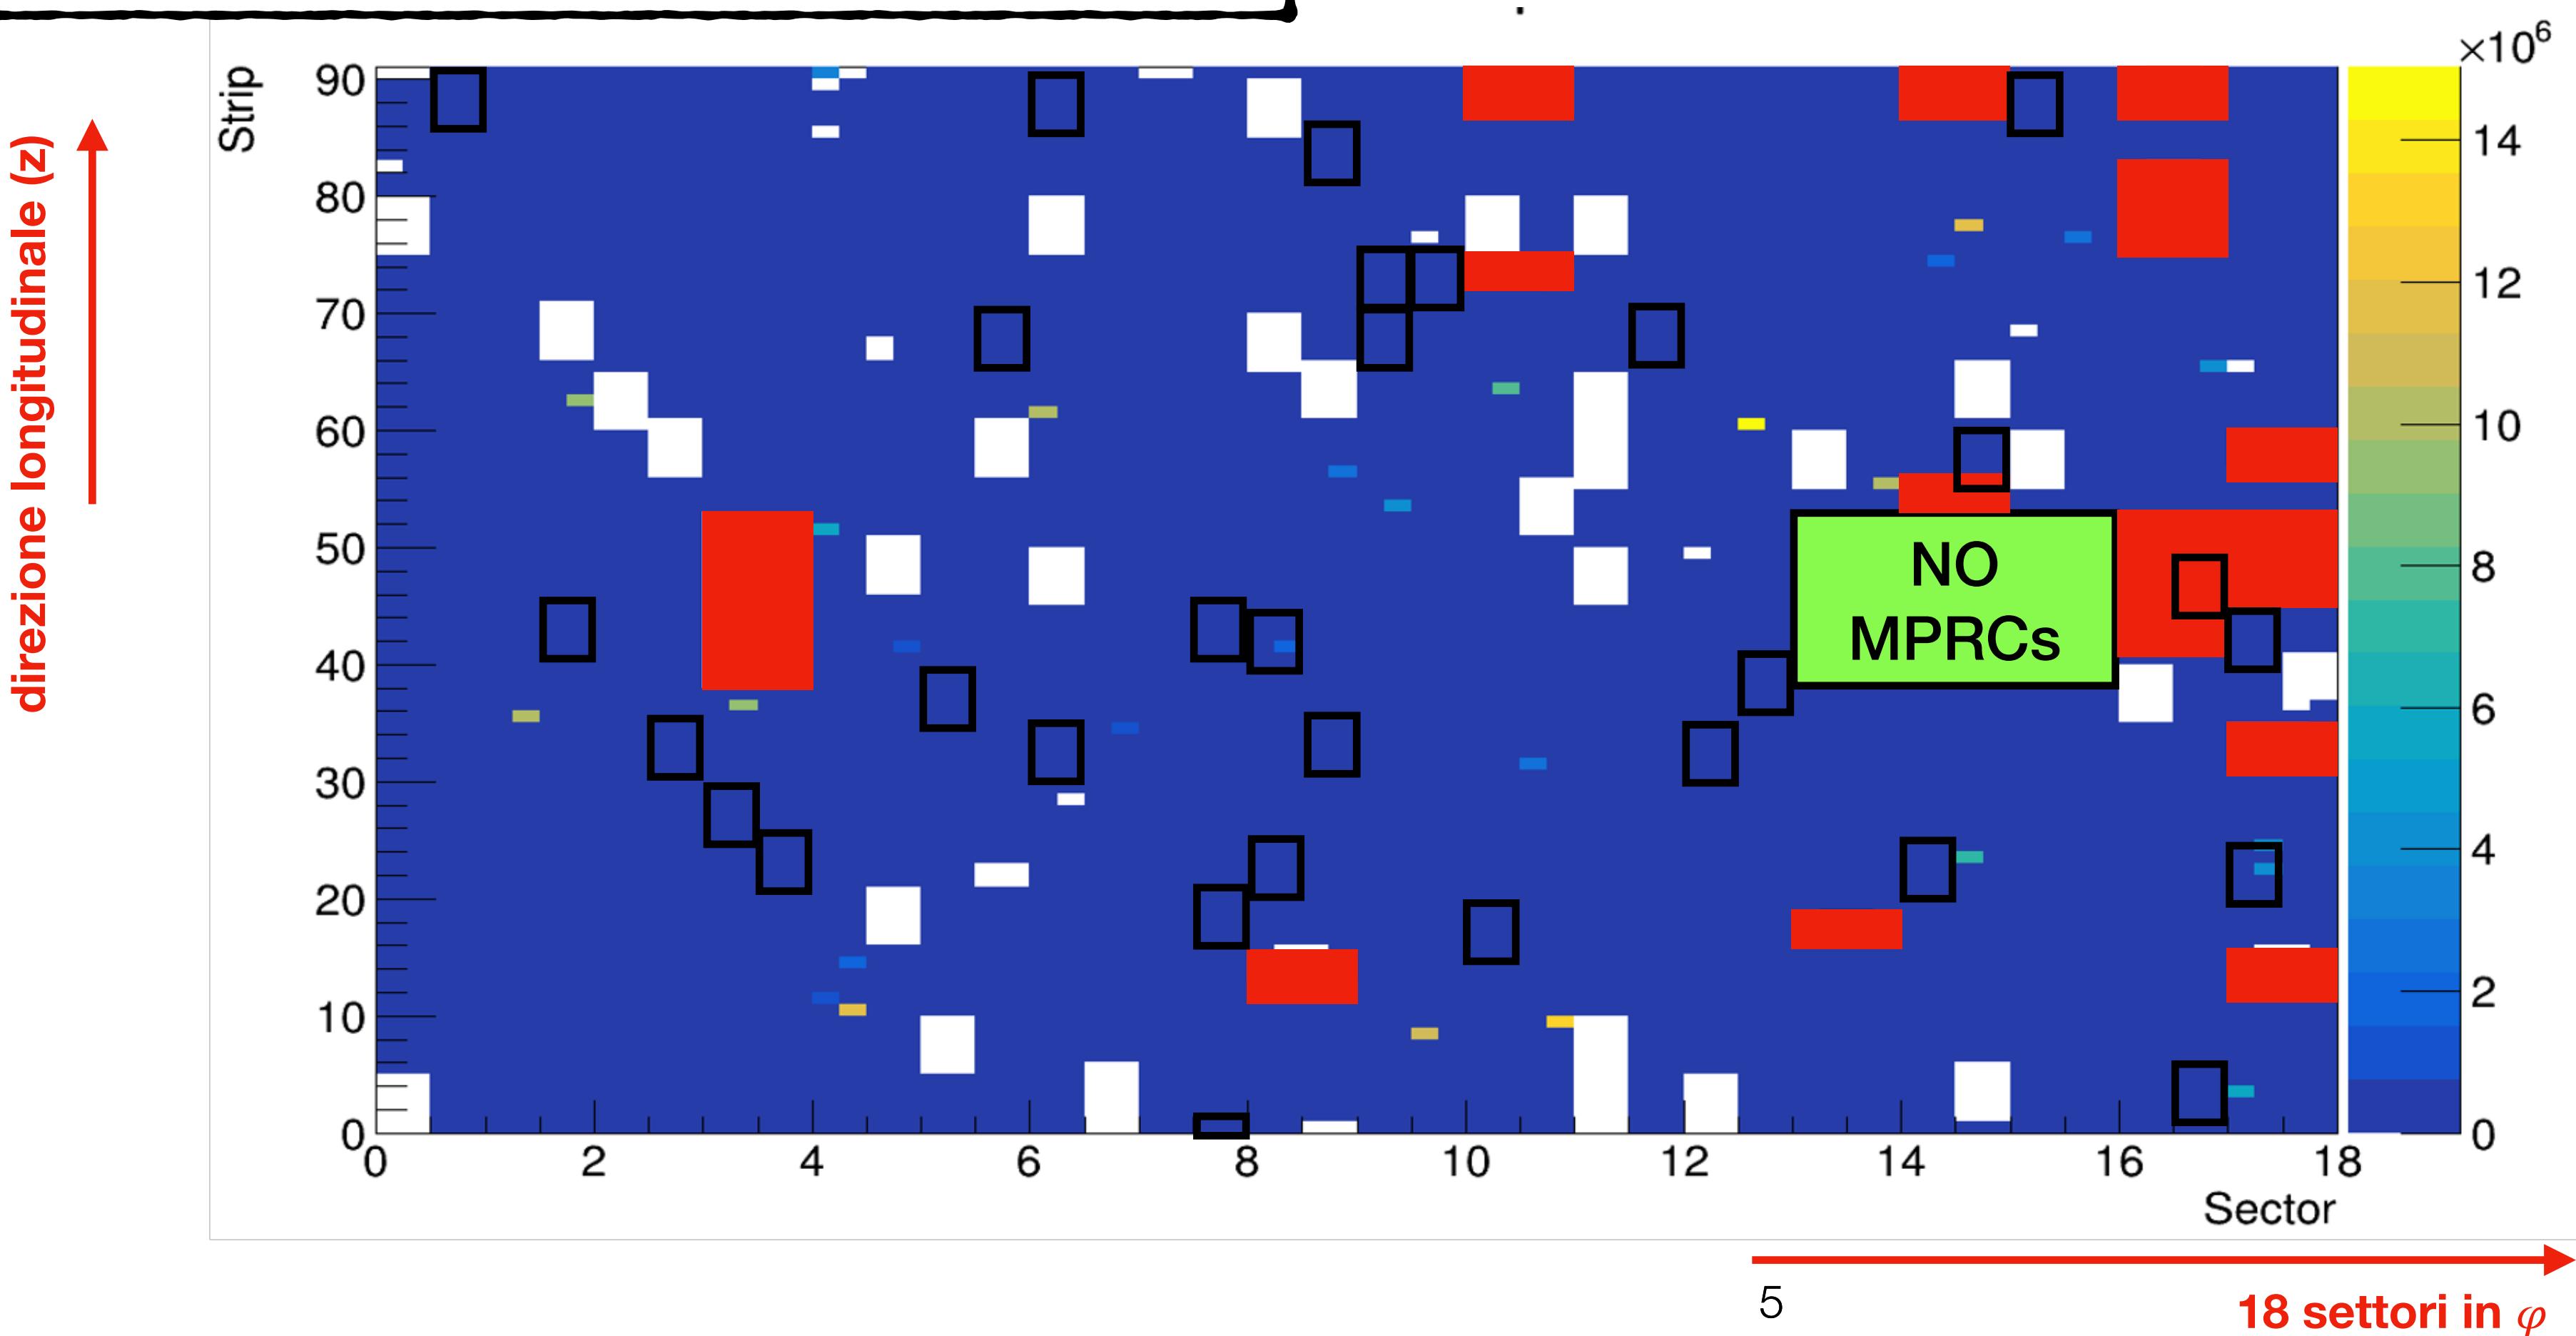
TOF Active Channel Map

Sources of inefficiency:

HV: 4.5%

TRM: 4.9%

TOF total acceptance: ~ 90.6%

- nessun canale è stato spento per malfunzionamenti di un rivelatore **MRPC**
- nessun segno evidente di ageing delle **MRPC**: dark current totale per oltre 1500 **MRPCs** ~ 2 uA
- I canali spenti per problemi HV (canali rossi nella mappa a fianco) **non sono recuperabili**... se vogliamo mantenere il livello di accettanza ~ 90% dobbiamo necessariamente intervenire sulle **schede TRM**

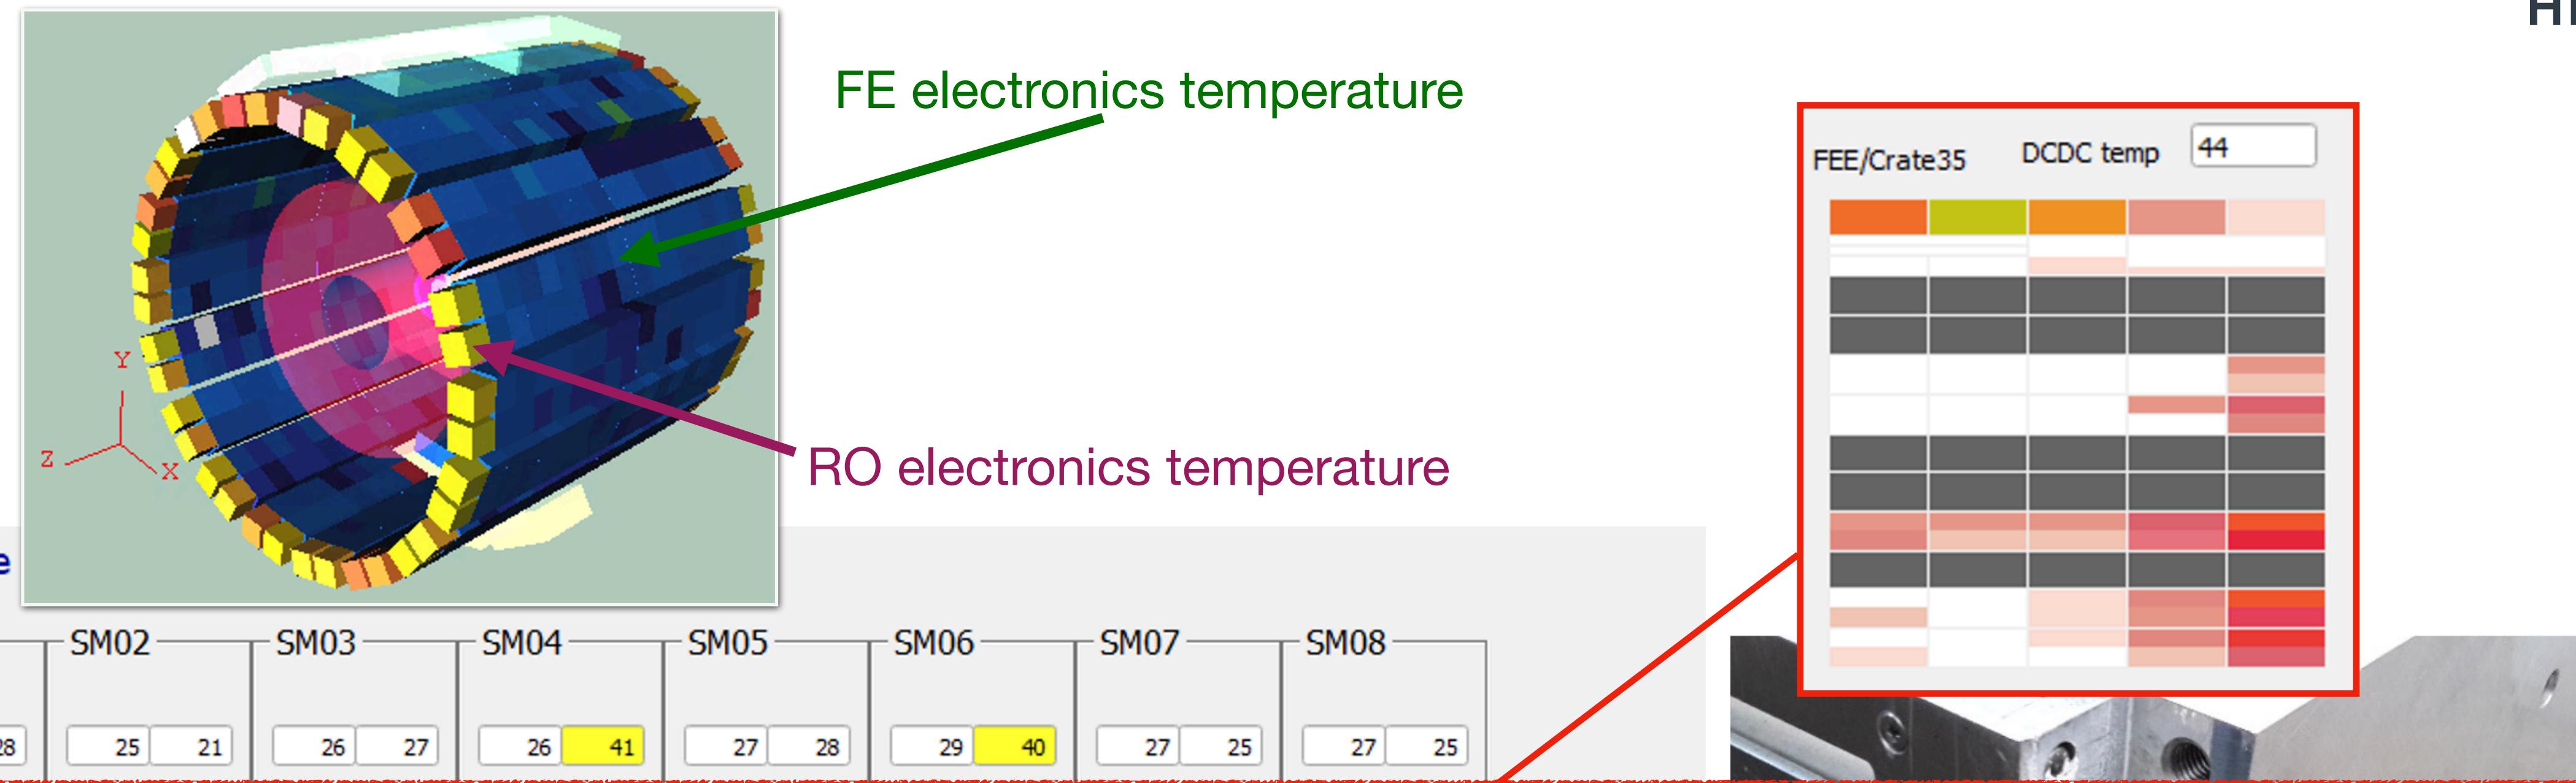
TOF VME crate cooling issue (2)

- a partial solution to prevent deposit in the TOF cooling plates is the use of [anti-corrosion inhibitor](#) to curb the deposit due to [Galvanic corrosion](#)
- CERN EN/CV inserted it in 2017 (after longstanding requests back to 2007!!) and it excluded it from the circuitry in 2019 without any communication to us. We learned that "by chance" in December 2019. In a meeting convened upon our request we learned the additive seems problematic (no data provided...)
- TOF formally escalated the matter to TC to intervene with CERN EN/CV making clear this way of working is **unacceptable**. And we made it clear this directly to CERN EN/CV in a devoted meeting.
- CERN EN/CV now says they will try another additive in ALICE in September (during TS). If nothing happens we will formally escalate the matter to the Management Board.

- Deposits in the cooling plant due to galvanic corrosion. TOF failed to design cooling avoiding mixing copper and aluminium. CERN EN/CV failed to alert ALICE and INFN engineers during cooling design review (2007). Amen.

- reintroduce a anti-corrosion inhibitor as a matter of priority
- invasive intervention during the next YETS:
 - option A: uninstall (replace) the cooling plates (heat exchangers) —> many mechanical interferences, surveys indicated that likely this solution is not feasible...
 - option B: free the heat exchangers from springs and deposits with a kind of tunnel digger —> many technical issues (lack of space, **rimozione dei detriti...**)
 - option C: new cooling plates on top (in close attach) to the clogged ones —> lack of space...

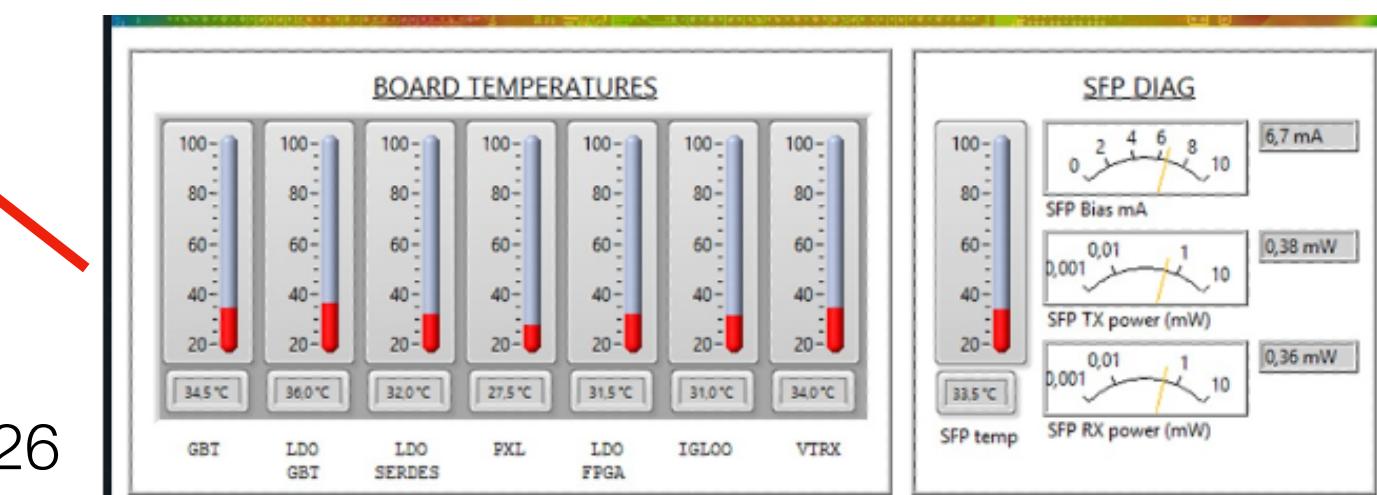
- Heatsink arrived 03/02/2022 in Bologna
- Crate in Bologna, with cooling circulating (15° C) + full power + DAQ running
- T sensors read every 10 seconds for one day
- VTRx sensor is the one important!

- the enhanced cooling solution moderately improved cooling in VTRx area. Further tuning and optimization remains possible
- if we install CE solution we loose the possibility to replace on the spot the VTRx without extracting the card**
- engineering cost of CE was **6 KEU (nessuna richiesta extra a INFN)**, for all cards would be **20 KEU** + 2/3 months effort and mission costs for personnel at CERN (**non faremo richieste straordinarie per questo item nel 2022**)

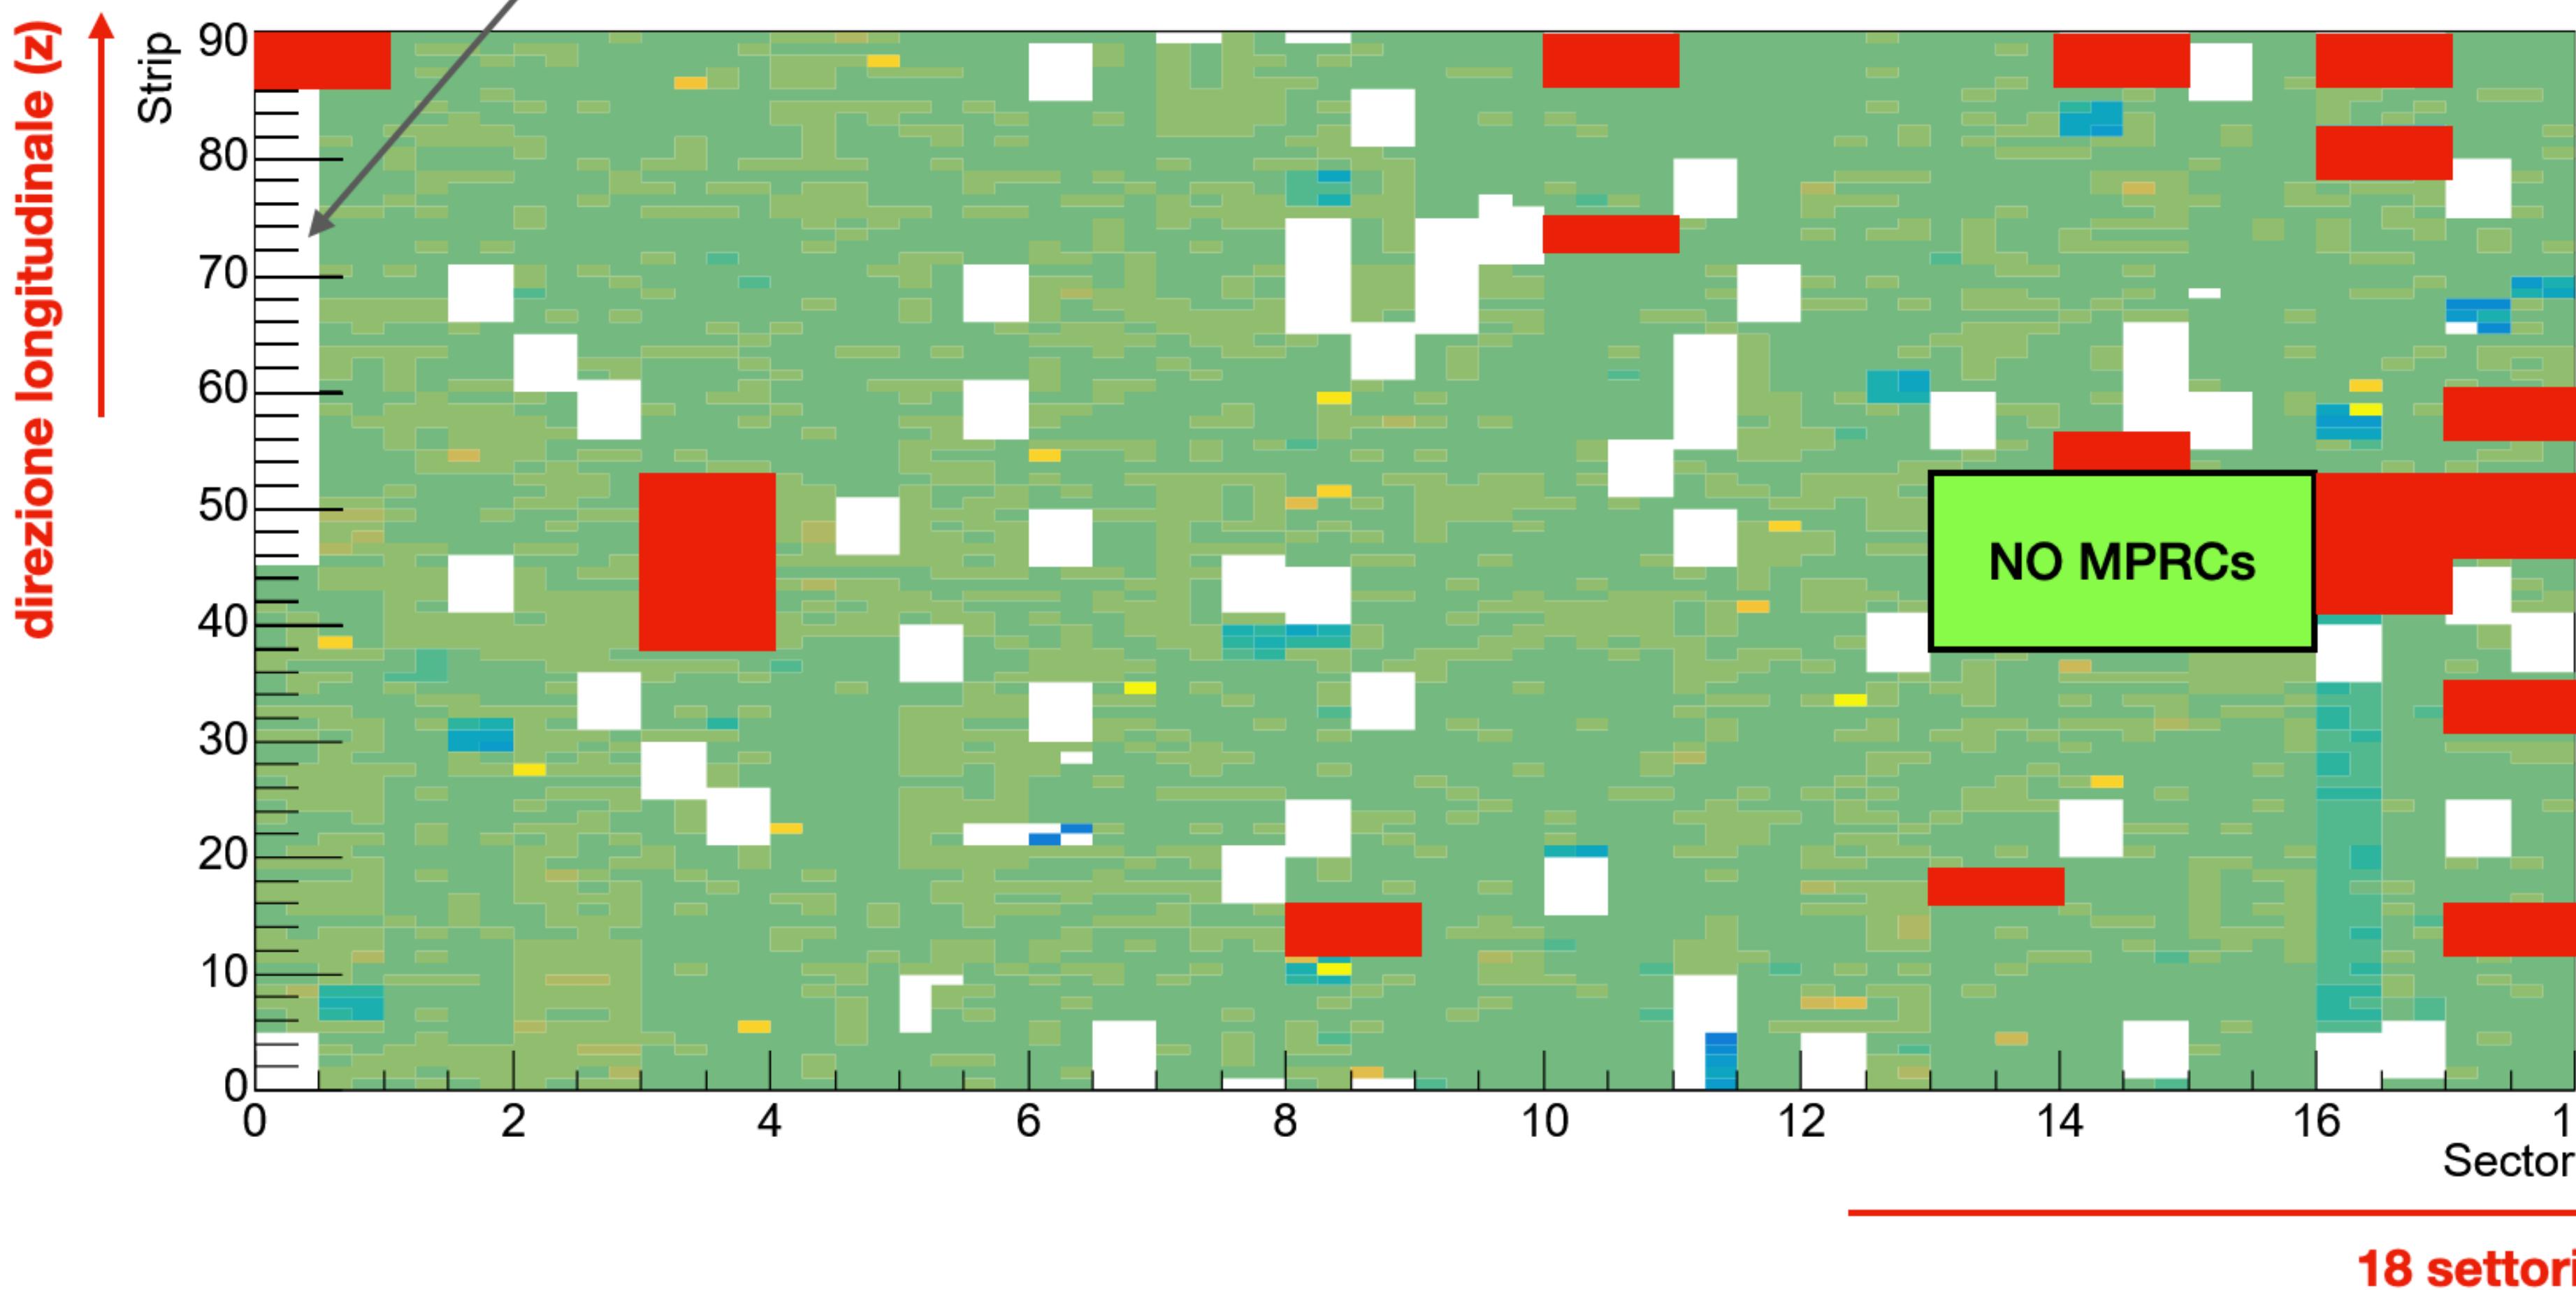
Crate 03, 48VPwS in FAIL

TOF hit map
