Status of the LVPS Transformer Problem

TileCal Maintenance Meeting

Gary Drake
Argonne National Laboratory, USA

CERN
Nov. 7, 2013

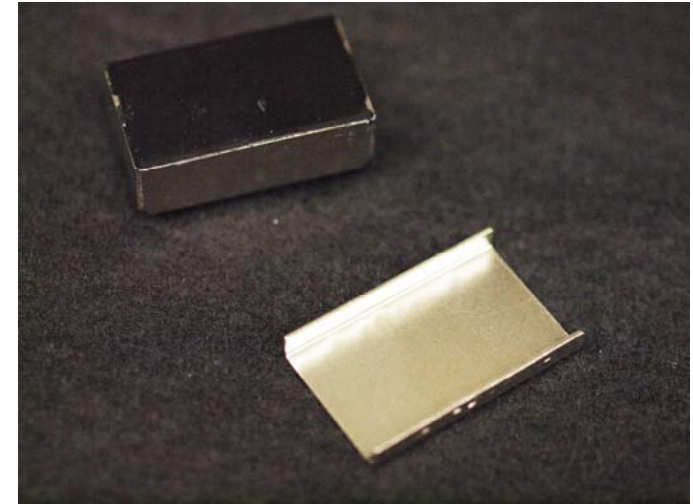
- What is known from the vendor:
 - The transformers were ordered in 3 batches:
 - 20 first prototypes
 - 400 for 40-box production
 - 2200 for 260-box production
 - “It is likely” that the large quantity was manufactured at a different time than the smaller quantities (vendor still checking)
 - The transformers for the large production were potted with a silicone compound (not sure about the small production – still checking)
 - Intended method for holding the covers on was the adhesive properties of the silicone
 - Method requires covers to be cleaned before gluing to ensure good adhesion
 - Vendor is now going through production records to try to find answers

- Theories being investigated:
 - Large production batch was done differently
 - Covers not cleaned properly
 - Thermal-cycling may be loosening adhesion of silicone
 - Covers manufactured with looser tolerance in large production

⇒ ***While cause is interesting, effect is devastating, and a solution is needed...***
