NA62 Collaboration meeting
1 – 5 September 2014, Ferrara (IT)

Mounting of RICH mirrors

M. Piccini, A. Bizzeti

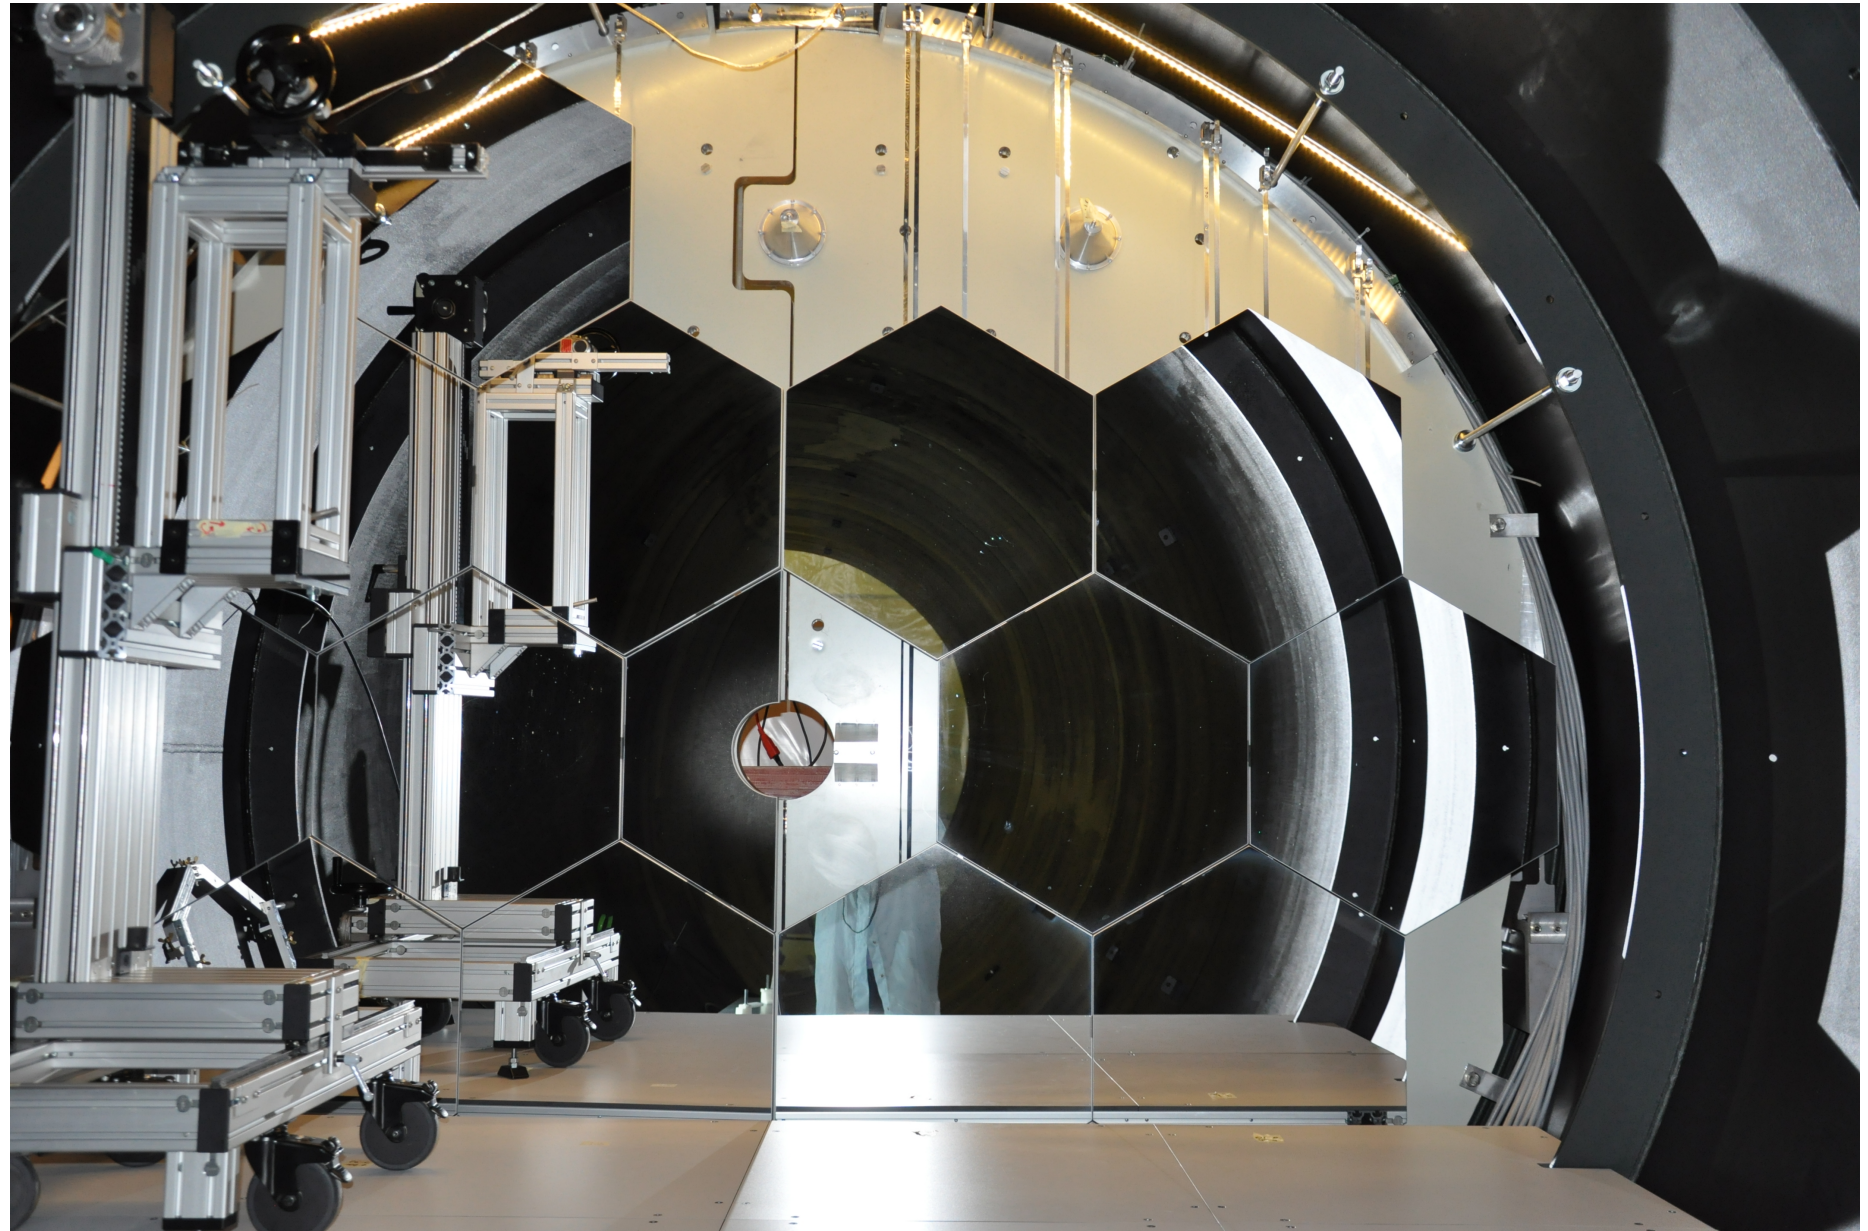
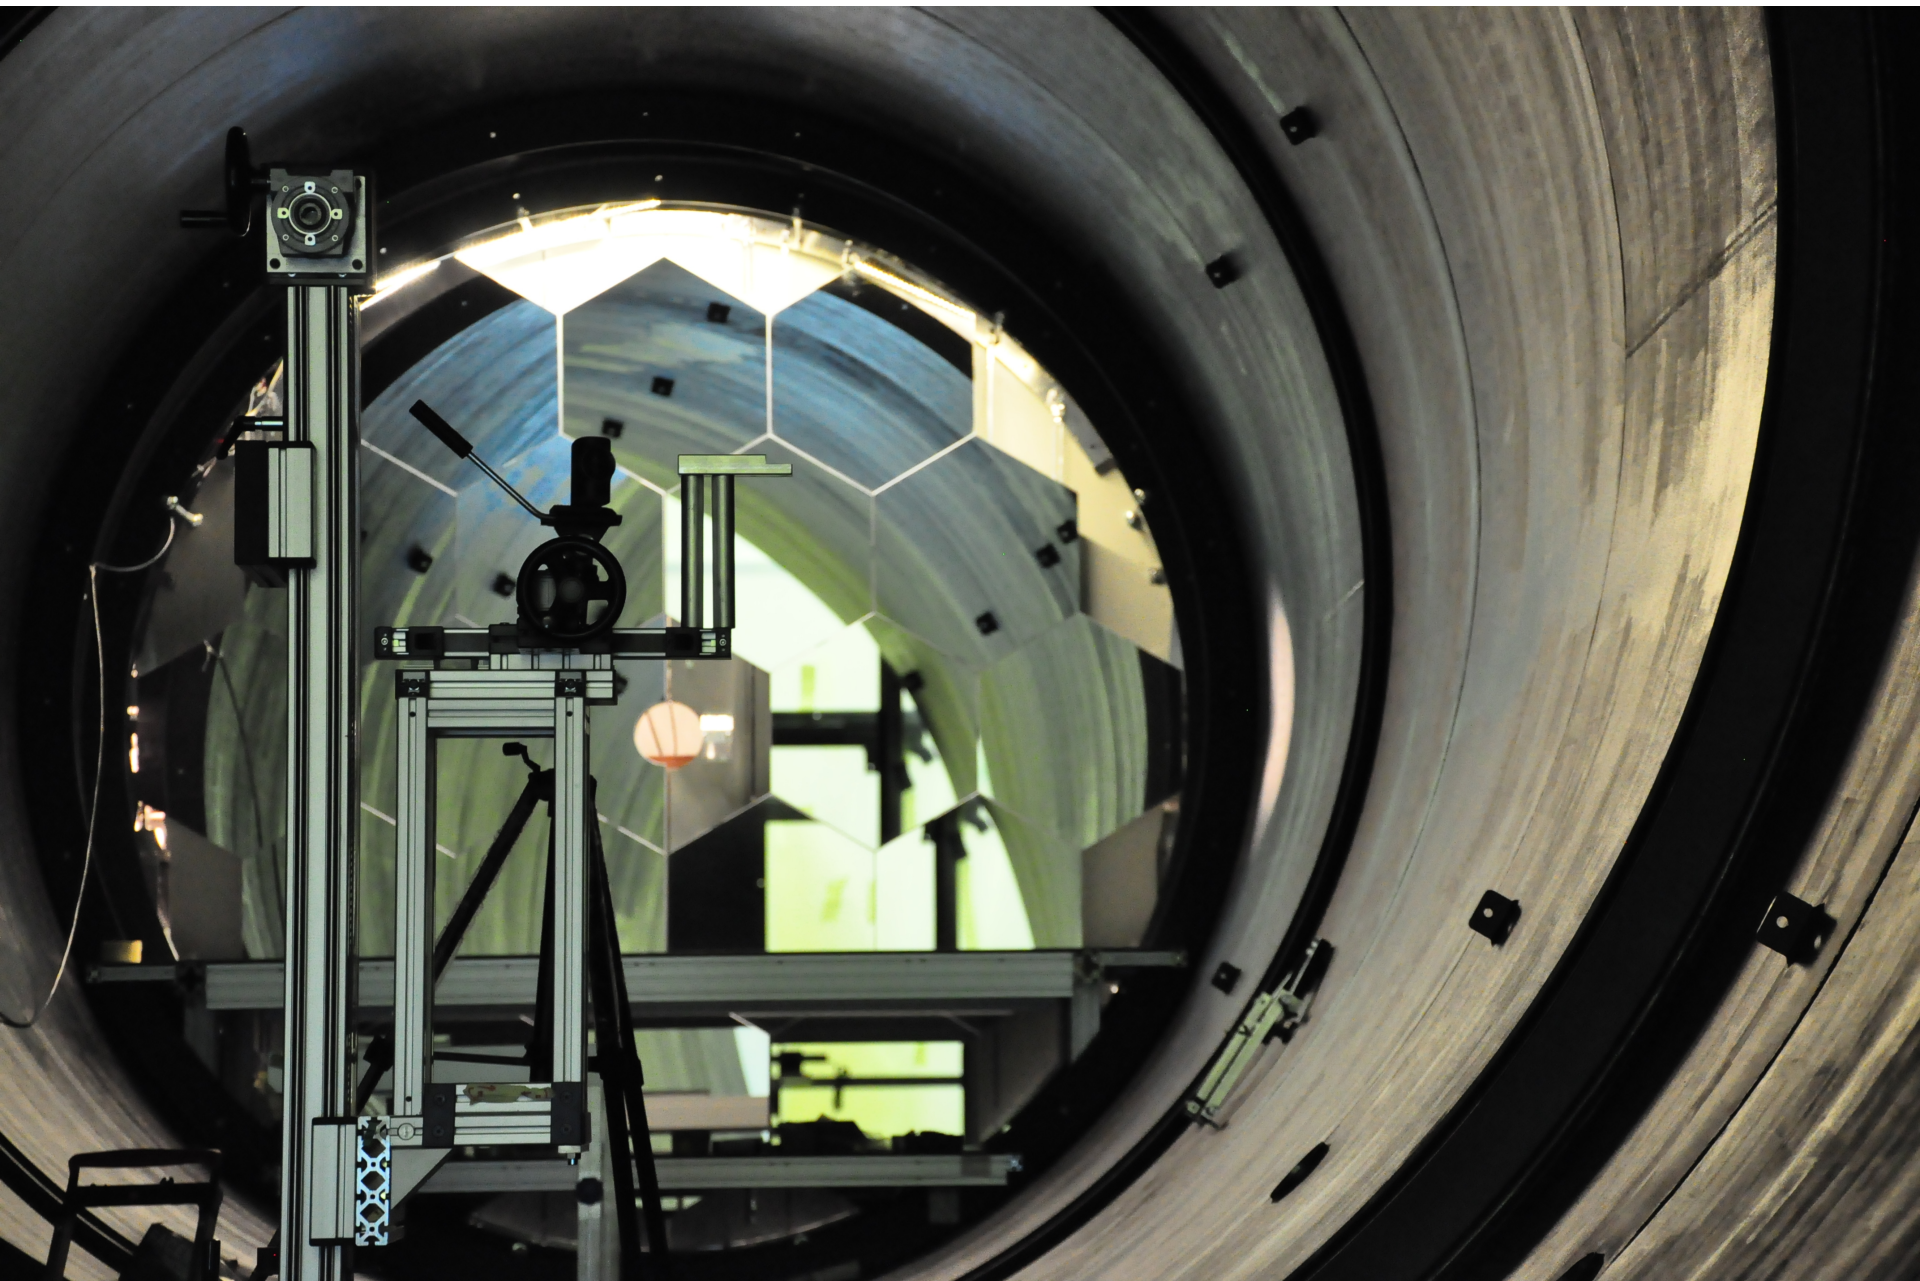
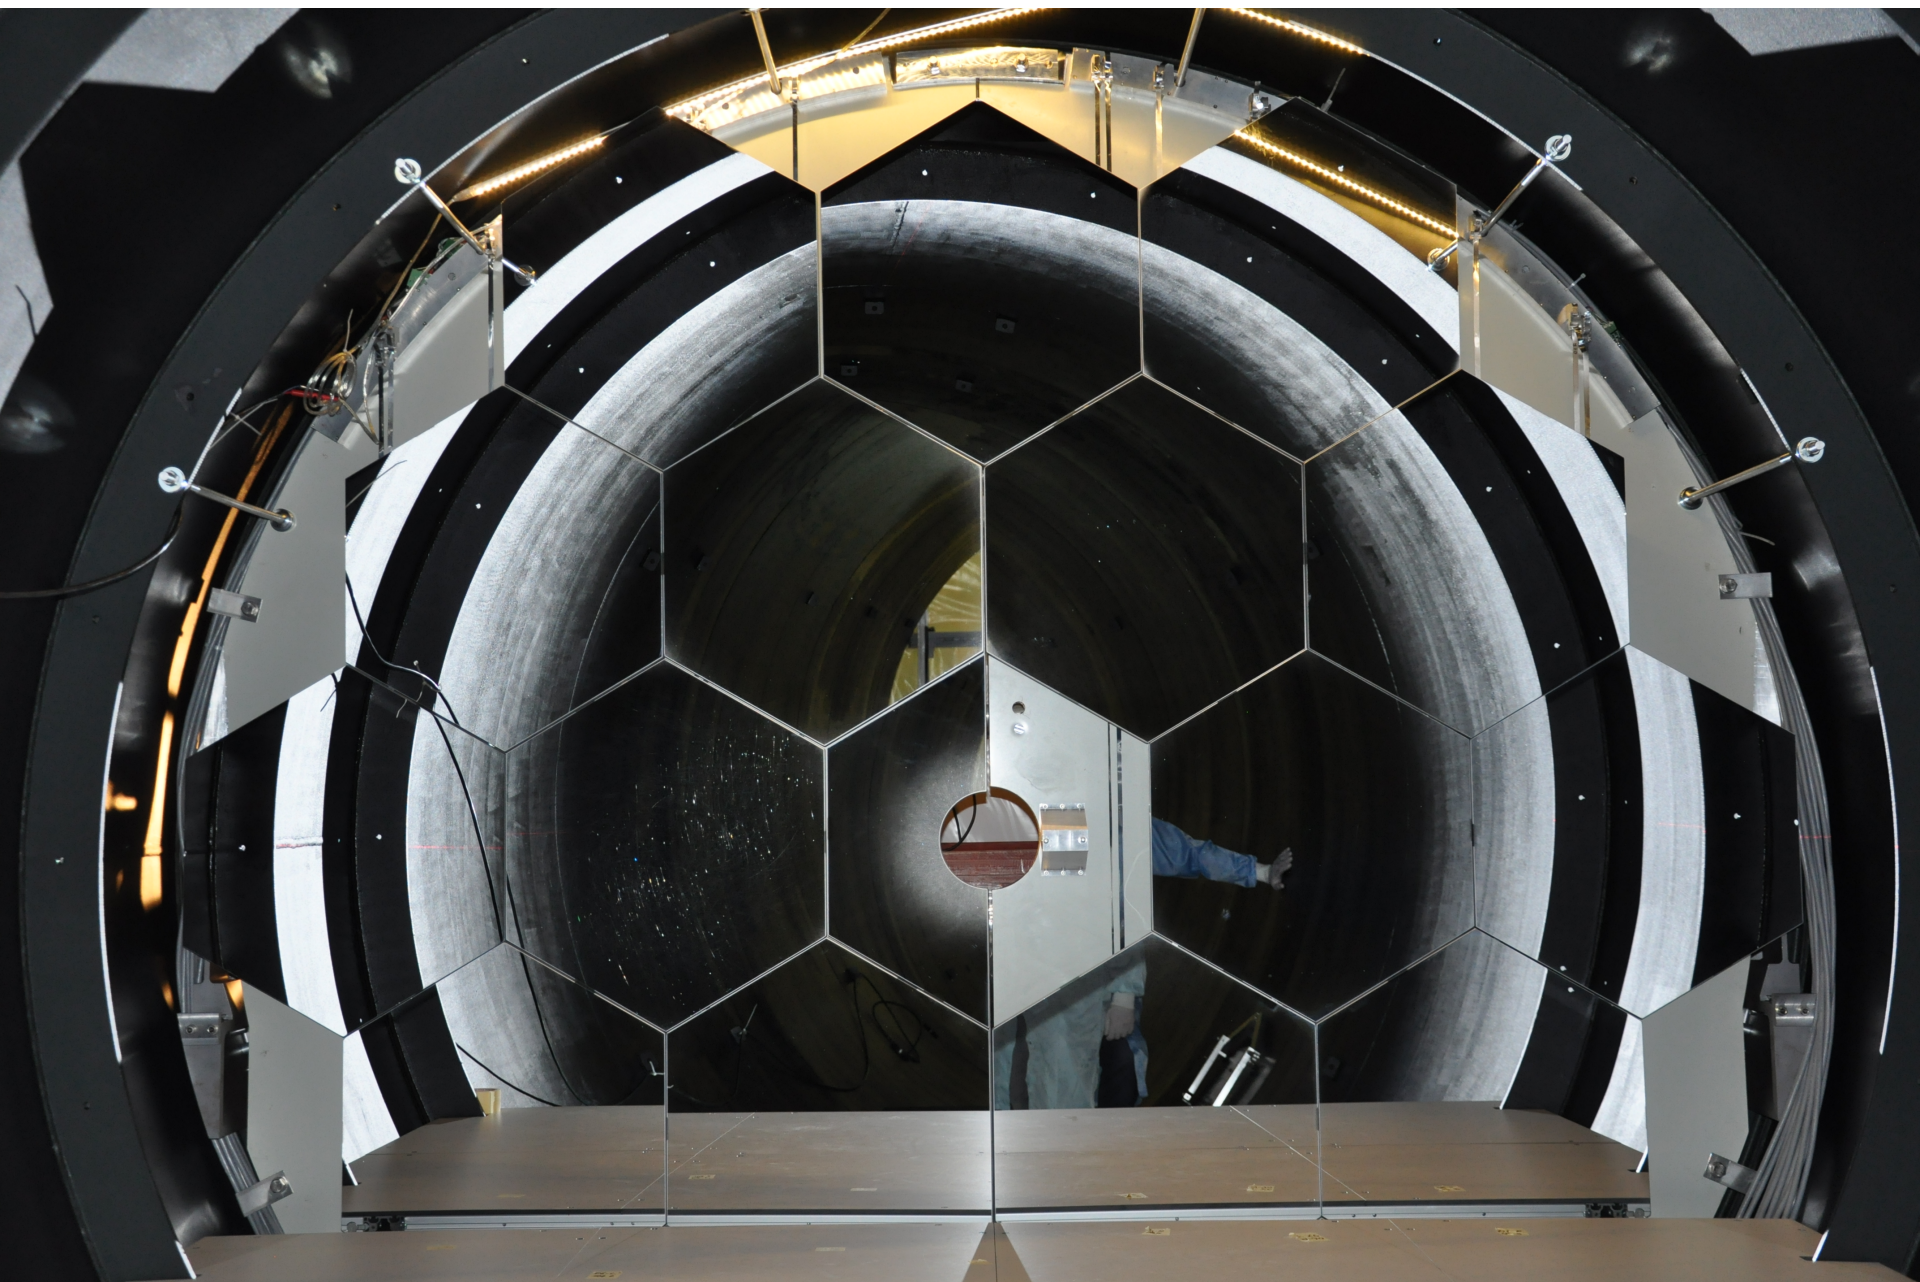
For the last raw the top part of the loading tool was touching the vessel, we install the first mirror by hands, just using the crutch, than for the last two mirrors we decide to produce a “nose” to avoid the problem

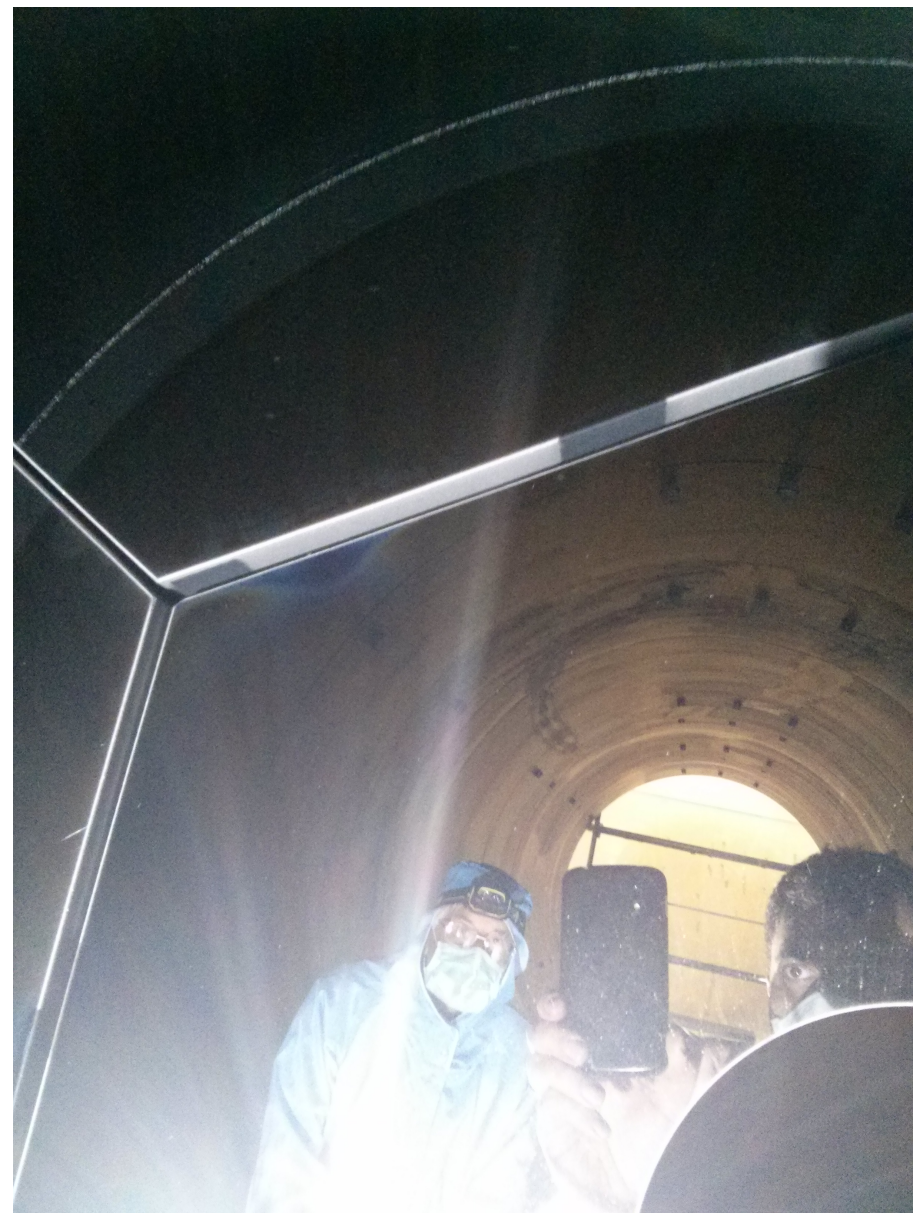
After two weeks from the installation of the first mirrors, we start to see a deterioration of the mirror surface.

The deterioration has continued during the past weeks involving many mirrors.

It is only visible looking to the mirrors from some angle (not from the front), no way now to predict what will be the effect on Cherenkov photons.

To investigate the problem small mirror samples aluminized with the main mirrors has been used as probes. Three were installed inside the Vessel touching the support panel (one is no more accessible) and others were isolated in dedicated boxes with some of the materials we have inside the vessel: carpet, glues, anticorrosive coating of the vessel (?)
