DAΦNE: results and consolidation activities

Catia Milardi
on behalf of the DAΦNE Team

DAΦNE activities

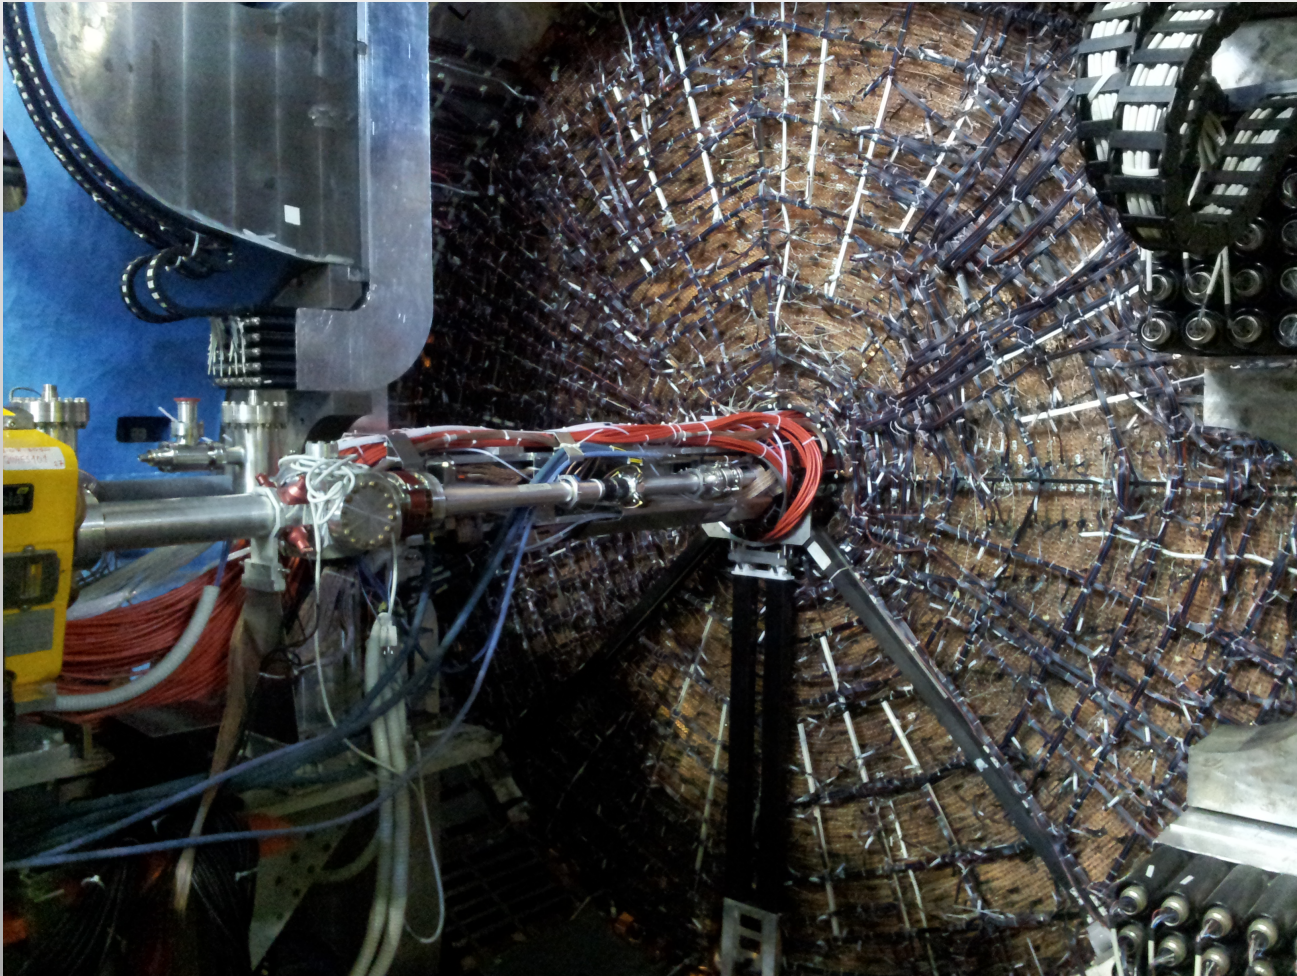
Third carbon fiber support installed

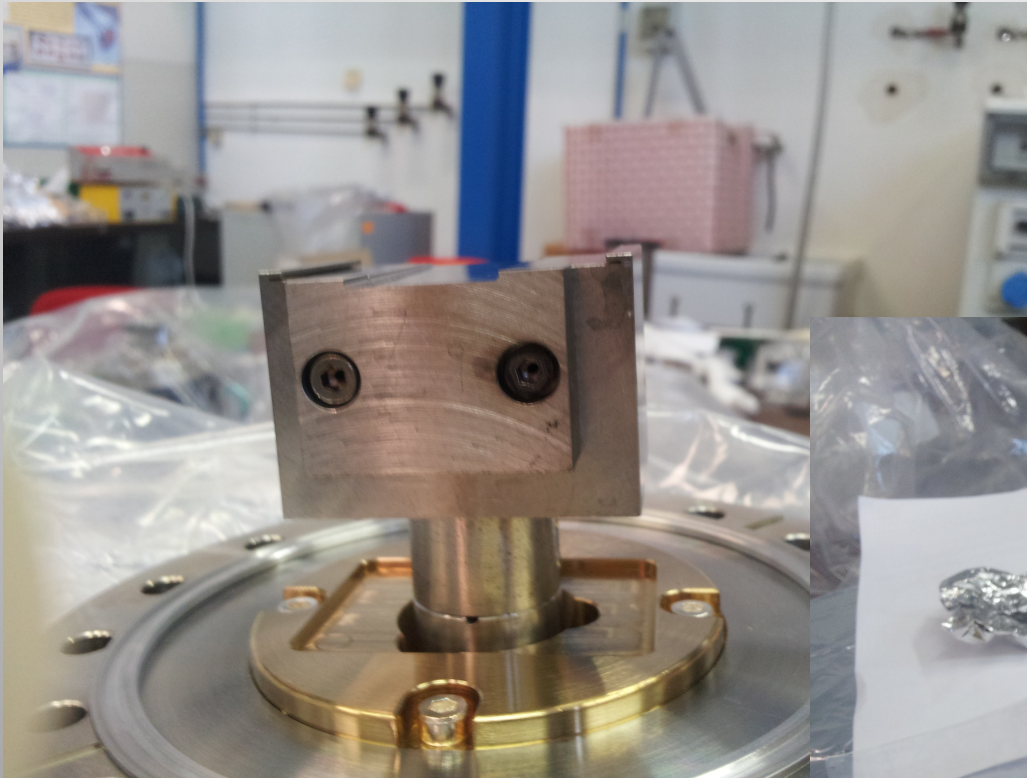
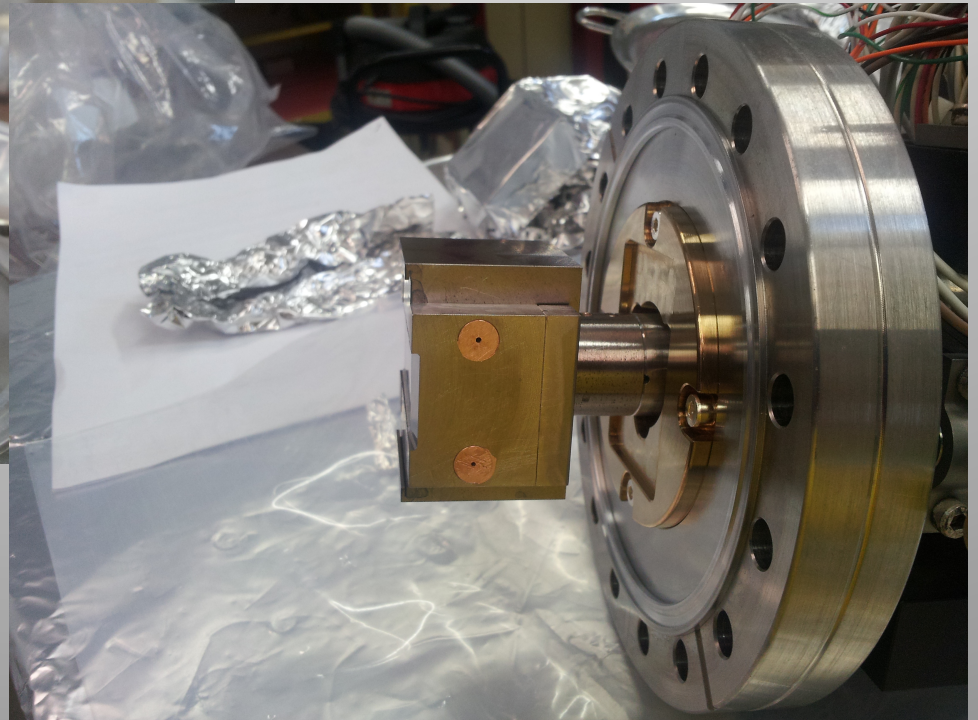
Collimators installed at the two sides of the IP and of the RCR have been modified

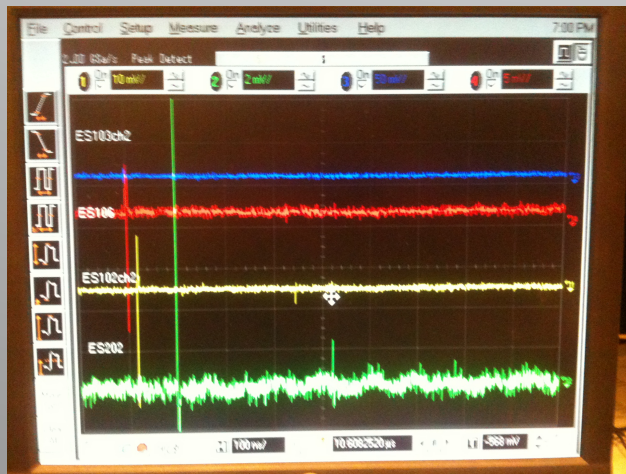
Activities have been prolonged by few more days to understand why transporting the e- beam through the ring was almost completely impossible

Uptime quite low since:

- new subsystems had bugs to be fixed
- electrical cables mixed for some magnets
- wrong polarities due to the power supplies maintenance

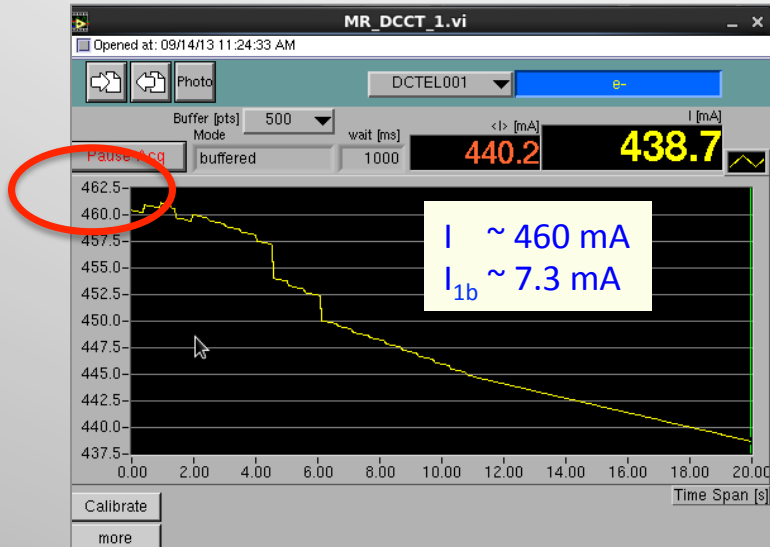
Beam current limited by collective effects:
Transverse beam size grows with the current due to ion trapping
transverse instabilities appear above $\sim 460 \text{ mA}$.

Further improvements required:
recovering optimal vacuum condition
tuning transverse feedbacks

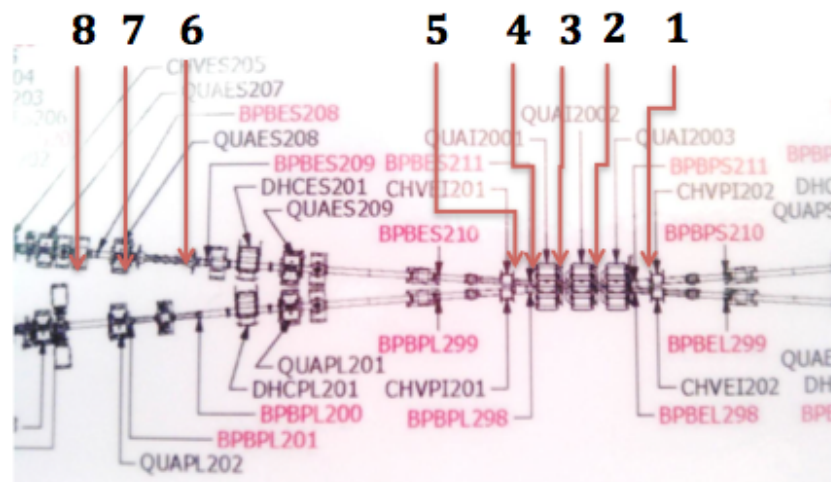
Activation Measurements along the RCR beam pipe

Elemento	Ingresso	Uscita	Ref - Note
1 - CHVEI202	1	0,6	Foto1 - uscita
2 - Spazio intermedio fra QUAET2003-QUAI2002	fondo		Il punto di misura era esterno alle bobine
3 - Spazio intermedio fra QUAET2002-QUAI2001	fondo		Il punto di misura era esterno alle bobine
4 - QUAET2001	1,6	Misura QUAET2002-QUAI2001	Foto2 - Ingresso
5 - CHVEI201	1	1,8	Foto2 - Uscita
6 - KICKER DUMP	1,1	2,8	Foto4 (I) – Foto3 (U)
7 - QUAES208	fondo	0,3	Foto5
8 - Punti precedenti (nel senso del fascio)	fondo	fondo

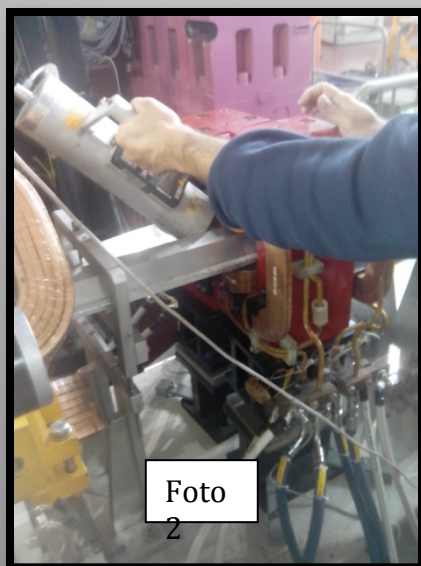
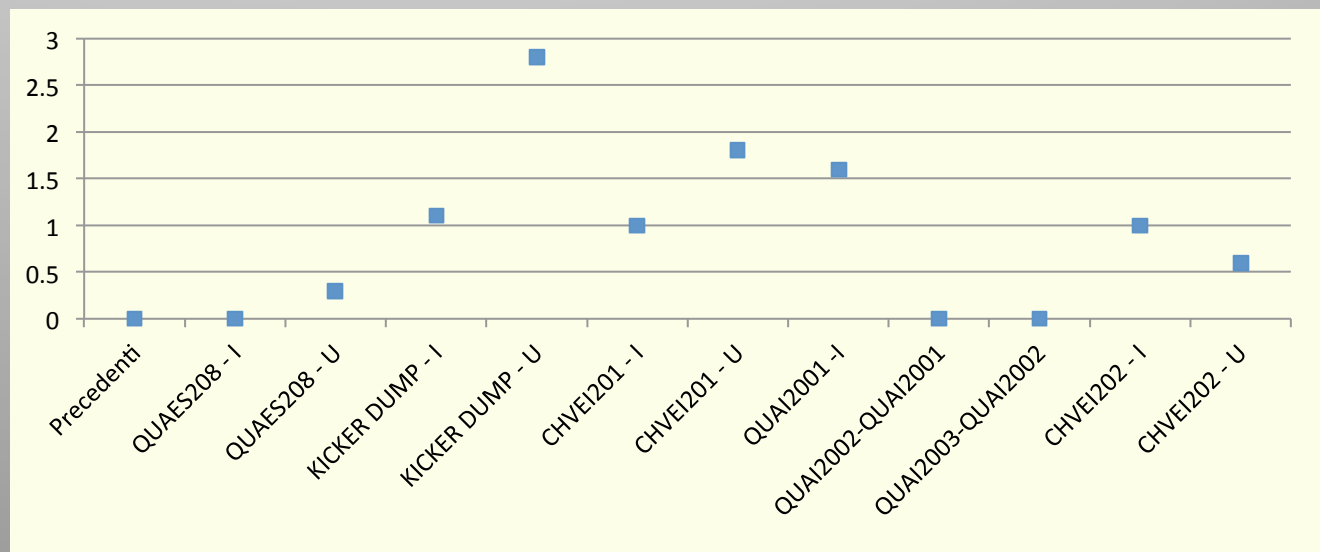
e^- are lost mainly in the dump kicker and in the half-moon vacuum chamber

Final shield configuration

Vertical lead screen (90 cm x 90 cm x 10 cm)

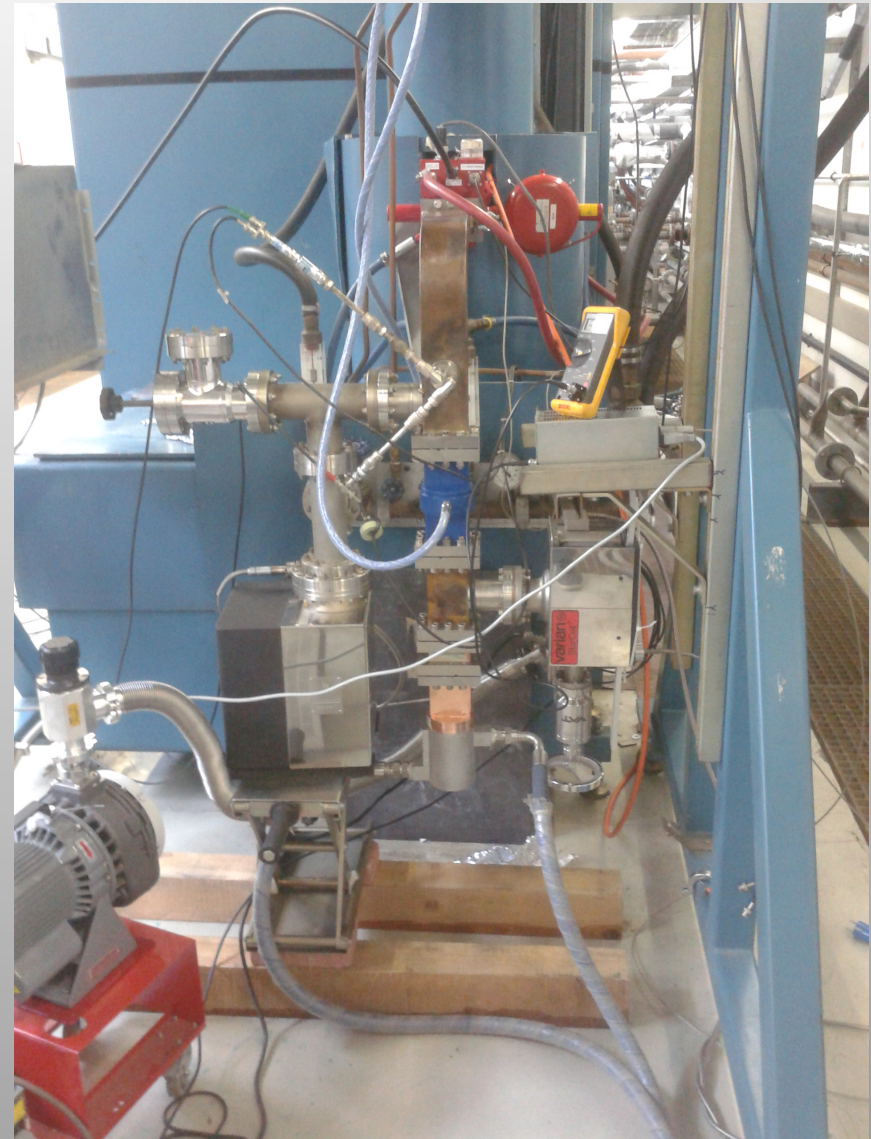
Klystron D had several faults during conditioning (vacuum interlock downstream the output window)

Regardless the new components the **D** RF power plant did not achieve the nominal working point

Simplified test configuration

RF elbow removed
