Status Update on SVD module construction

Stefano Bettarini
Universita' di Pisa & INFN

On behalf of the Belle II SVD Group

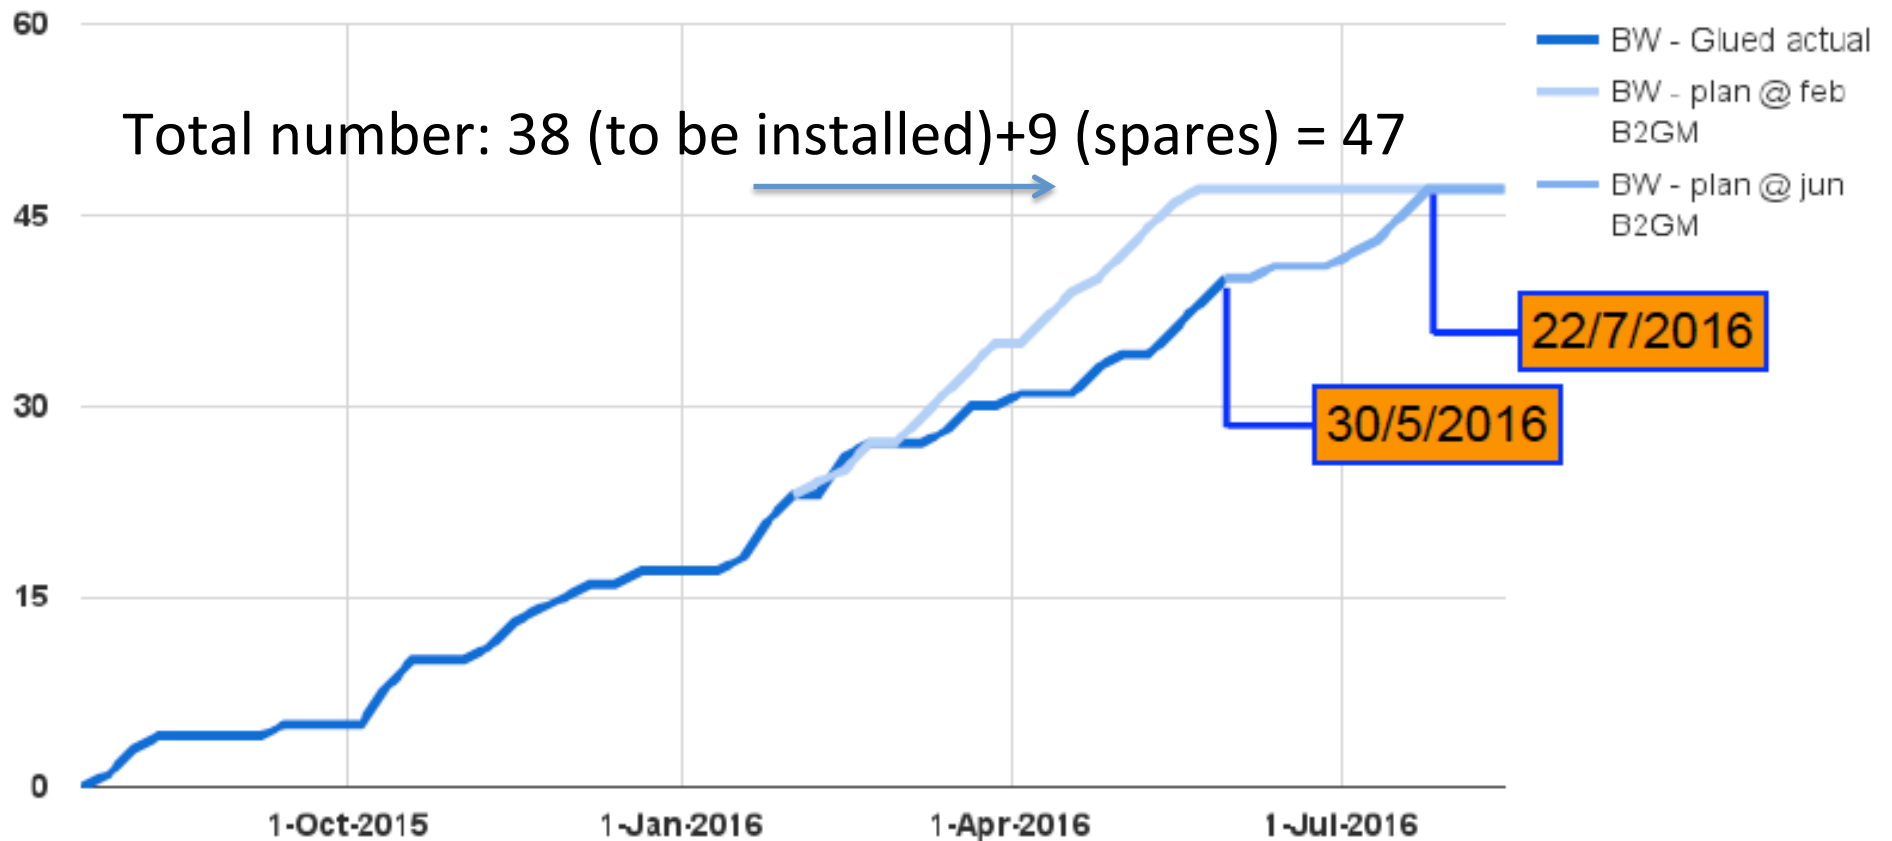
BW production schedule

No failure experienced so far

End of SBW prod. expected in late July

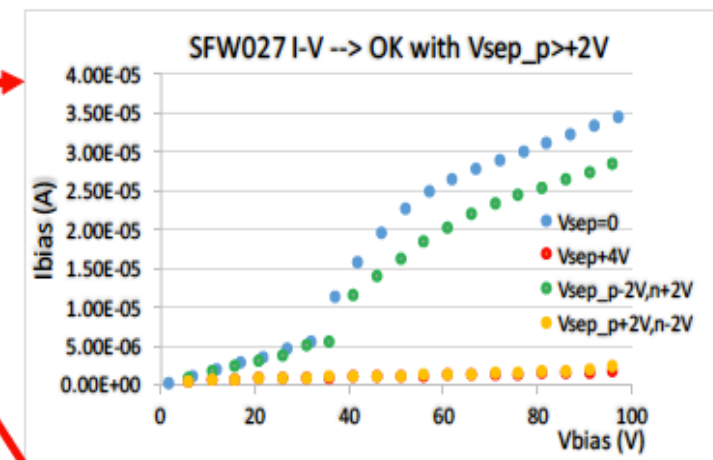
Bias current problem on few assembled sensors

- A few modules (see below) have shown a huge increase in sensor bias current ($2\mu\text{A} \rightarrow 40\mu\text{A}$) after connections to the APV chips with sensitivity to Vsep (i.e. APV extra voltage w.r.t sensor bias)
- The cure was found empirically on first bad module in Nov 2015: disconnect the guilty pinhole(s) fix it
- After more problematic modules found (2 Micron + 1 HPK) we started a deeper investigations to explain the effect.
- Connecting to APV chips a defective strip that has both a pinhole AND high leakage current, due to a DC defect, could cause the high leakage current since the DC defect sits at a different Voltage (APV input) w.r.t its voltage when the strip is only connected to the bias ring via R_bias.
 - Some tests also done in TS to confirm this hypothesis.

Only few affected modules (~6%) and the cure found is effective:

- Micron: 3 out of 33 assembled on SFW: 2 cured, 1 still to be fixed
 - 6 more out the 19 still to be tested/assembled, can be affected
- HPK: 2 (1 in L4 fixed + 1 in Pisa still to be fixed) out of ~ 50 HPK assembled
- HPK sensors probably less affected: no high leakage strips declared by HPK during sensor test and fewer pinholes w.r.t Micron sensors...but many still to be assembled.

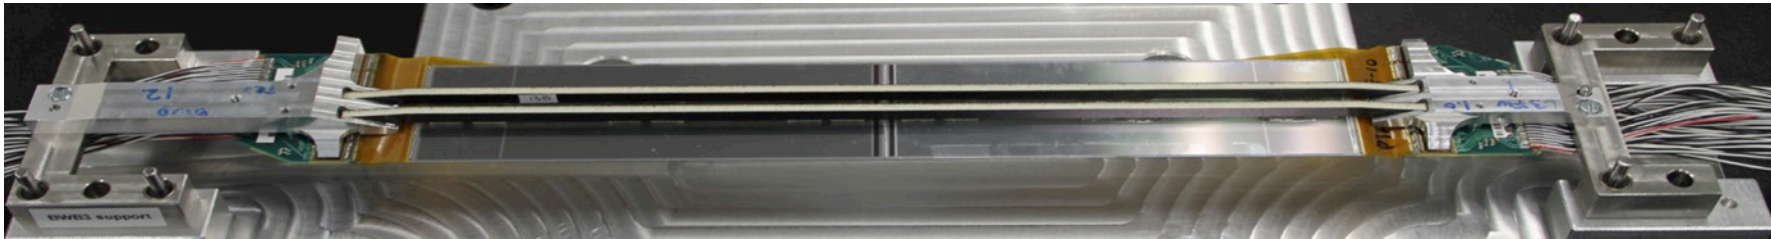
- In the layer3 ladder sensors are placed head to head, conventionally read-out outside the sensitive region.

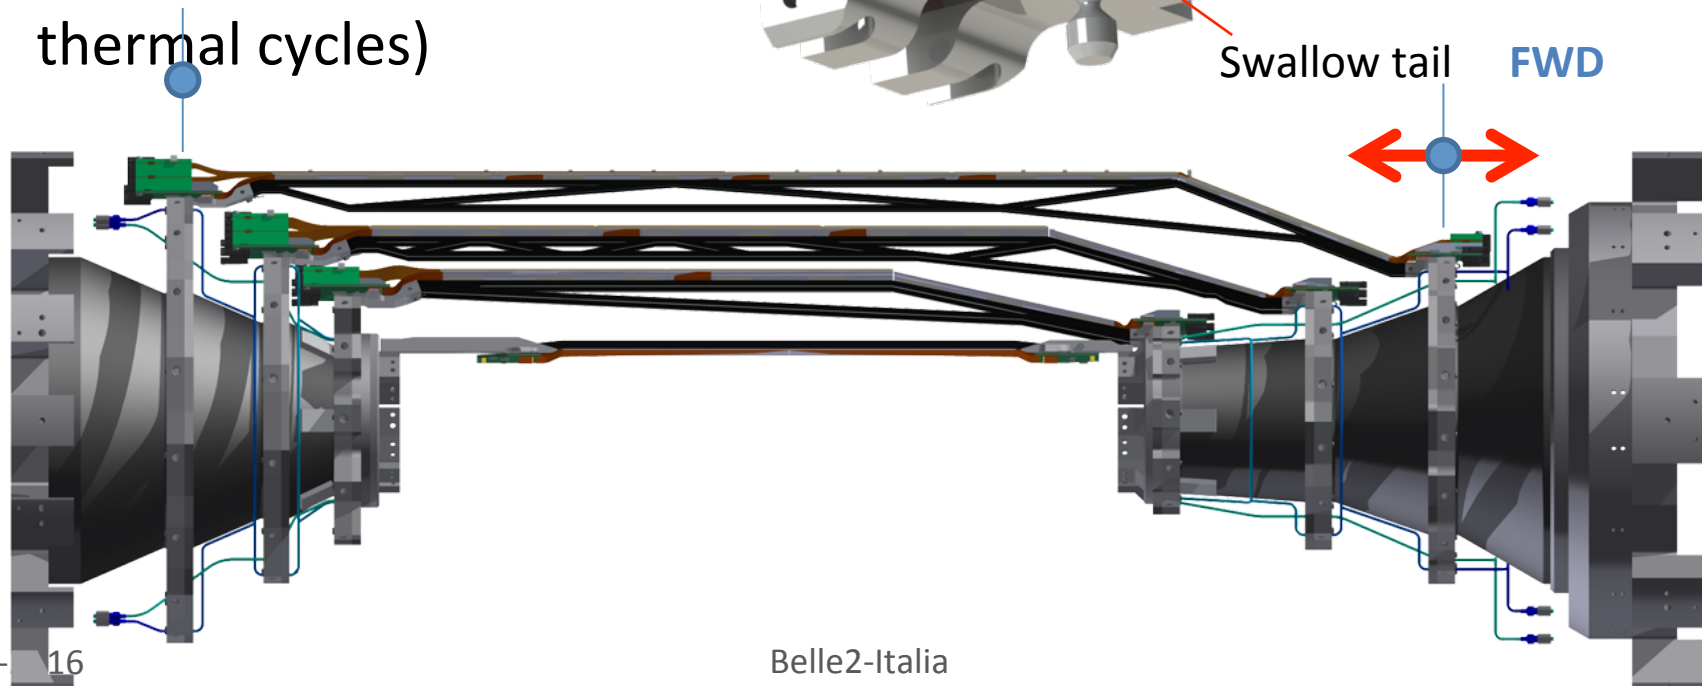
Mounting a Ladder

Ladders are positioned by two precision pins

- Fixed on backward side (origin)
- Sliding on forward side to allow thermal movement (verified effective with thermal cycles)

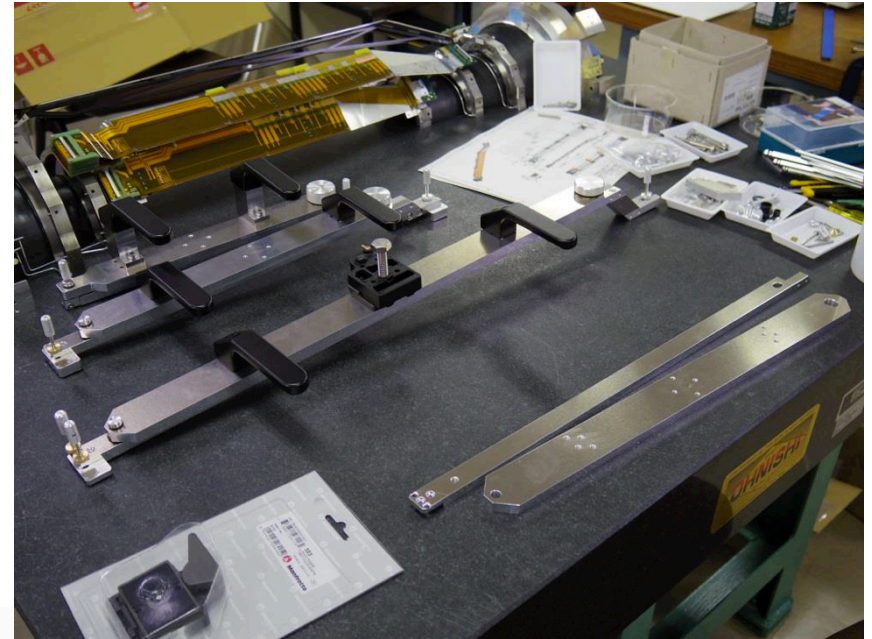
Ladder mount tools

Ladder mount jigs for all layers have been prepared.
Stage of the ladder mount jigs adjusted for the new jigs
