EP-DT

Ecogas GIF+++ EP-DT

16 Apr 2019

Summary of performed tests

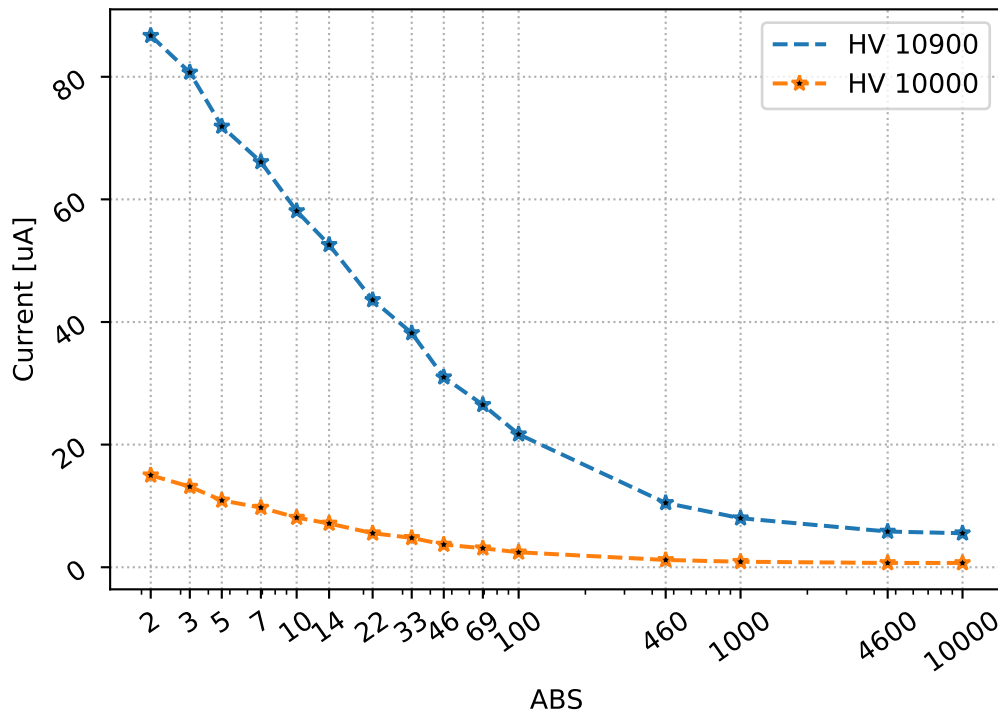
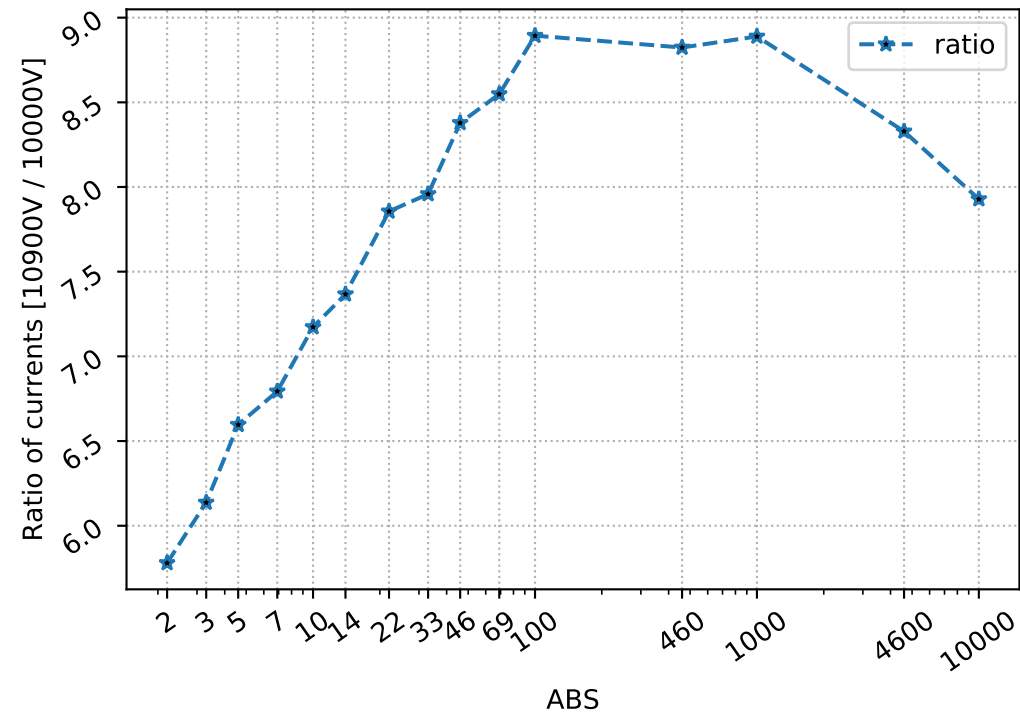
- **Filter Scan** with HFO mixture:
- P, T = 959.5 mbar, 21.6° C
- **Manual** scan: HVapp = (working point 10900V, standby 10000V)

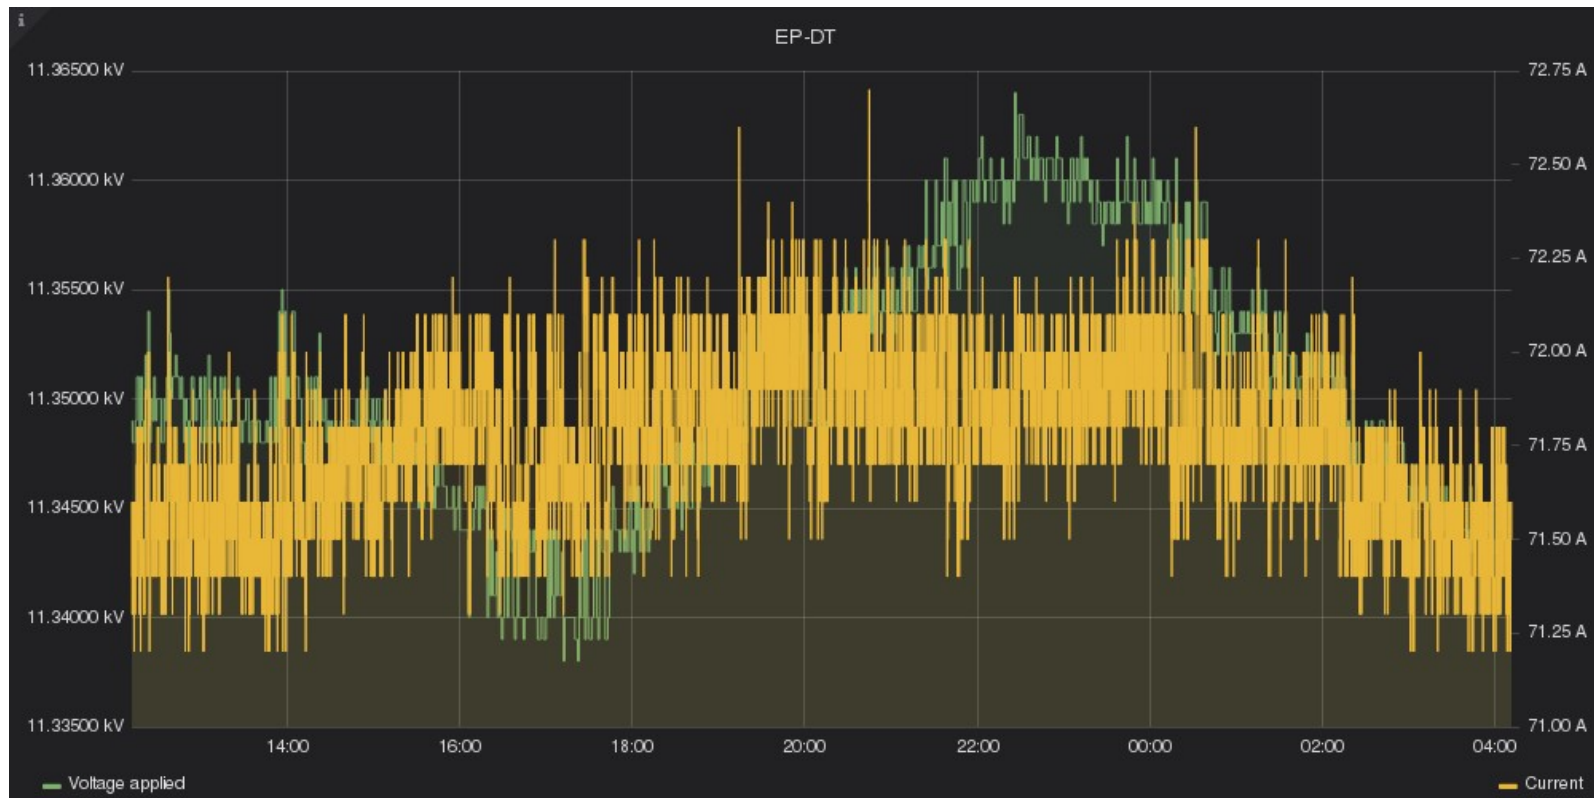
- **Stability** with HFO mixture:
- **ABS 22**, H_{veff} 12600-12800V, duration = 5 days
- WEBDCS used to control H_{veff}
- Currents appear *to be stable*: ± 0.5 μA max fluctuation
- Screenshot: <https://epdt-rd-monitoring.web.cern.ch/d/pqvlTZRWz/global?orgId=1&from=1557655907000&to=1557713507000>

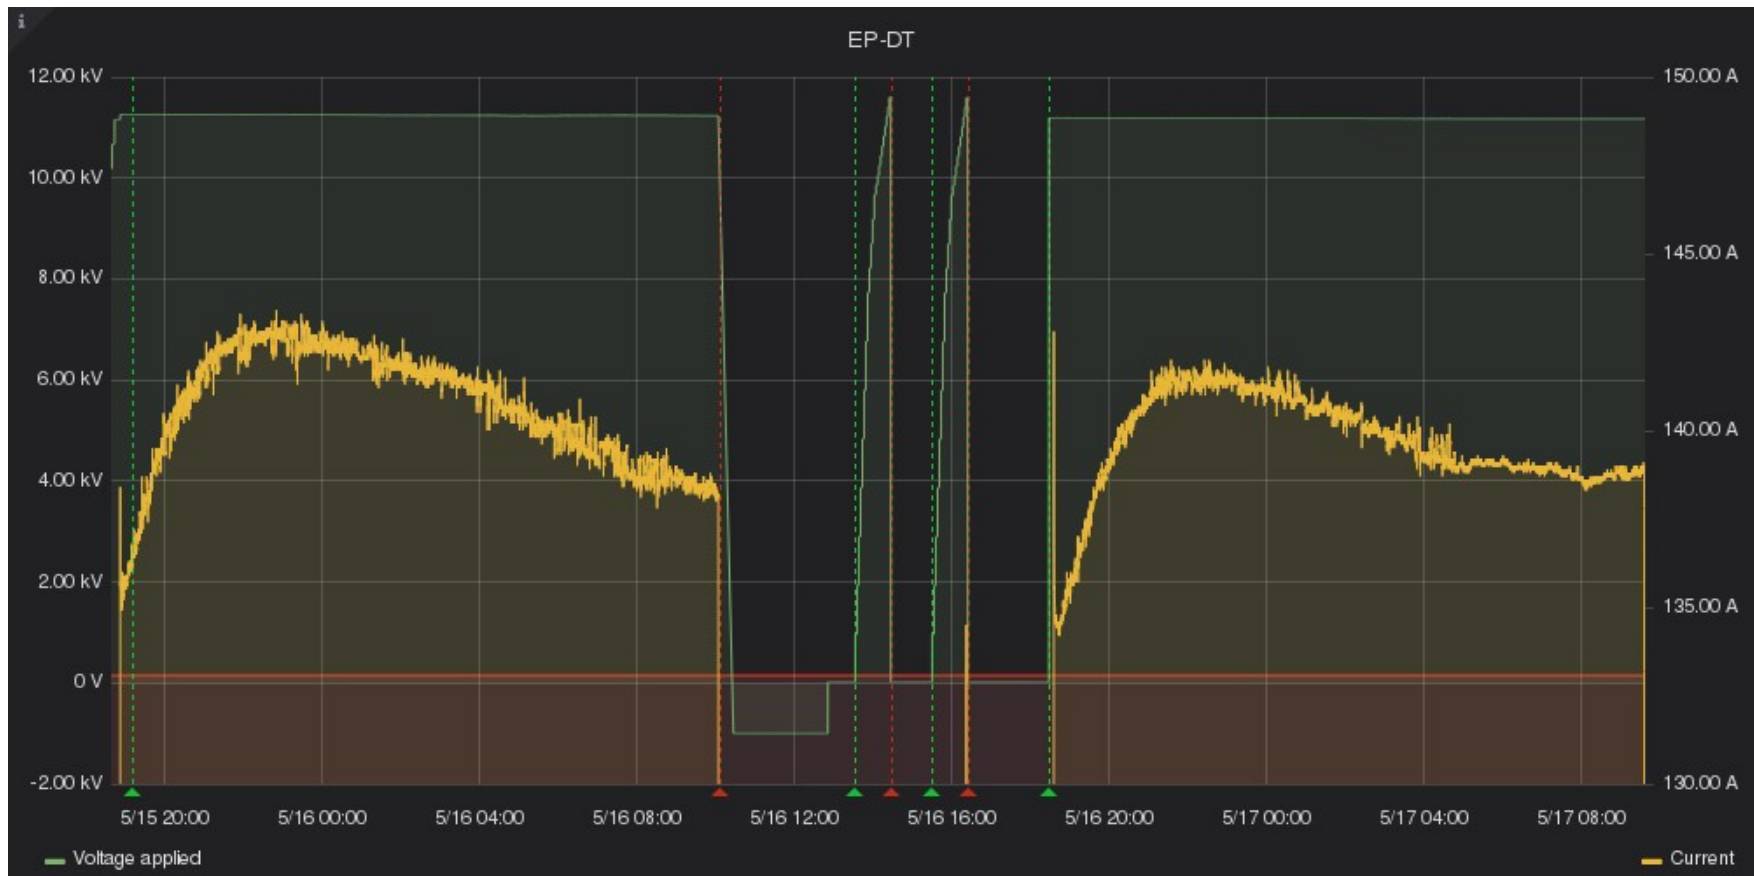
- **Stability** with HFO mixture:
- **ABS 2.2**, H_{Veff} 11600V, duration = 2 nights so far
- WEBDCS used to control H_{Veff}
- Currents from 134 μ A to 141 μ A in ~2 hours. Then stabilized at 139
- Screenshot: <https://epdt-rd-monitoring.web.cern.ch/d/pqvlTZRWz/global?orgId=1&from=1558024618902&to=1558076596985&panelId=5&fullscreen>

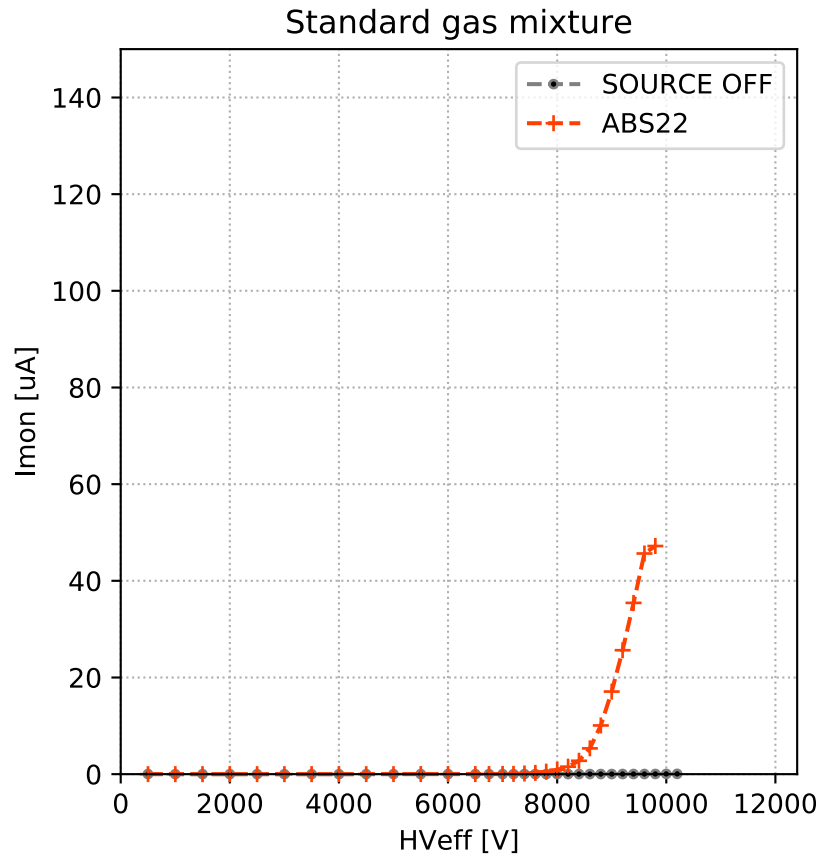
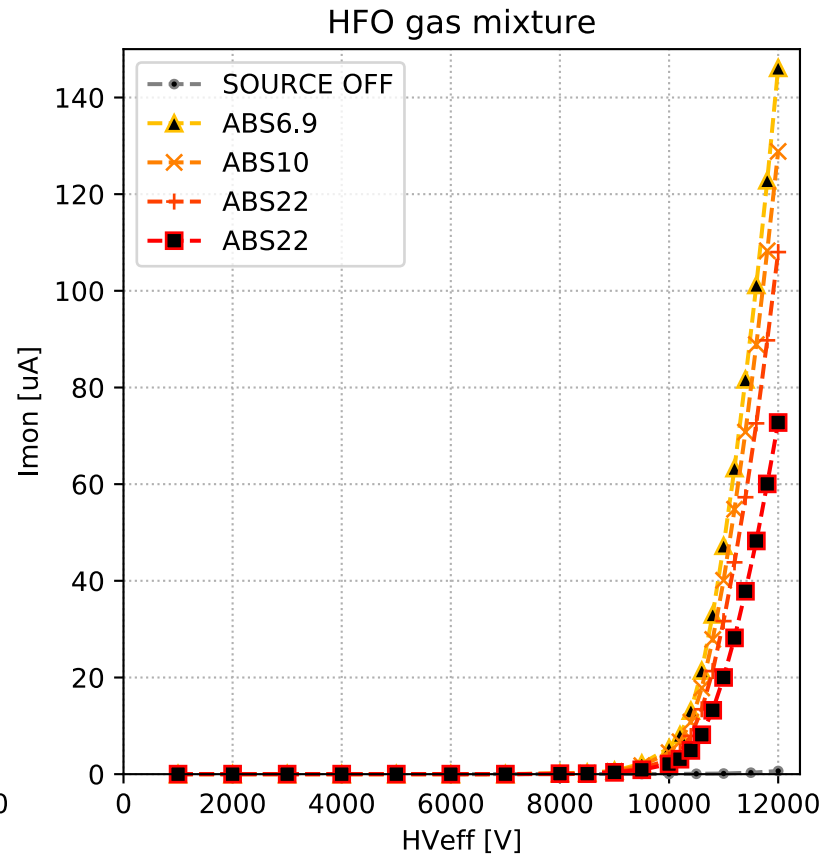
- **Few points** for standard gas mixture
- HFO mixture: transition from dark to physics current at ~10500V
- STD mixture: transition from dark to physics current at ~8500V
- Estimation of Delta in knee between HFO and STD mixture

- Delta(SourceOFF) ~ 2400V
- Delta(ABS22) ~ 2100V
- Delta(SourceOFF) **after irradiation** ~ 2150V

scan	mixture	abs	knee
8	std	0	8648
9	std	22	8343
10	std	22	8373
11	hfo	0	11131
12	hfo	0	10911
23	hfo	22	10493
24	hfo	0	10821
25	hfo	0	10807
26	hfo	6.9	10605
27	hfo	46	10713
28	hfo	10	10627

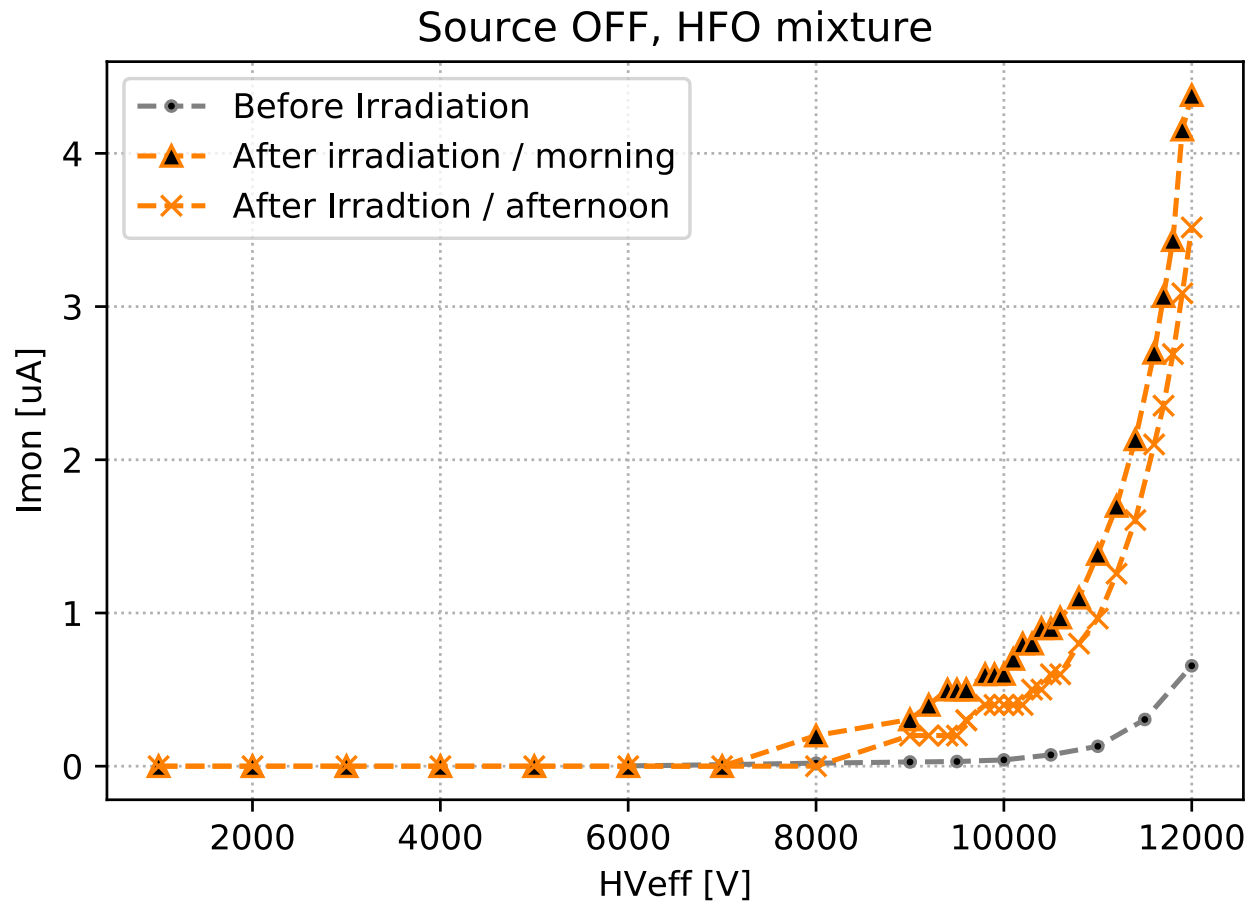
- Comparison of source off with HFO before and after irradiation
- Results are quite interesting: **increase** of *dark* current and *physics* current
- Might be due also to **gap/frame issues**

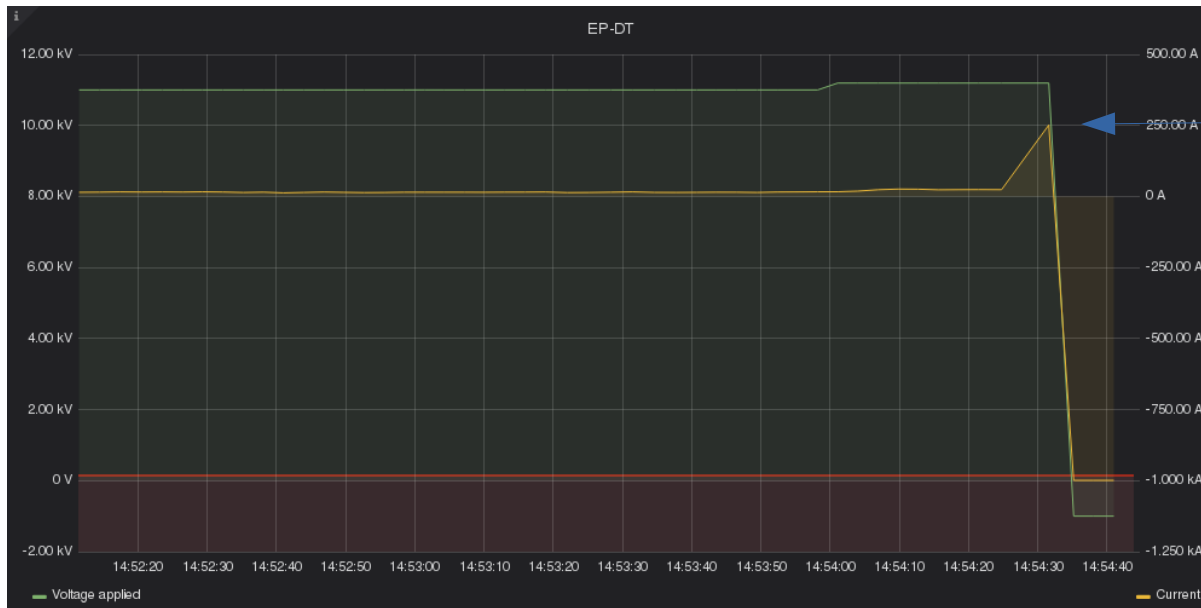
- During source scan EPDT-RPC3 chamber had a **spike** and switched off the hv module
- Turned out to be the **HV connector** from gap side. The connector has been fixed
- However, the chamber has now some **small discharges** between gap and frame

Current spiked to over 200uA

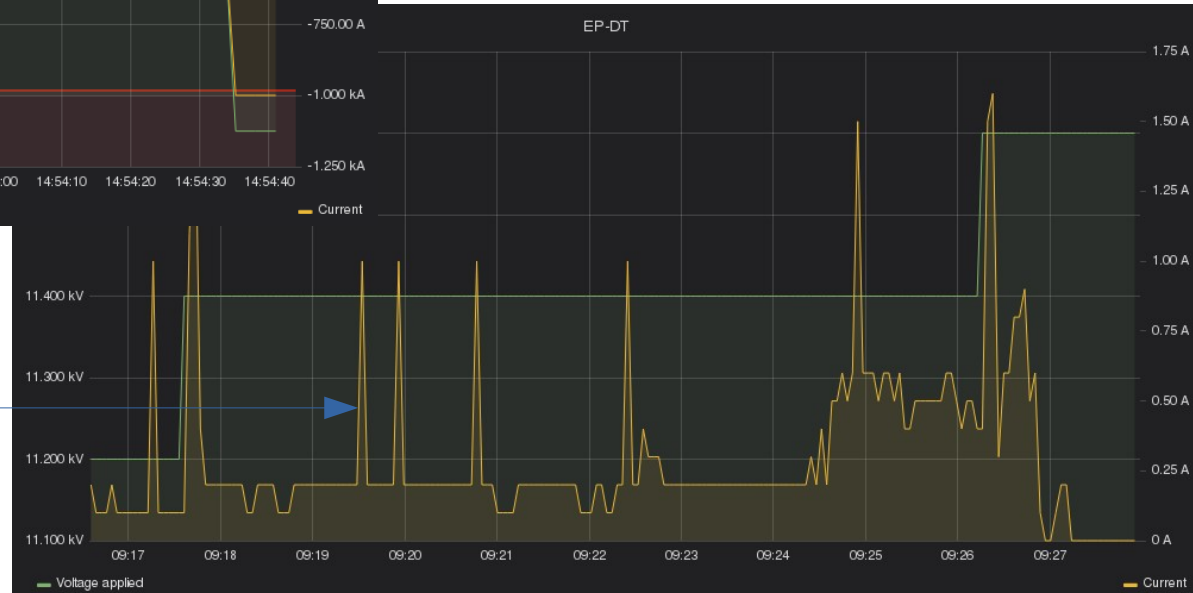
Current wasn't stable after reparation with source off
