Status report of the Start Counter

FOOT general meeting
11 June 2020

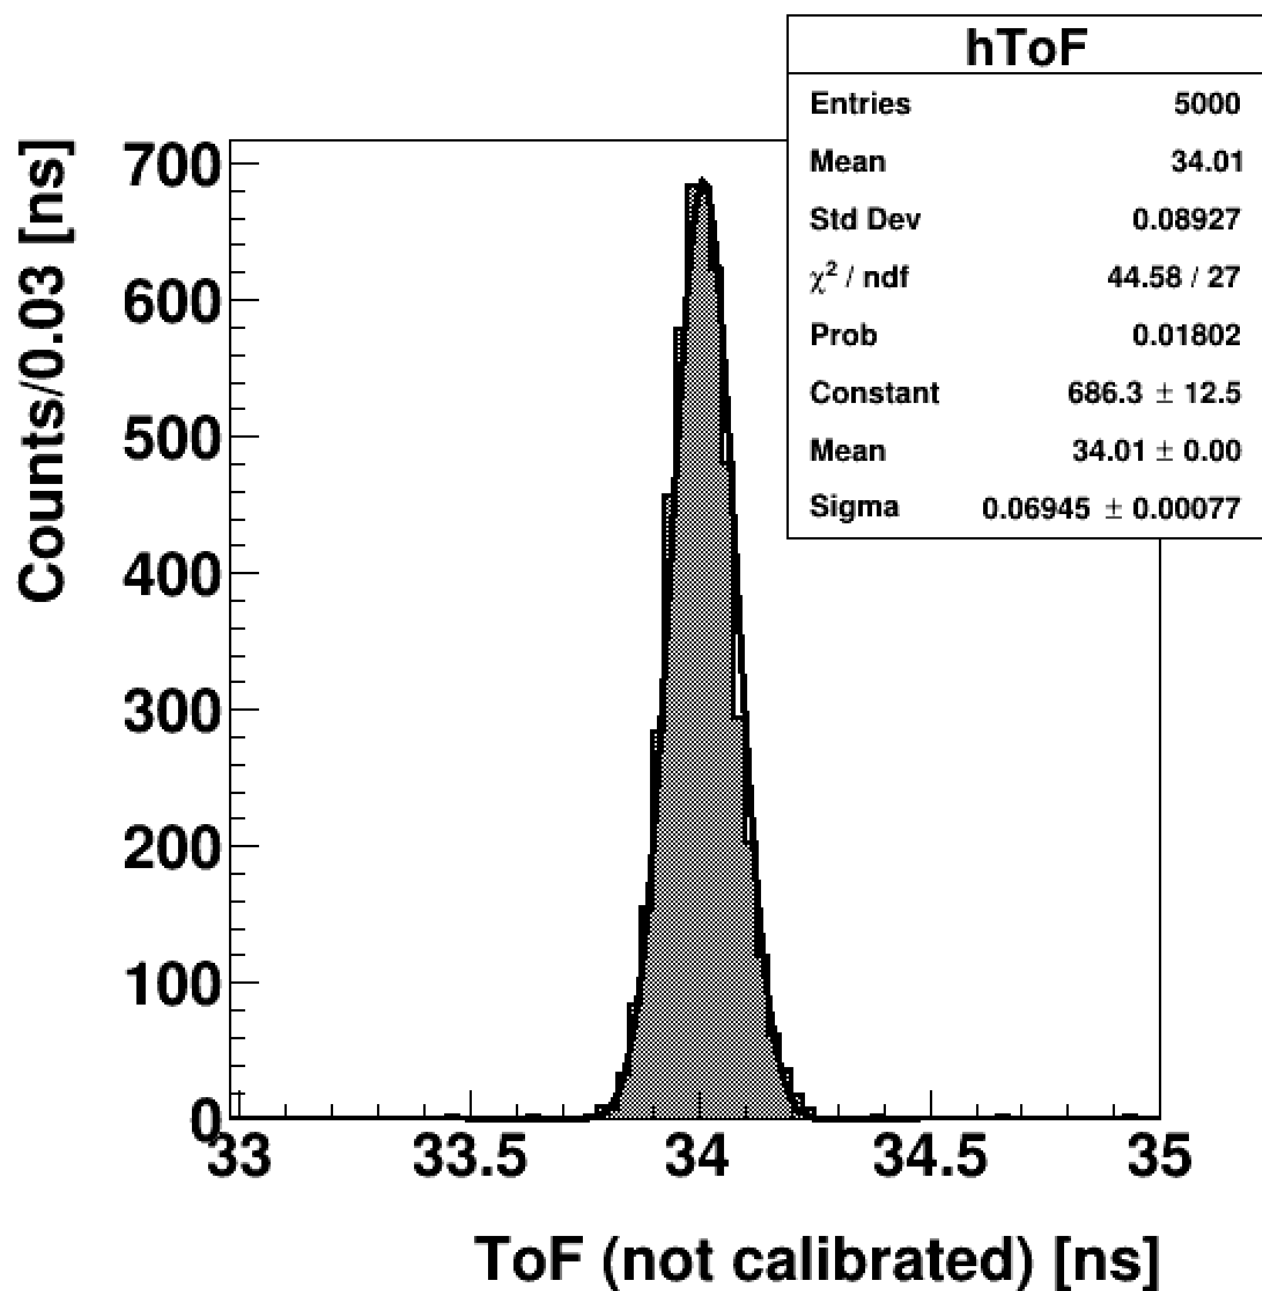
run 2210(11,12)

$\sigma \sim 70\text{ps}$

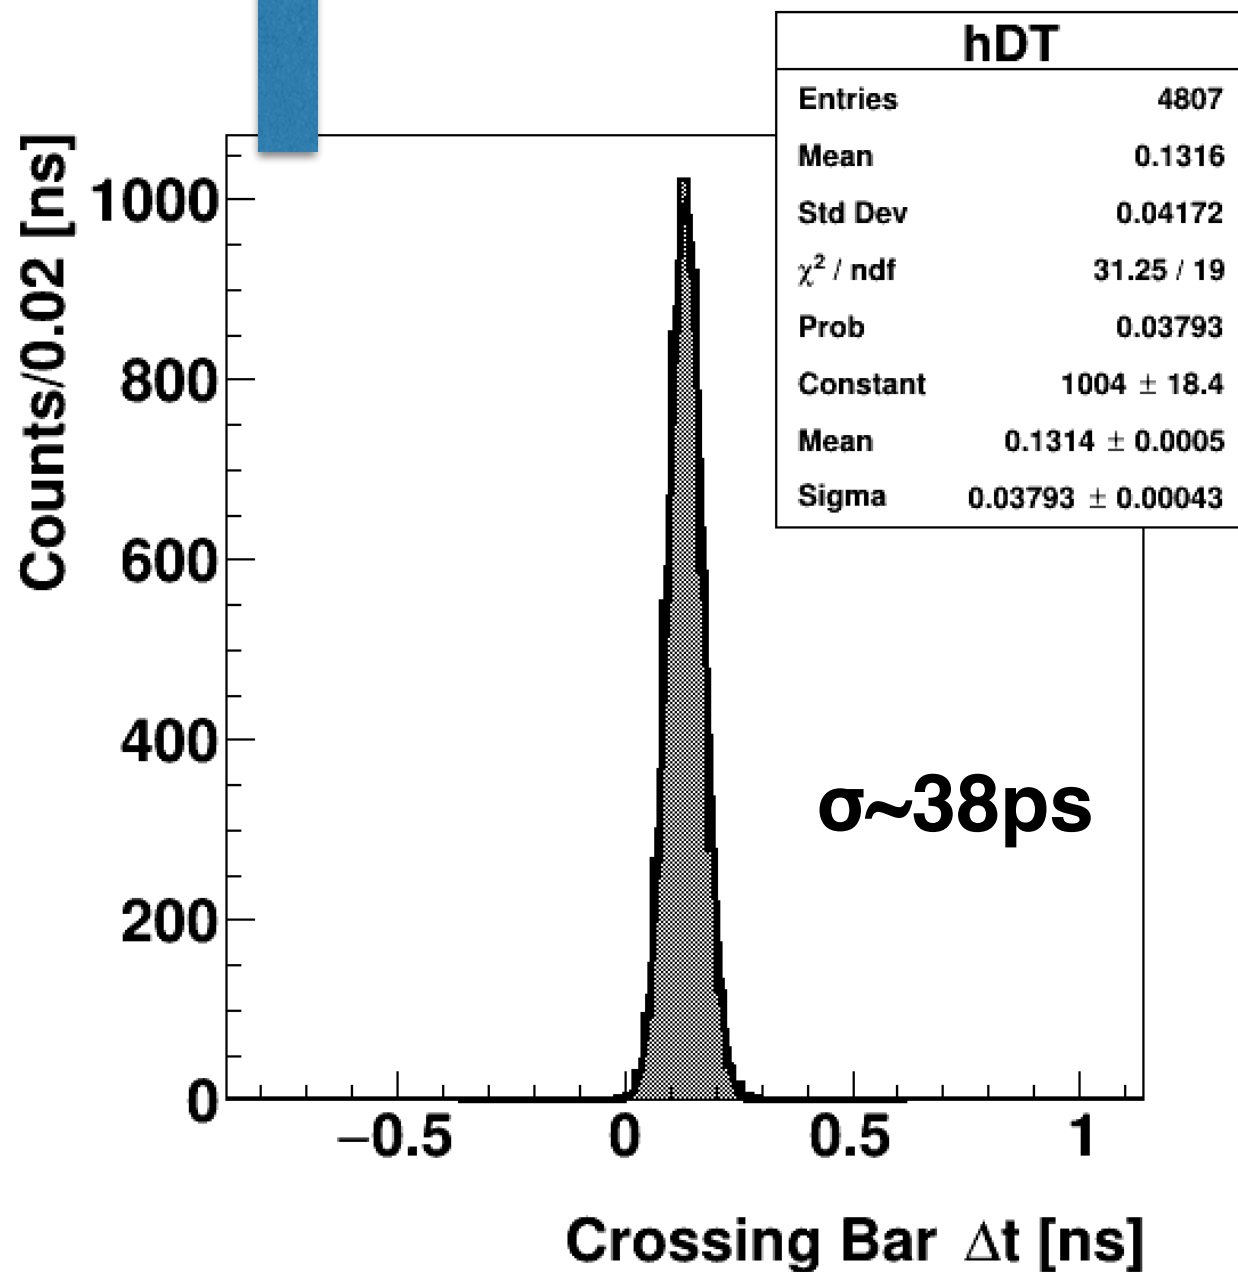
Check on the TW

bar29

run 2210(11,12)

run 2239(40,41,42)

bar9

- ▶ It seems that the resolution difference is due to the ST

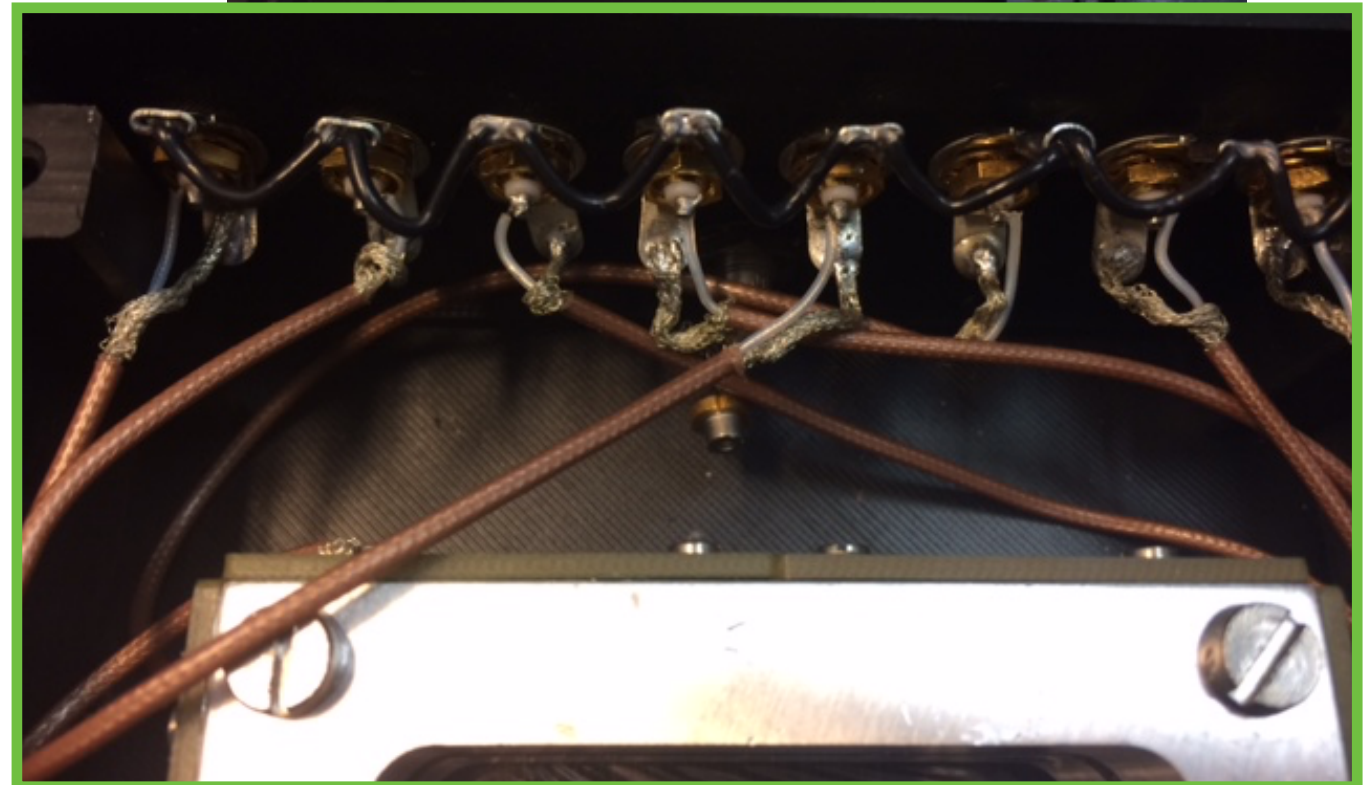
Update of the hardware

- ▶ Before the GSI2020 data-taking:
 - ▶ **Scintillator layer replacement.** We realised that the scintillator was cracked in the center... a new study of the response was needed
 - ▶ **The ground of the single channels have been shorten (detector side)** to reduce the impact of noise picked-up within GSI environment.

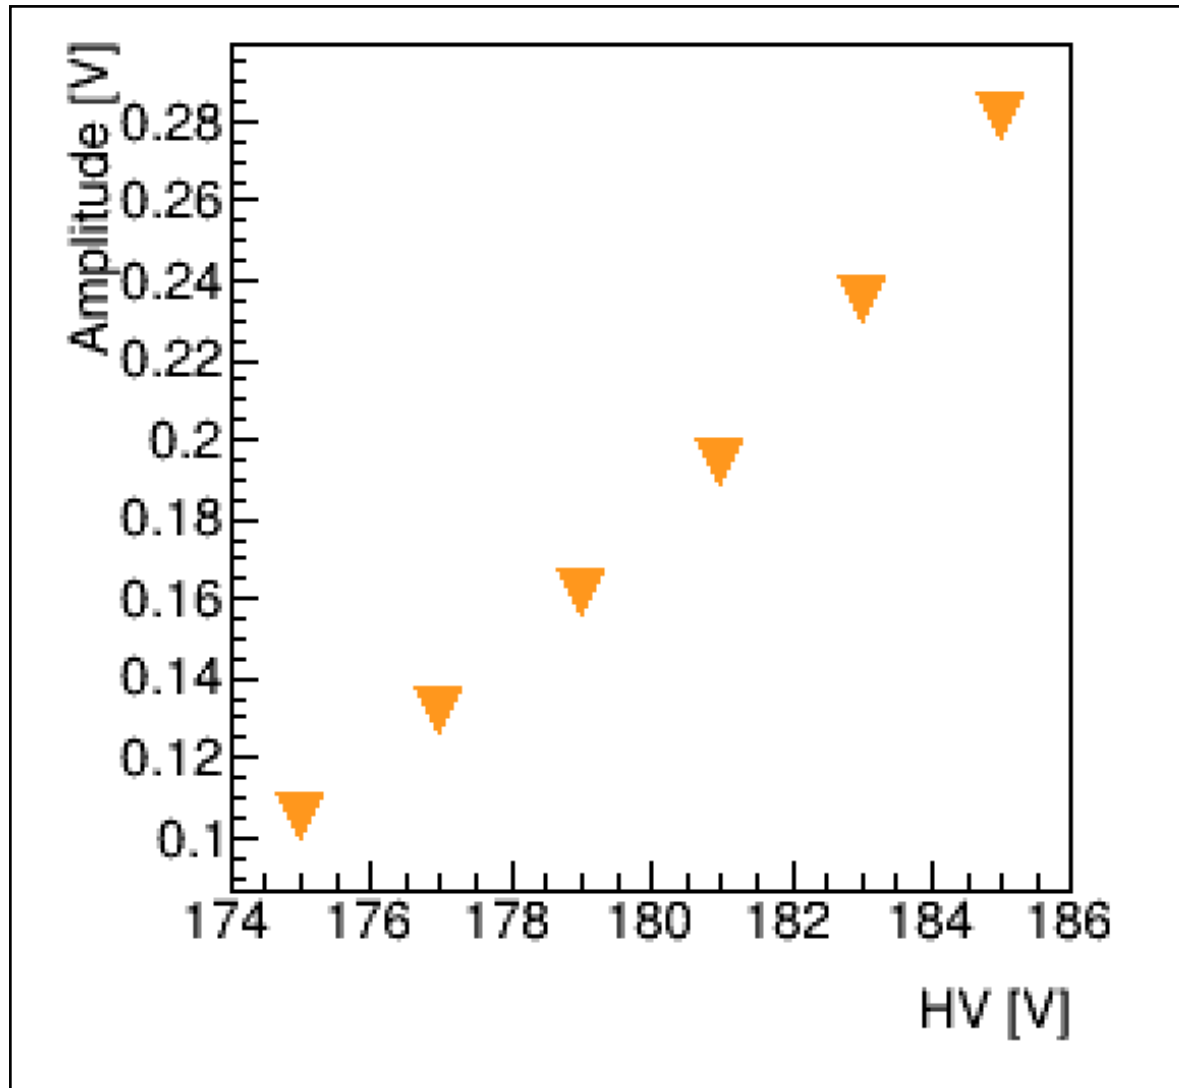
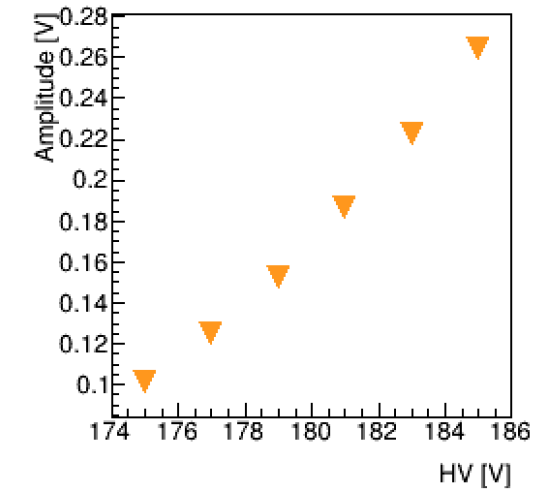
Channel gain equalization

- ▶ The different response of channels can be equalised properly tuning the HV
- ▶ The gain in the BD region of the SiPMs vary of a factor $\sim 2-3$

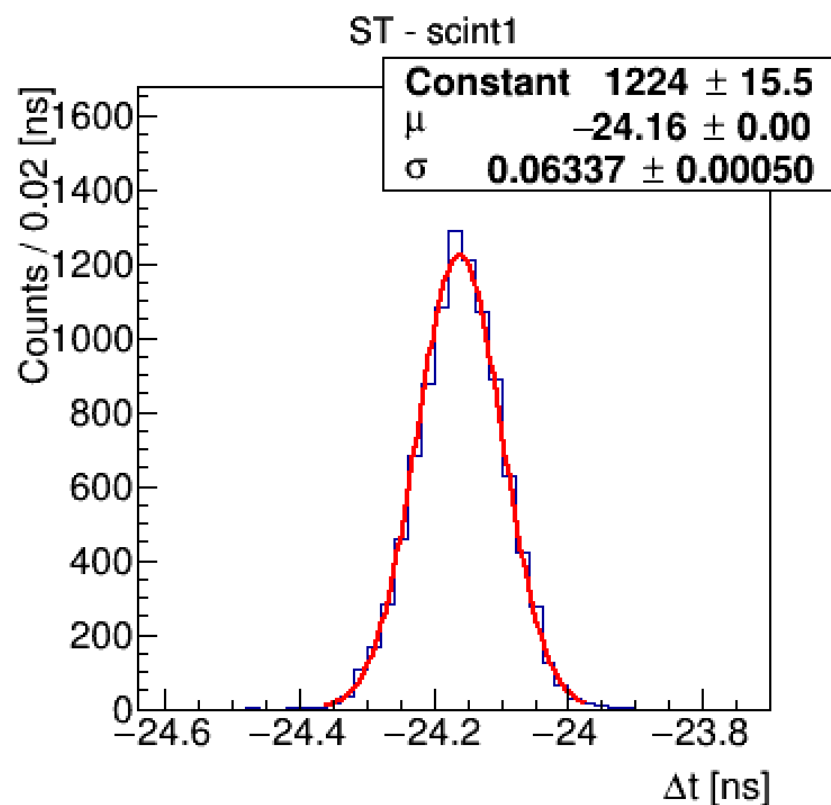
Time resolution

$$\sigma_{\text{ST},1}^2 = \sigma_{\text{ST}}^2 + \sigma_1^2$$

$$\sigma_{\text{ST},2}^2 = \sigma_{\text{ST}}^2 + \sigma_2^2$$

$$\sigma_{1,2}^2 = \sigma_1^2 + \sigma_2^2$$

$$\sigma_{\text{ST}} = \sqrt{\frac{1}{2} \left(\sigma_{\text{ST},1}^2 + \sigma_{\text{ST},2}^2 - \sigma_{1,2}^2 \right)} \sim 53 \text{ ps}$$

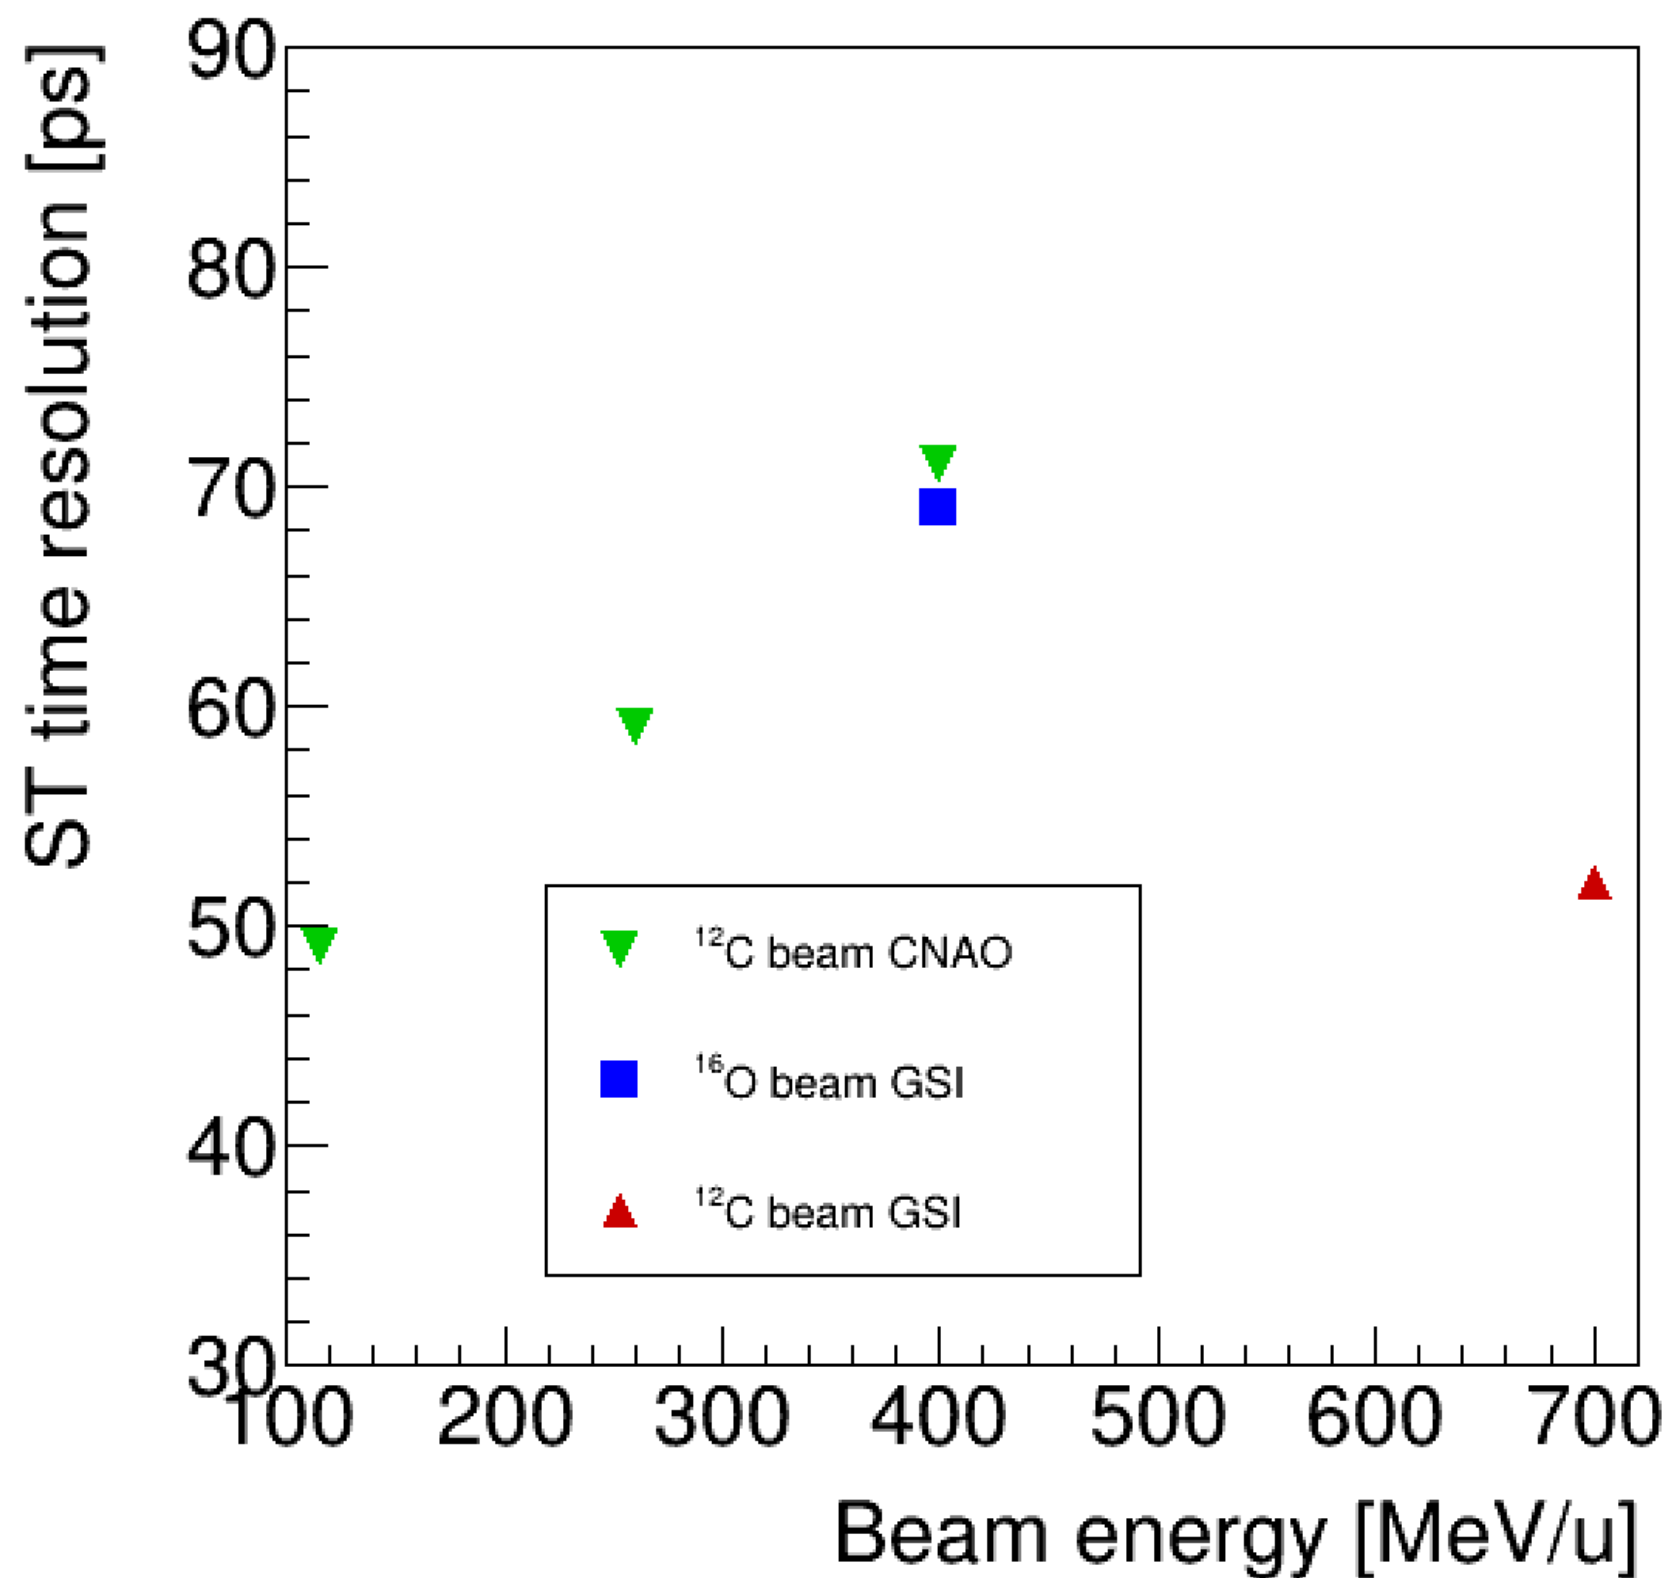
Comparison with the past

- ▶ The noise is **still observable**. We observed a “low frequency” component that could be observed as a baseline fluctuation, and a “high frequency” component.
- ▶ The amount of noise dependent on ... whatever! (cable configuration and orientation, positioning in the room). Small setup variations dramatically affect the noise picked up by the system.
- ▶ However, acting on the WD internal filters and using **a reasonable threshold (40-50mV), at the operating HV it seems that could be take under control** (~Hz noise rate), keeping an high efficiency on the incoming ion detection.
- ▶ The impact on time resolution has to be evaluated, but the obtained results suggest that should be minimum/negligible.
