Pixel tracker update

- 1. Vertex improvements after GSI data taking
- 2. Inner Tracker (IT) status
- 3. Conclusions

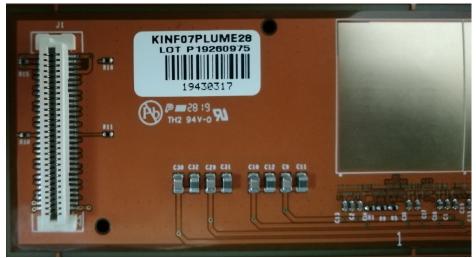
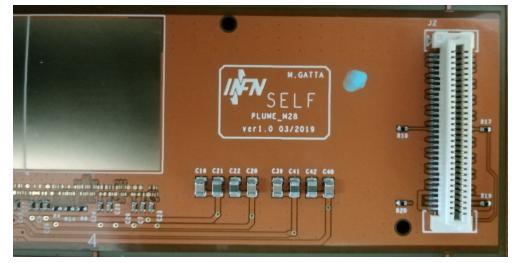
The PlumeM28 first PCB prototypes: at G&A to start the assembly jig construction

- PlumeM28 (kapton PCB) to hold the sensors
 1 PlumeM28 holds 4 sensors and is definde a module. Two glued modules assembled with a RVC (Resistive Vitreous Carbon foam) spacer thick 2mm forms a Ladder.
 The Inner Tracker is composed by 4 Ladders covering (acceptance) about 8x8 cm.
