CYGNO MEETING - 12/02/21

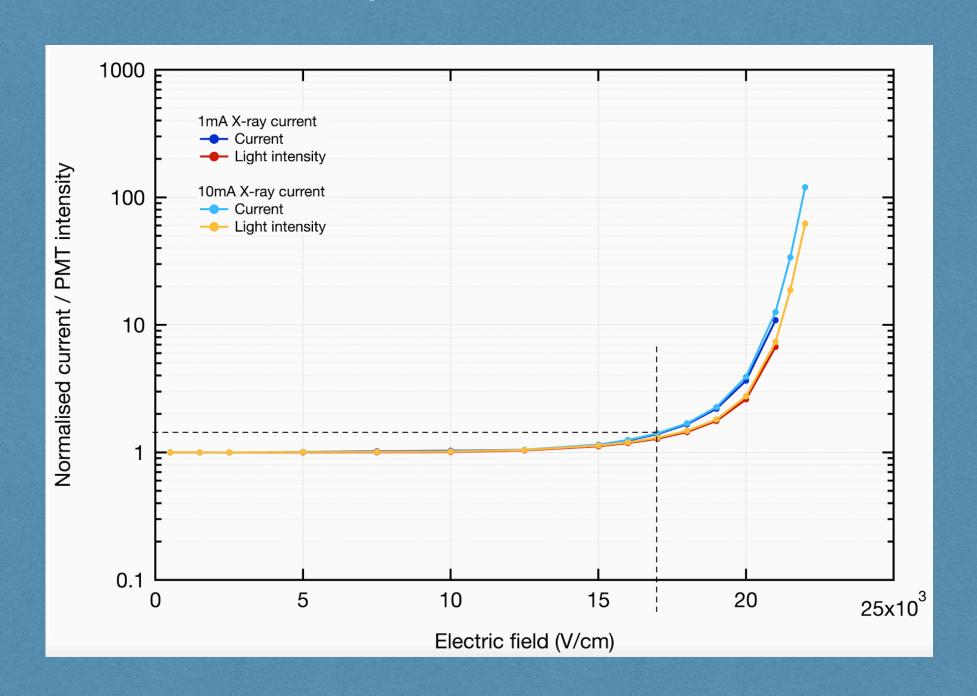
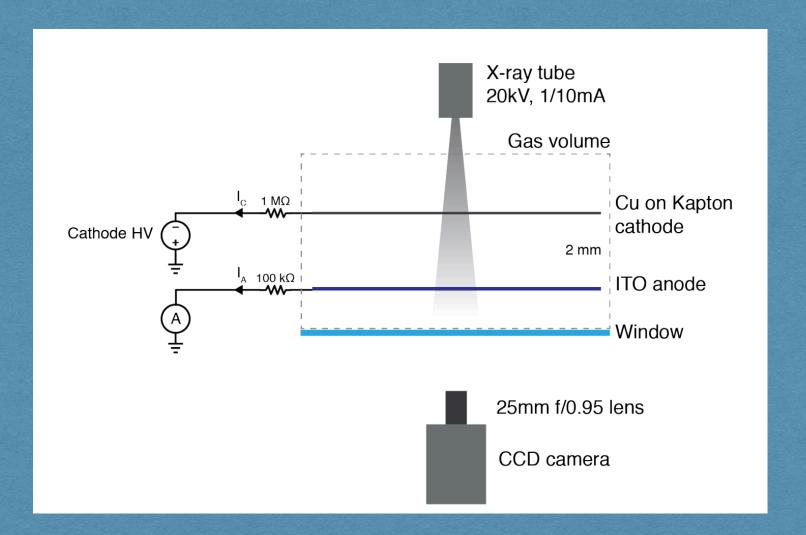
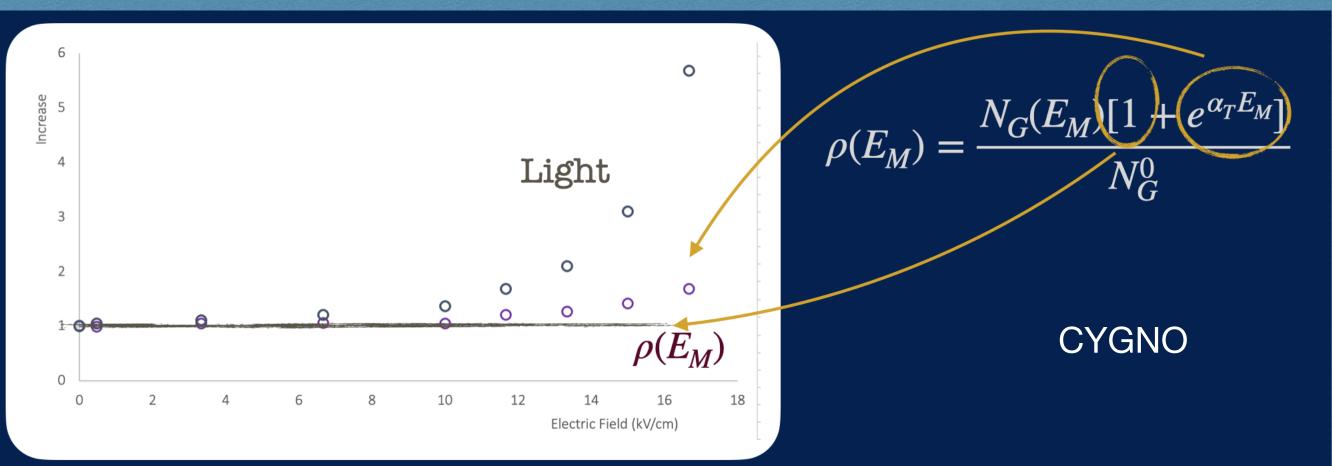
- RD51 is testing a parallel plate setup without GEM

- Same behavior of current as us. This is confirming the goodness of our charge measurements and that gain is mainly in the gap;
- Light/charge ratio still 1. Under study ...

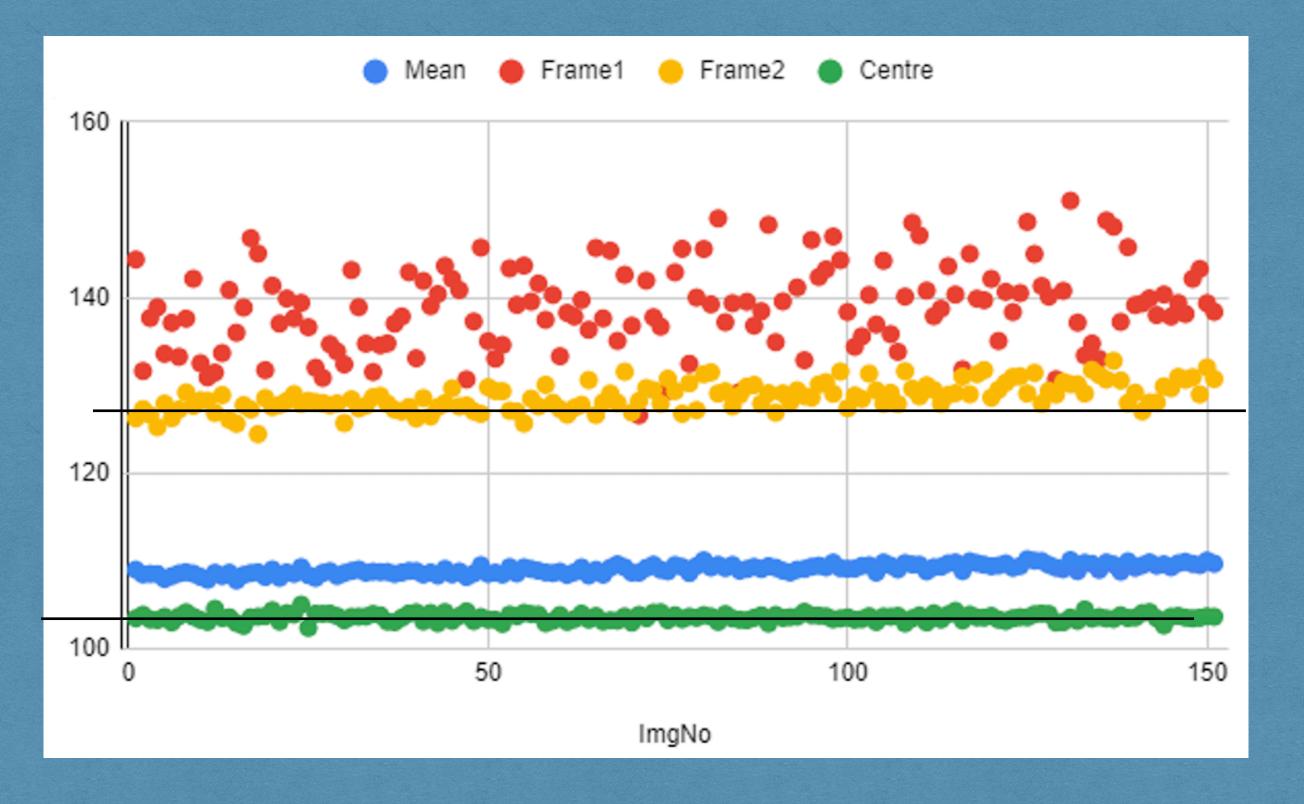
LIME FC started to "produce" unexpected (and unwanted) light from the external sides

This effect, appeared after 36 hour from HV-On, seems to increase with time

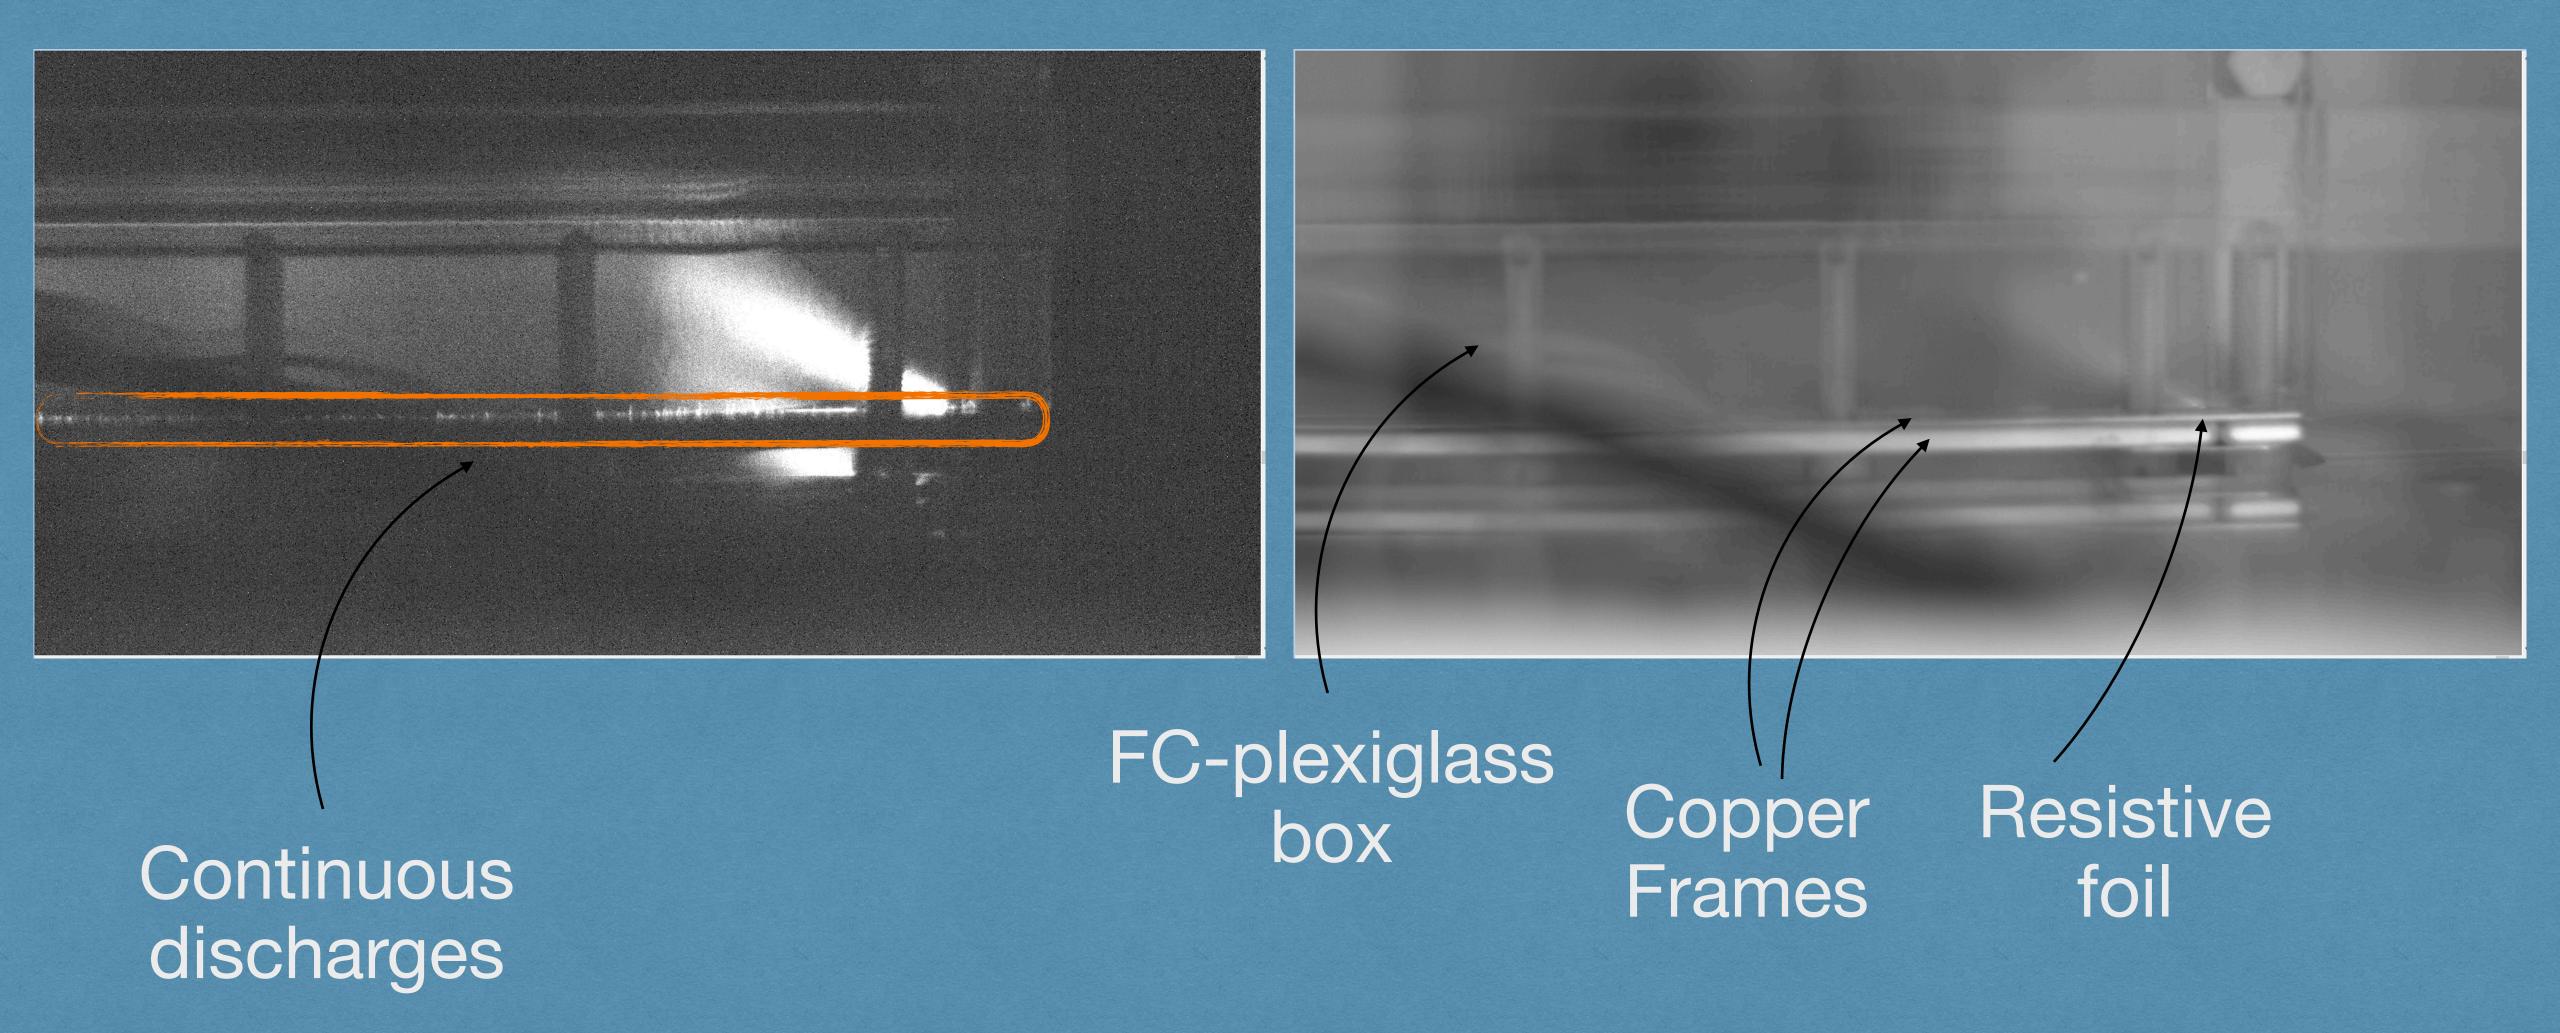
Yesterday we installed the camera on the top and scanned the FC

Room Light Off

Room Light On

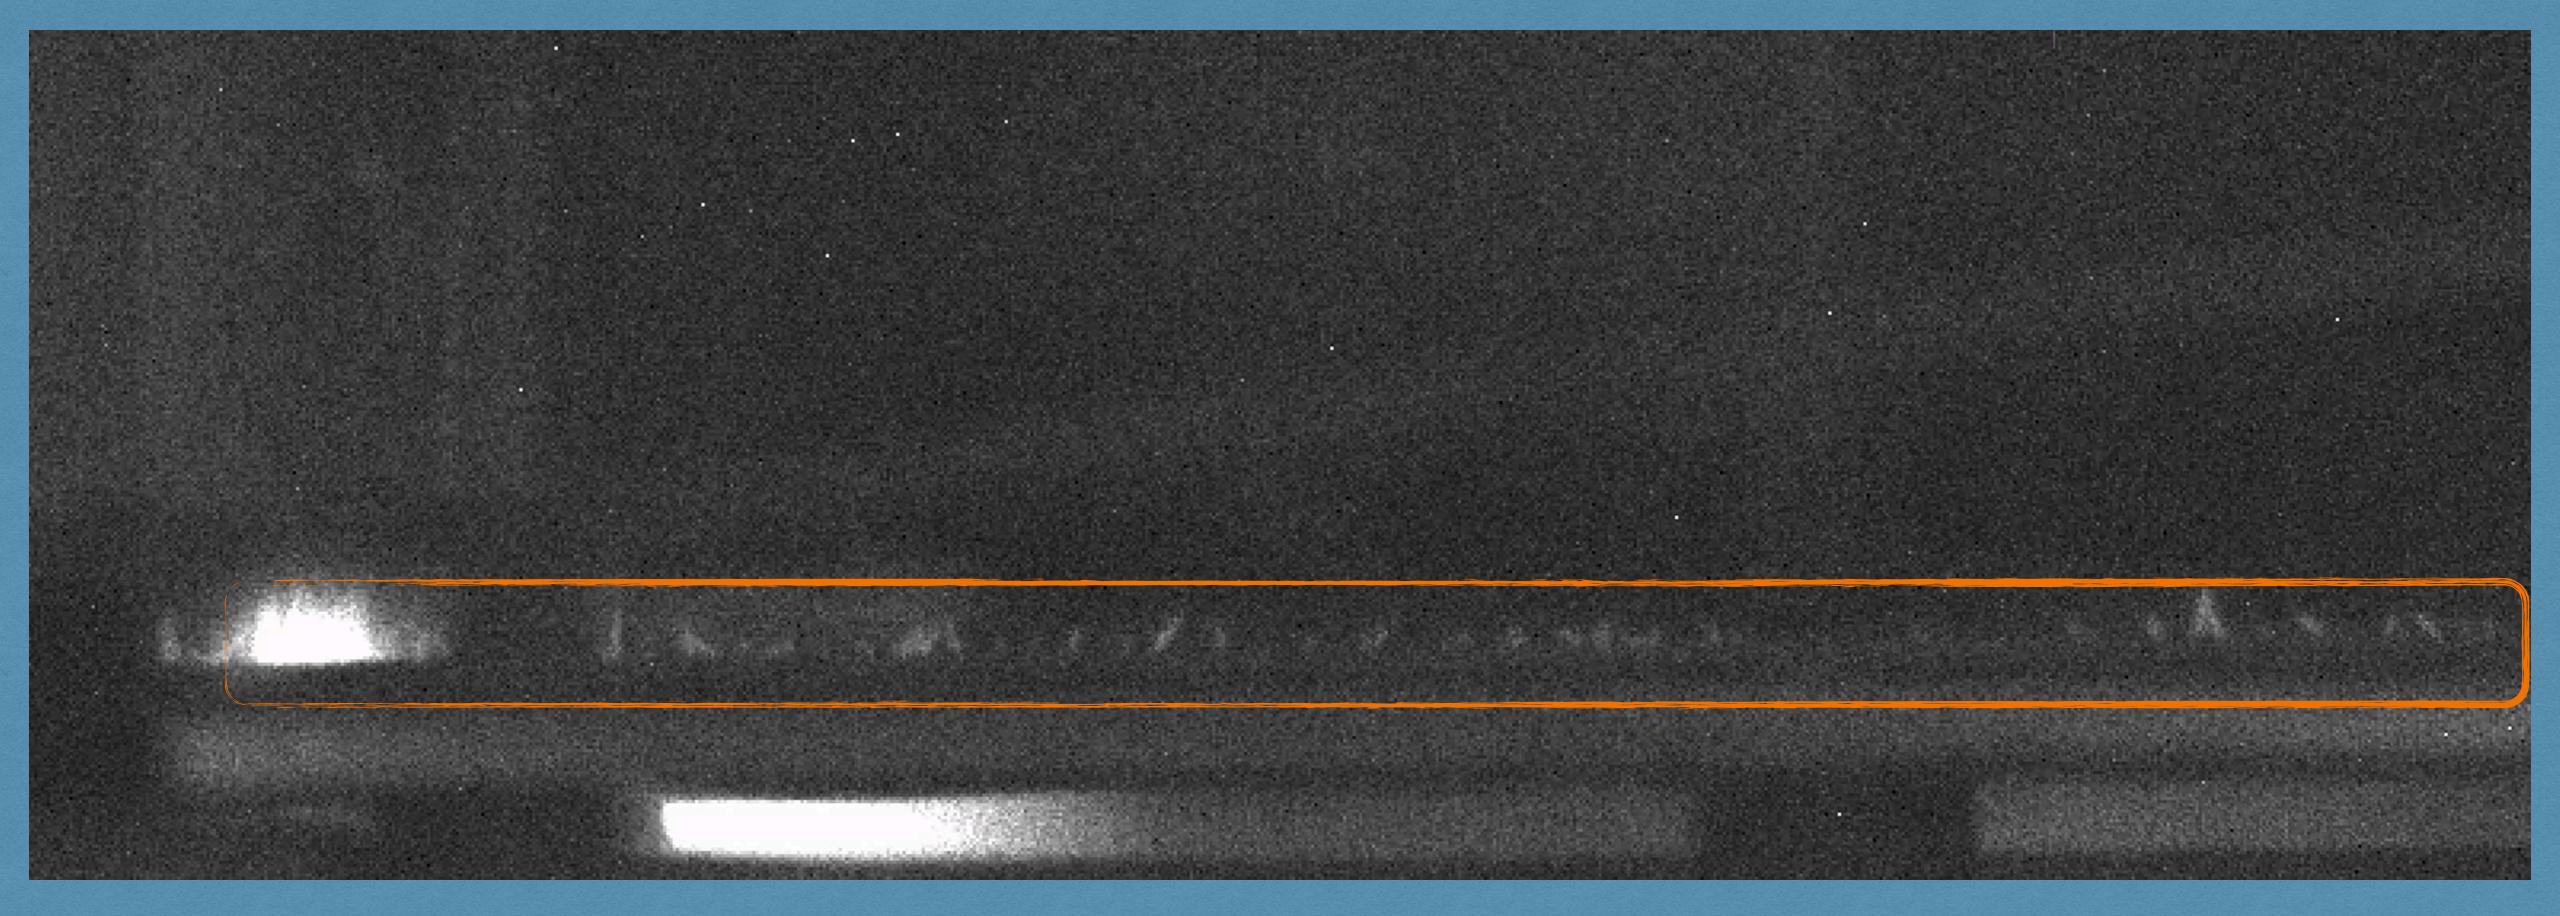
CLOSE-UP

Discharges on the FC side in towards the GEM were clearly visible

No other discharges were discovered in the FC
