PIERRE
AUGER
OBSERVATORY

SDEU: stato produzione, installazione e test

G. Marsella

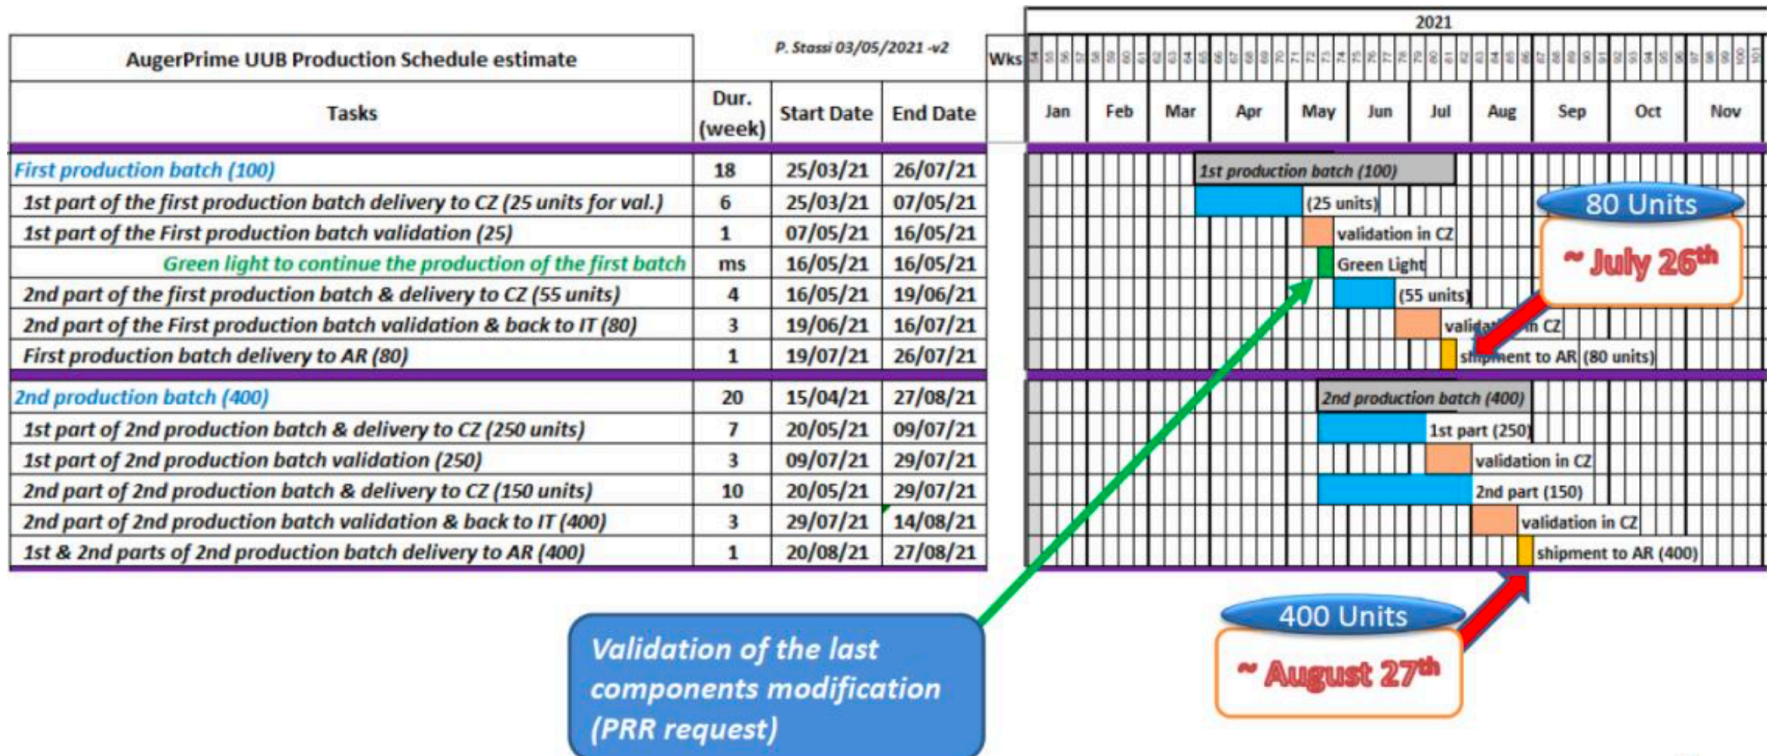
UUB fabrication schedule

The currently estimated schedule is below.
