Update: R&D on SiPM

Annealing and characterisation

Bologna Group

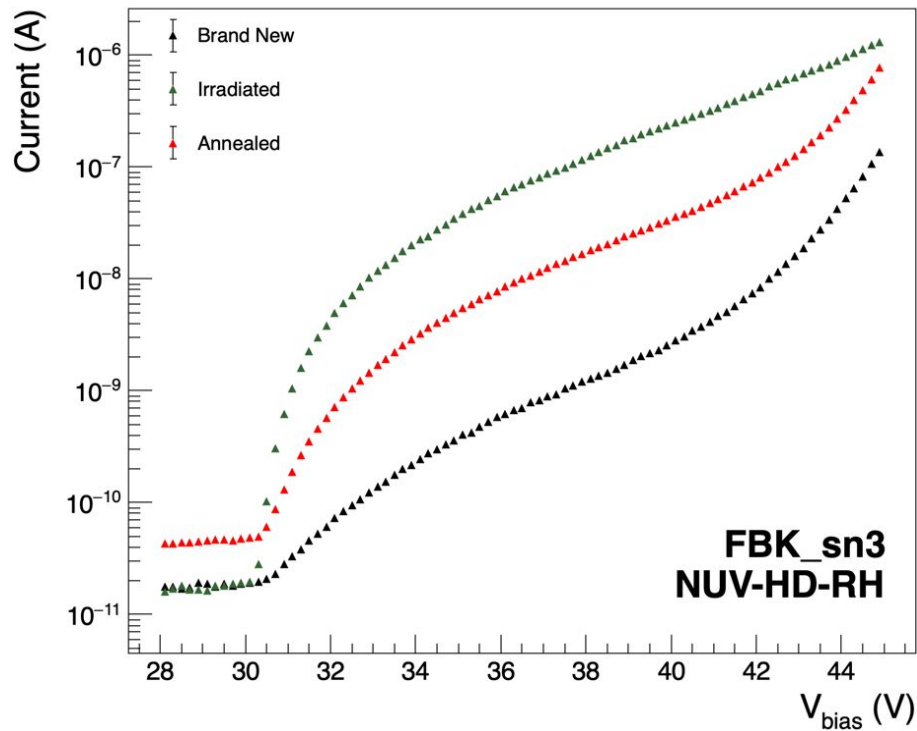
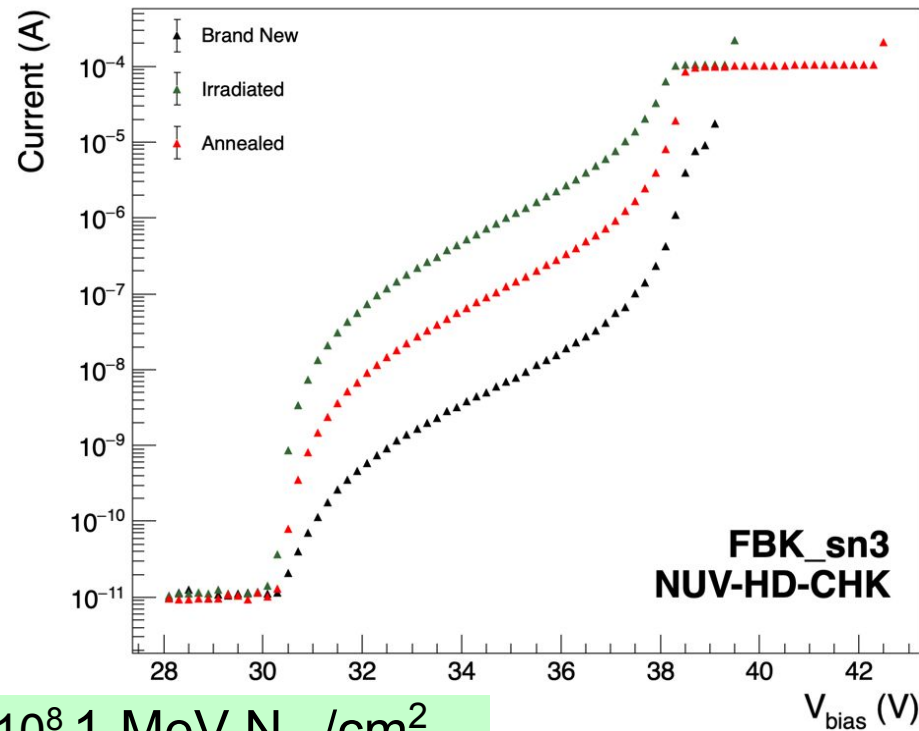
I-V changes

10^8 1-MeV $N_{\text{eq}}/\text{cm}^2$

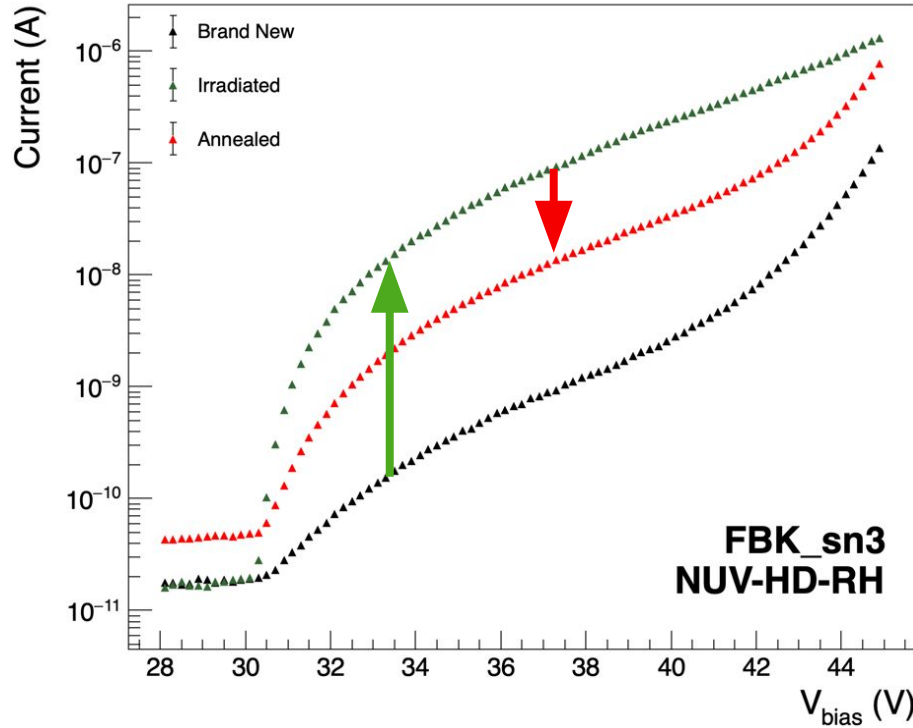
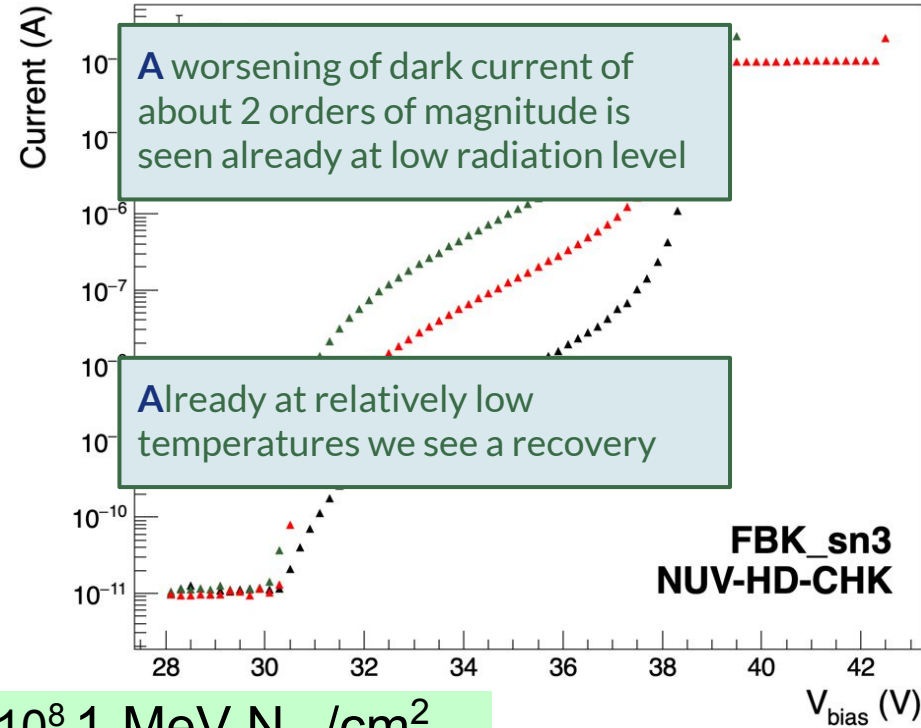
I-V changes

24h at 100°C and
for 168h at 125°C.

1. A consistent factor of 10 for recovery has been found for the 1-week 125°C annealing cycle
2. Radiation damage does not seem to affect light response noticeably up to 10^{10}
3. We have a new quick, automated system w/ parallel measurement
4. We see a difference for two different methods for evaluating light response, ON-OFF and coincidence

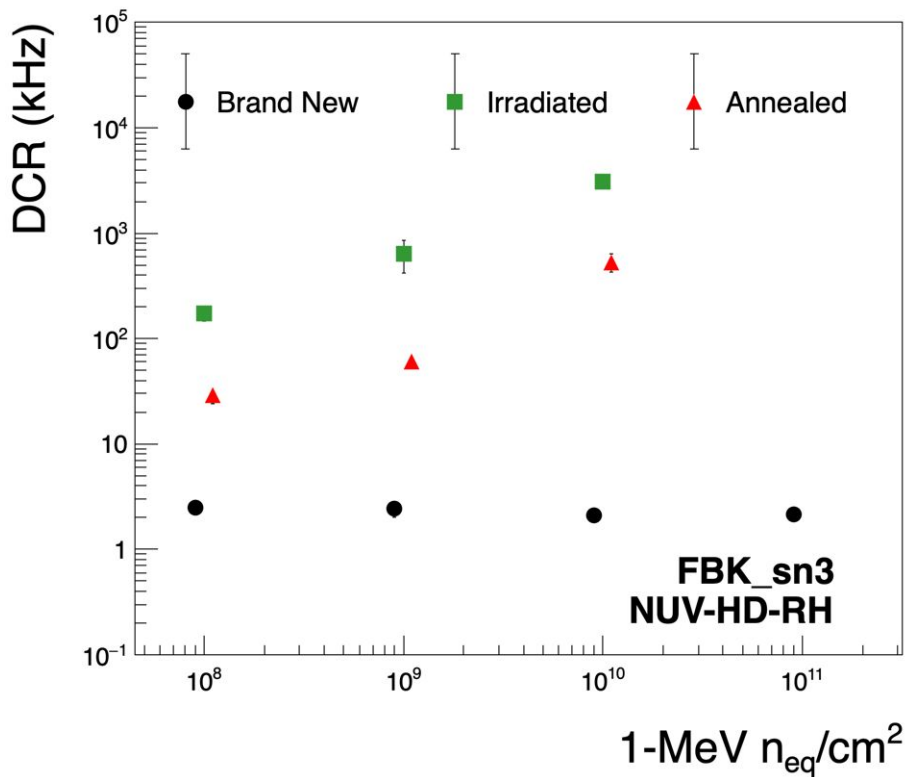
Dark Current and Count

$T = -30\text{C}$

$V_{\text{over}} = 3\text{V}$

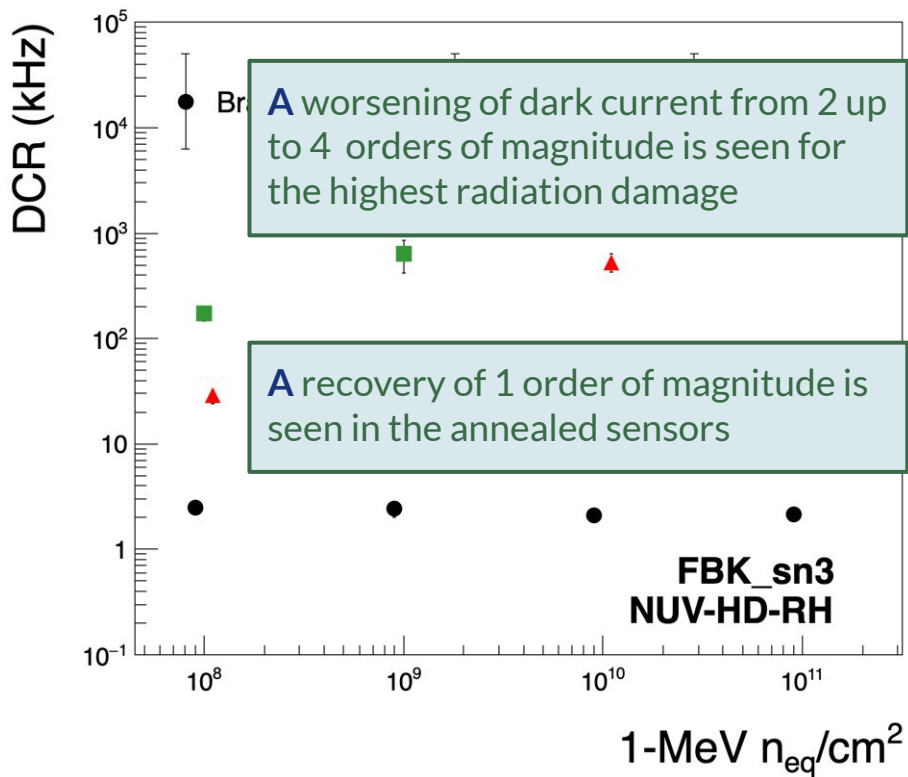
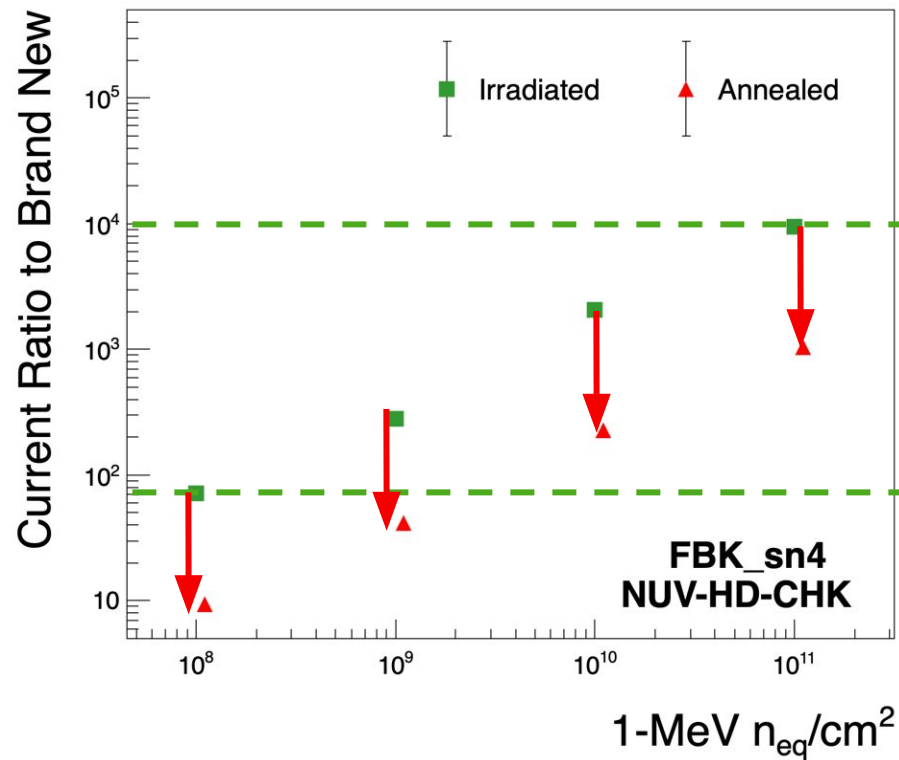
Dark Current and Count

$T = -30\text{C}$

$V_{\text{over}} = 3\text{V}$

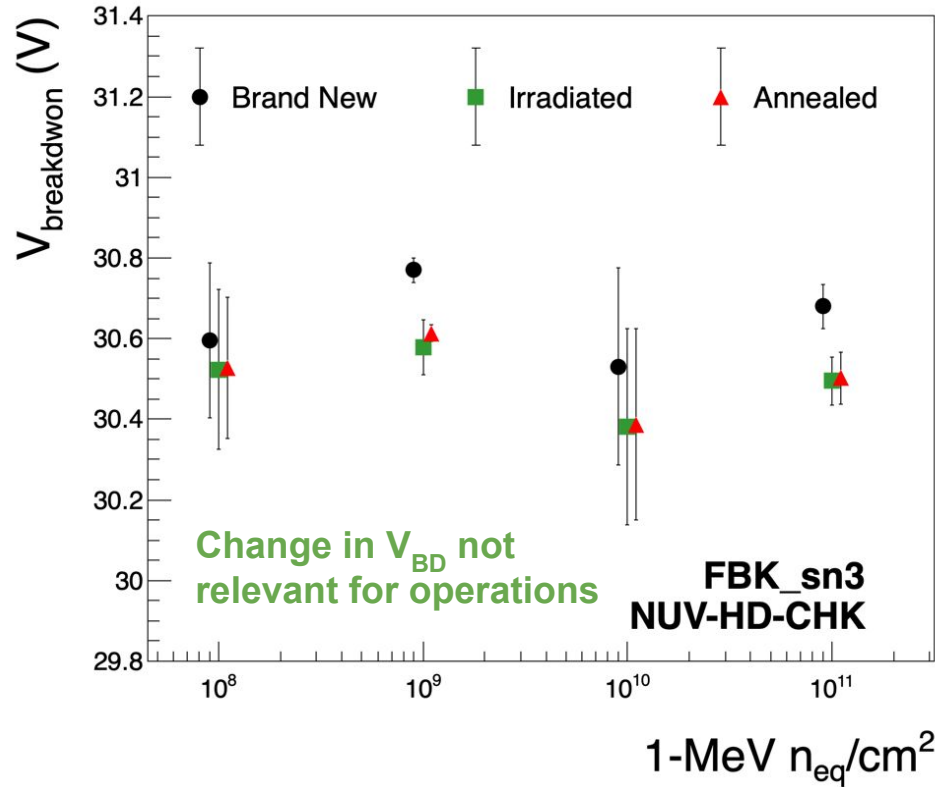
Bias Voltage

T = -30C

The error bar represents the dispersion of the distribution

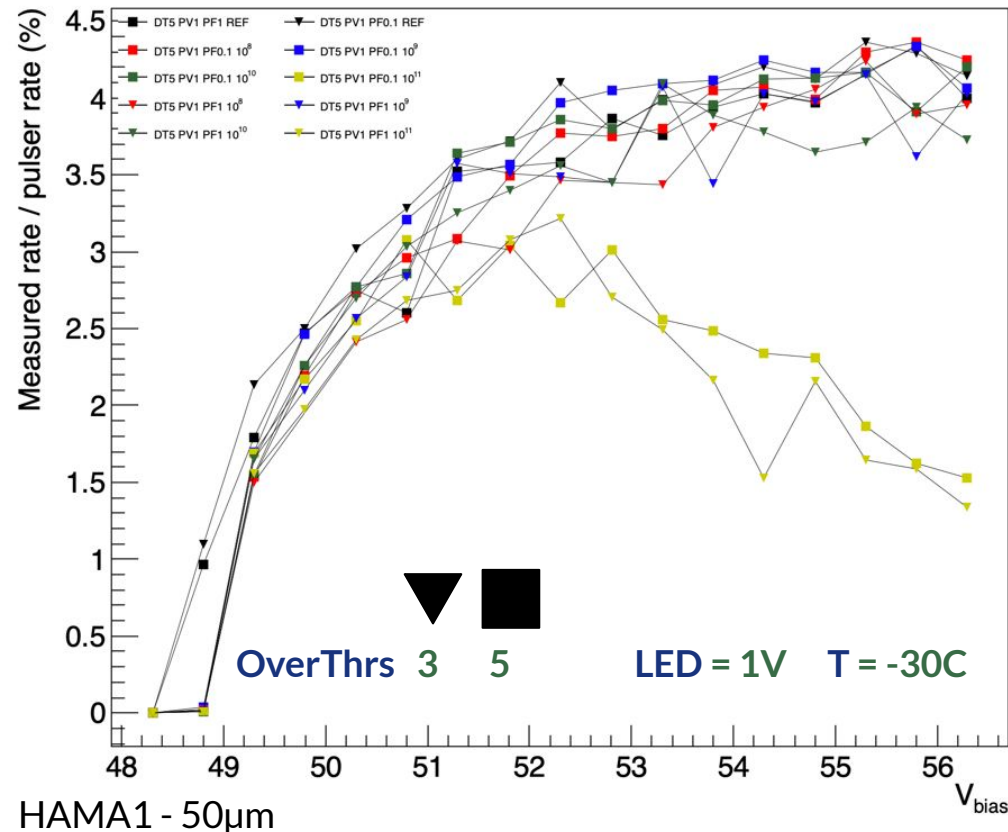
Characterising SiPMs

For 10^8 10^9 10^{10} irradiation the light response seem to be consistent with the **reference**

For 10^{11} irradiation the light response seem to start deviate from **reference**
