GEM commissioning with PICO

A. Cagnotta - Riunione INFN Gr.1 Napoli

12/01/23

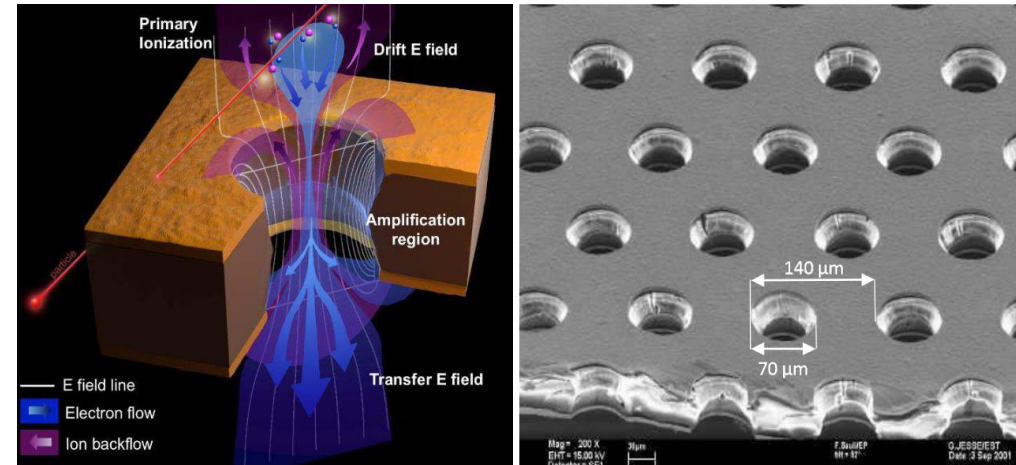
❑ GEM technology

- ❑ 2 conductive plates (Copper) spaced out by an insulation material (Kapton)
- ❑ bi-conical holes are performed in the foil
- ❑ Copper 5 μm , Kapton 50 μm
- ❑ Electron amplification in the holes

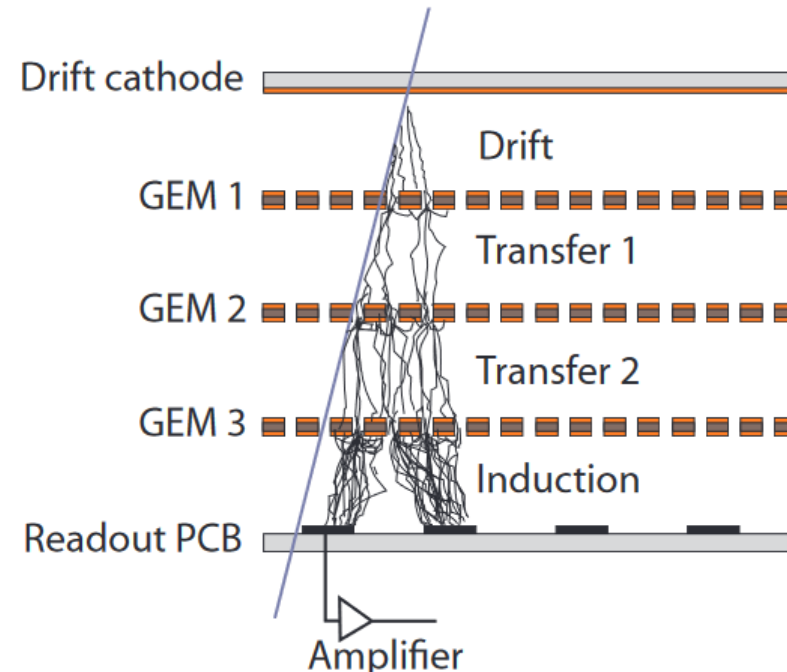
❑ Triple-GEM

- ❑ 3 cascade GEM foils
- ❑ Gas mixture Ar:CO₂ 70:30
- ❑ Amplification up to 10⁵ with a modest high voltage (~400V)

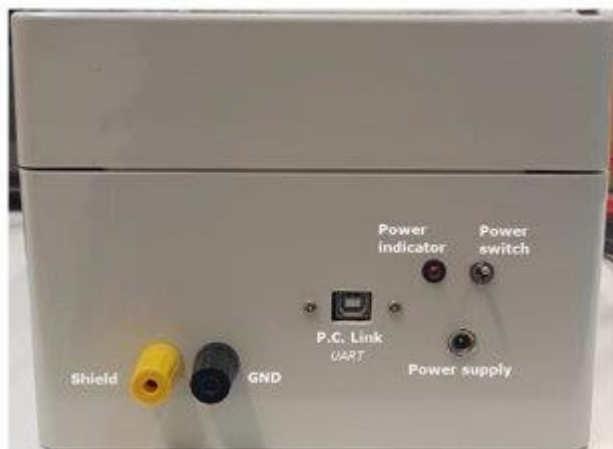
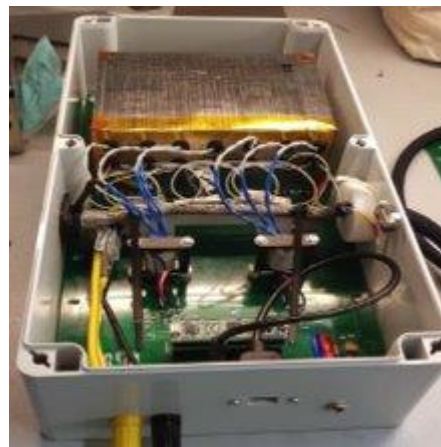
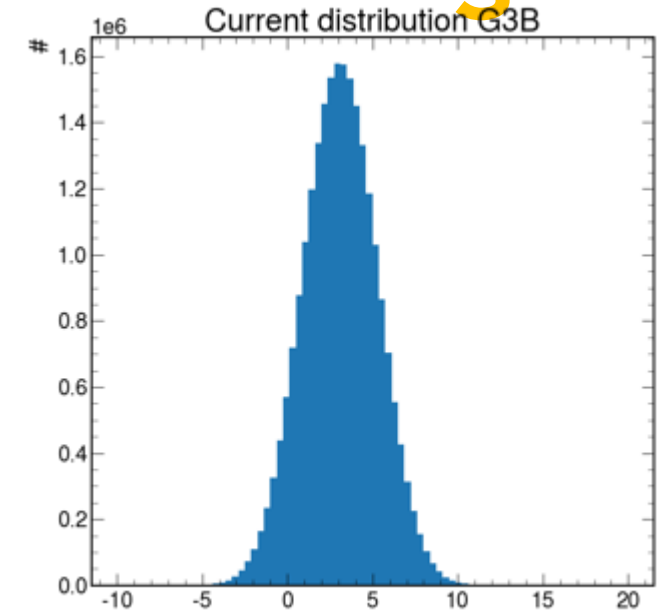
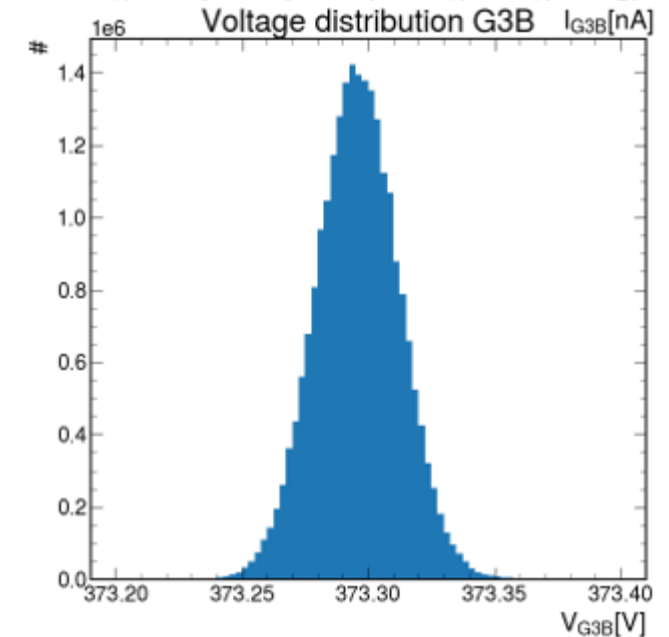
Pico-ammeter for triple-GEM monitoring

- ❑ High-granularity, high-resolution Pico-ammeter (PICO for friends) 100% made in Naples
- ❑ PICO allows a simultaneous monitoring of 7 GEM electrodes, both current and voltage
- ❑ Sampling 380Hz, typical sampling of CAEN boards O(Hz)
- ❑ Resolution $\leq 30\text{pA}$ (much smaller than noise)

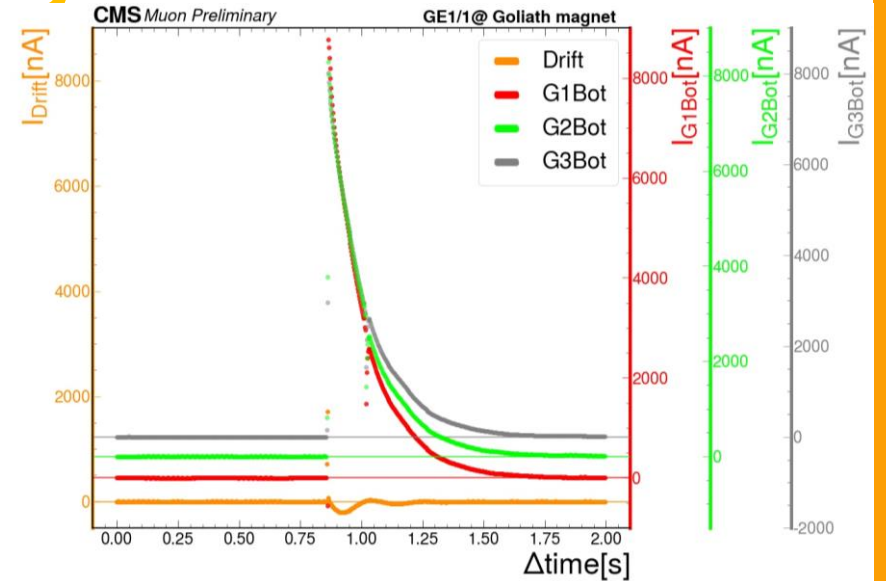
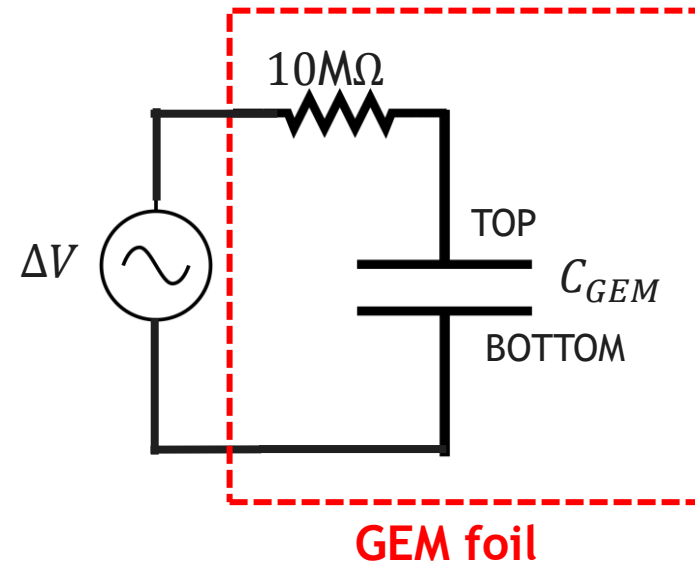
Discharge event recorded by PICO

- Examples of discharge recorded by PICO,
- In the upper plot are shown the currents flowing on GEM bottom + drift foils,
 - positive polarity
 - exponential shape
- In the lower plot are shown the currents flowing on GEM top foils,
 - negative polarity
 - exponential shape
- With PICO we have the possibility to check for consecutive events (more than 1 discharge in 1s) and to follow possible minor damages on the foils

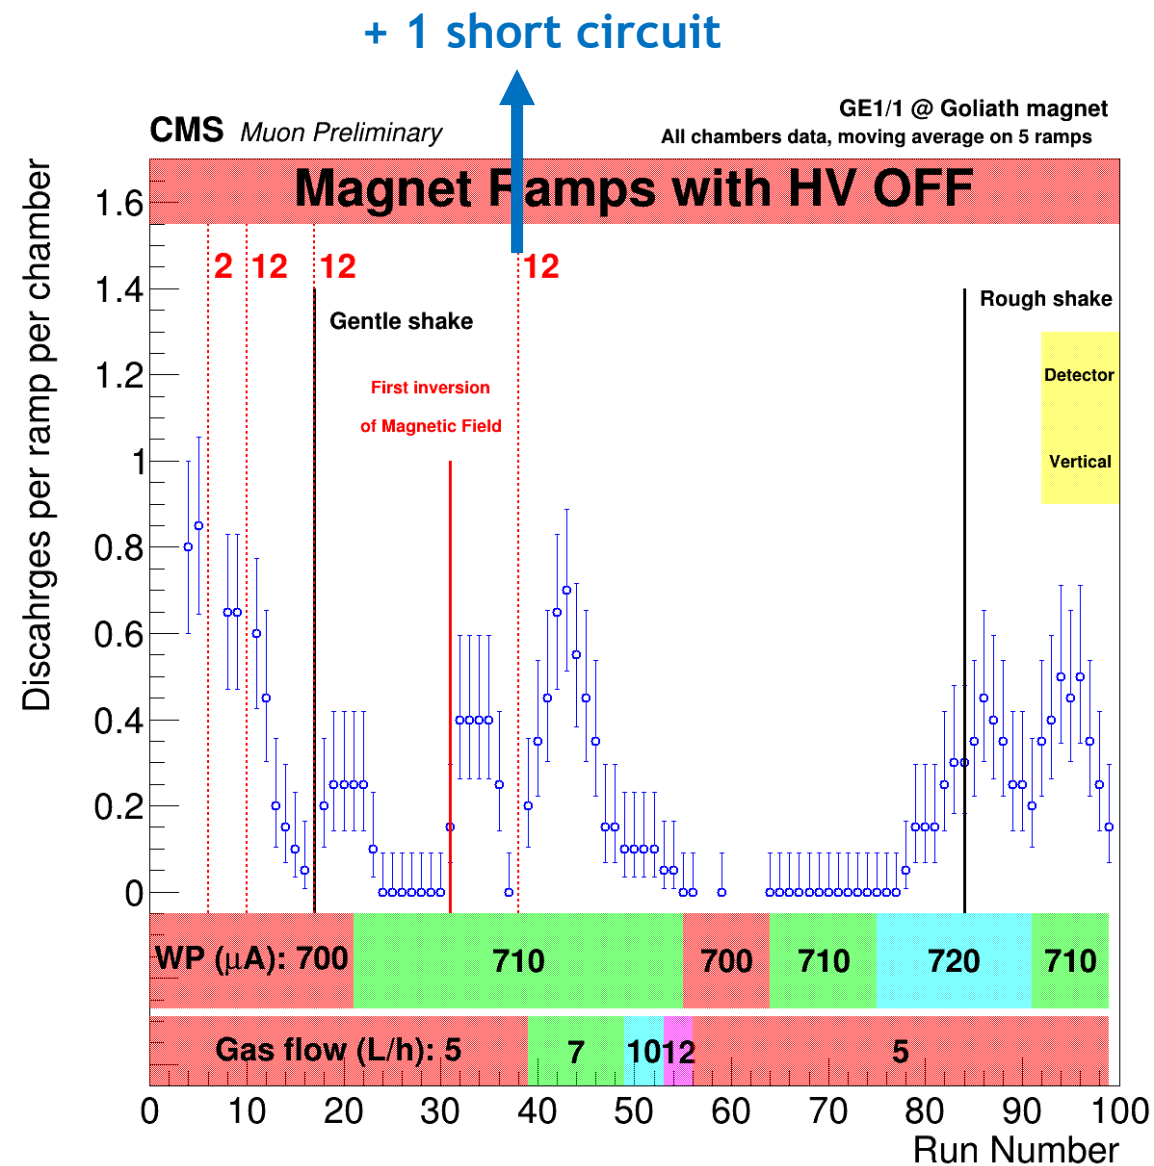
Number of discharges in different operating conditions

- In the plot are reported the moving average number of discharges per magnetic ramp, mediated on 5 ramps.
- the red dashed lines indicates when the magnetic ramps with detector HV OFF were performed
- the black lines indicates when chambers were mechanically stressed
- Main phase of the tests:
 - classic P5 operation
 - mechanical stress
 - inversion of the magnetic field

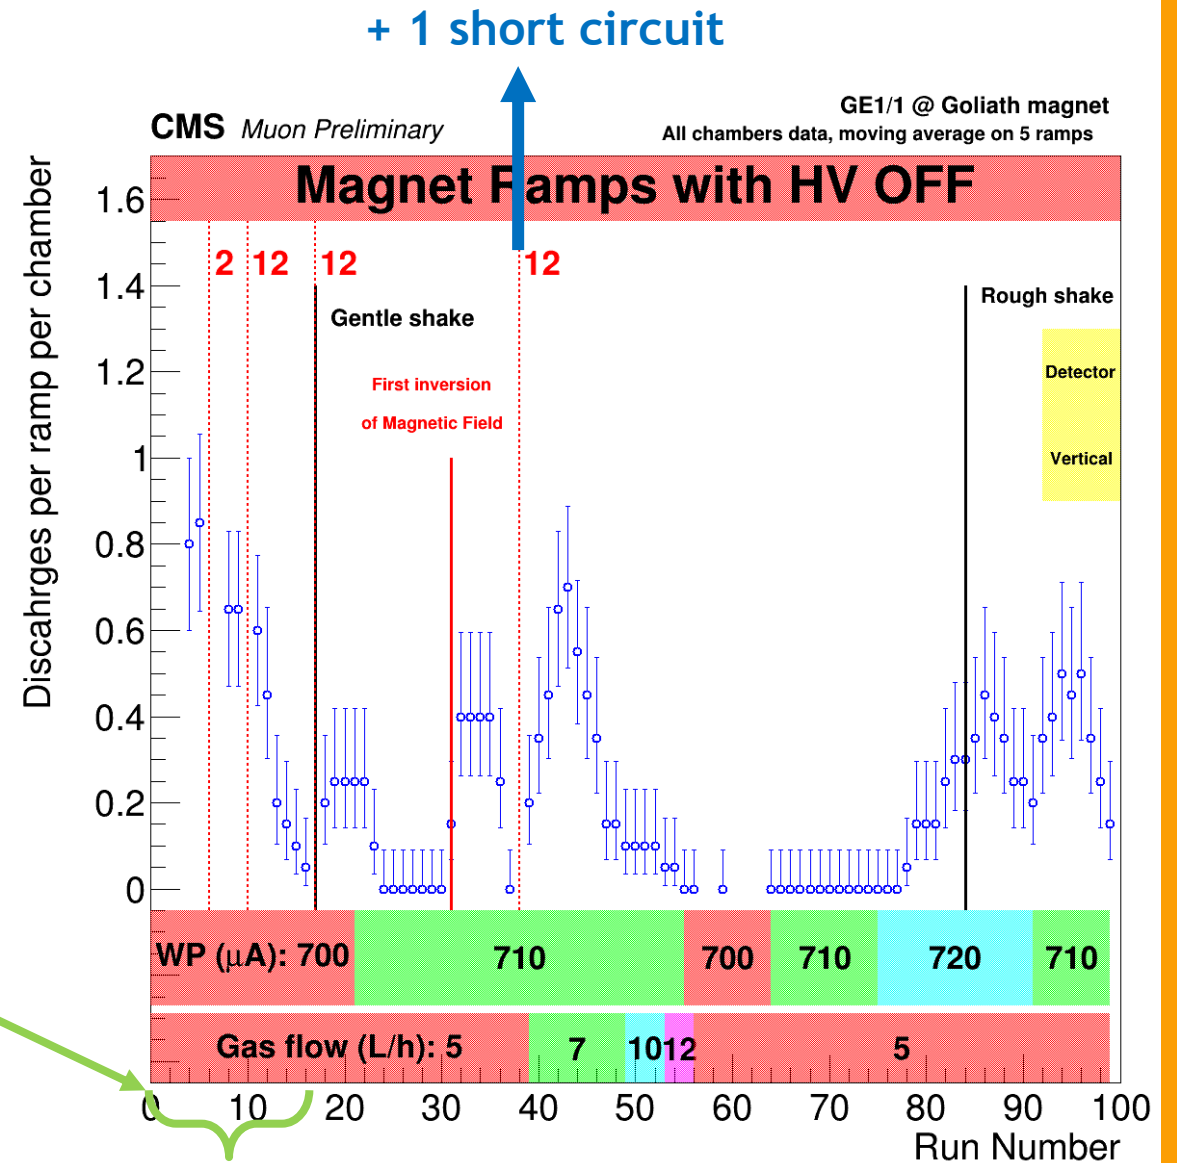
Number of discharges in different operating conditions

- In the plot are reported the moving average number of discharges per magnetic ramp, mediated on 5 ramps.
- the red dashed lines indicates when the magnetic ramps with detector HV OFF were performed
- the black lines indicates when chambers were mechanically stressed
- Main phase of the tests:
 - classic P5 operation
 - mechanical stress
 - inversion of the magnetic field

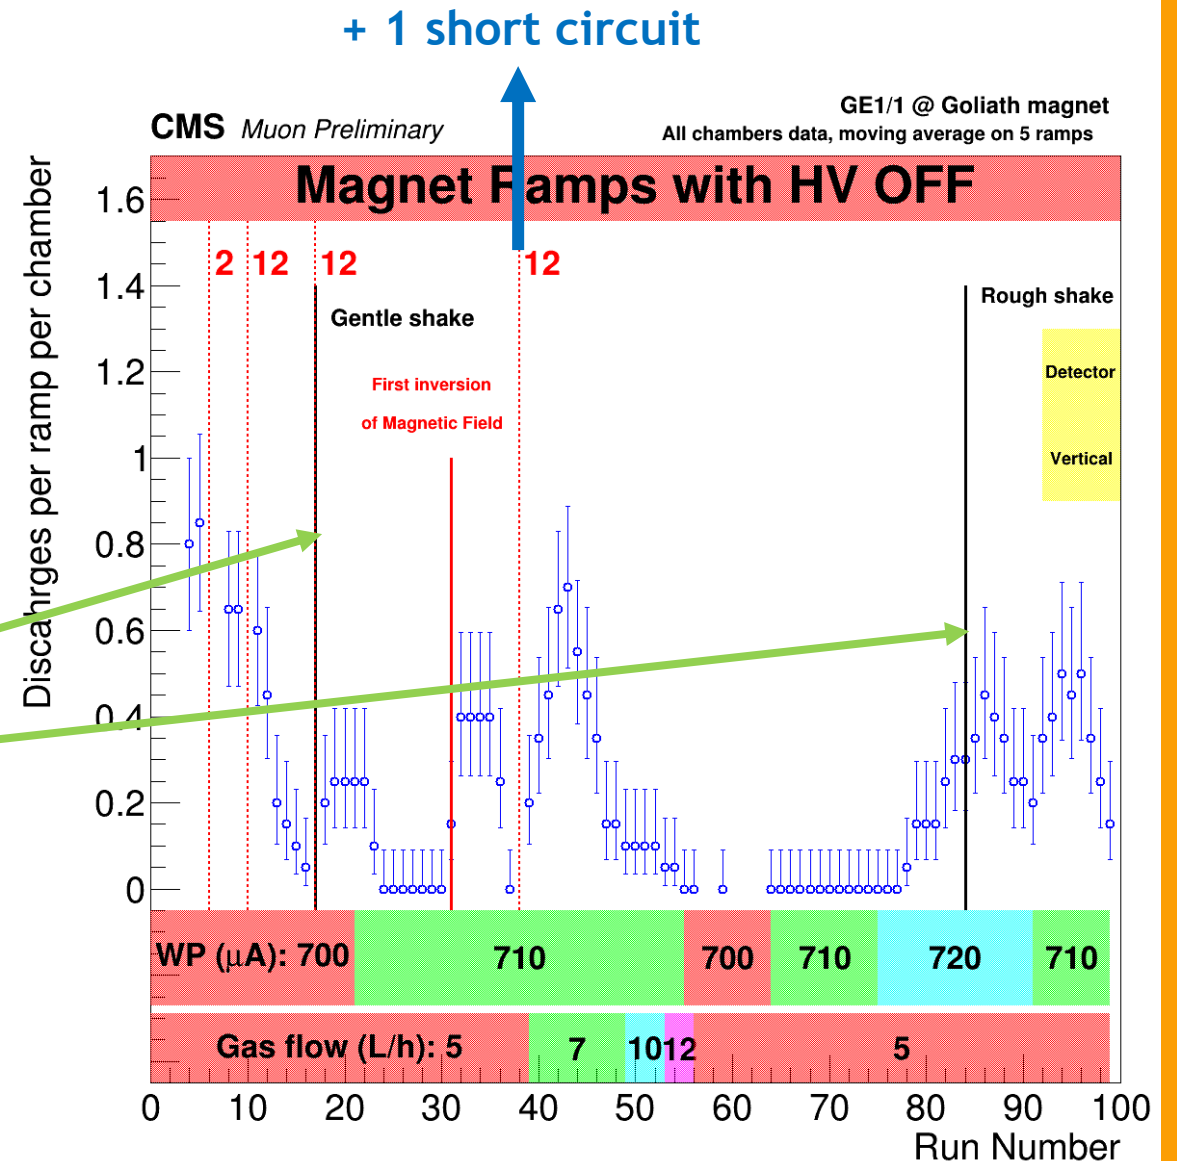
Number of discharges in different operating conditions

- In the plot are reported the moving average number of discharges per magnetic ramp, mediated on 5 ramps.
- the red dashed lines indicates when the magnetic ramps with detector HV OFF were performed
- the black lines indicates when chambers were mechanically stressed
- Main phase of the tests:
 - classic P5 operation
 - mechanical stress
 - inversion of the magnetic field

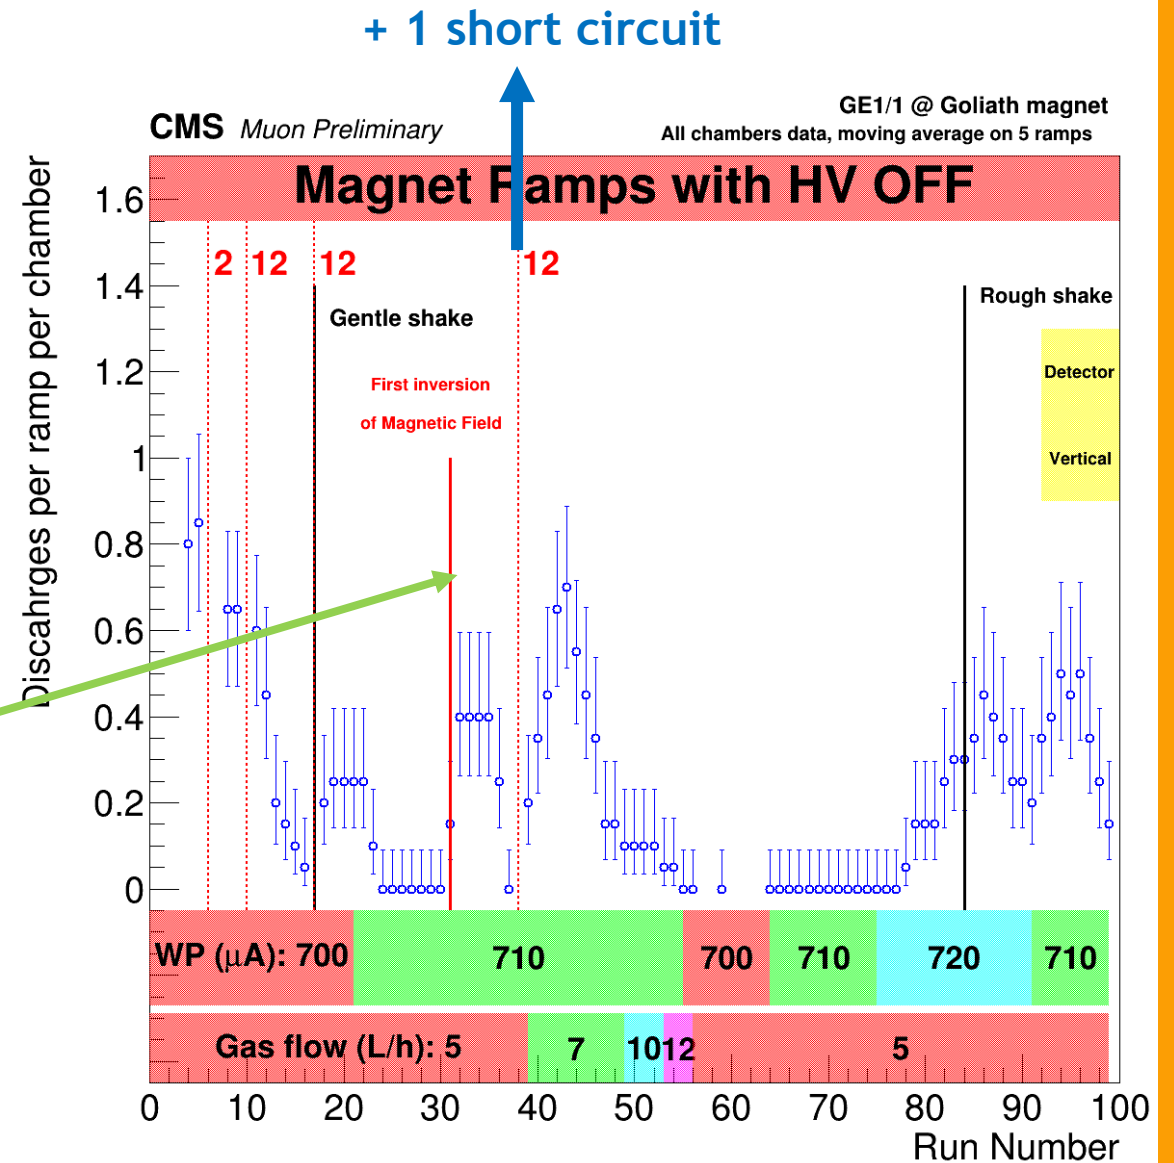
Number of discharges in different operating conditions

- In the plot are reported the moving average number of discharges per magnetic ramp, mediated on 5 ramps.
- the red dashed lines indicates when the magnetic ramps with detector HV OFF were performed
- the black lines indicates when chambers were mechanically stressed
- Main phase of the tests:
 - classic P5 operation
 - mechanical stress
 - inversion of the magnetic field

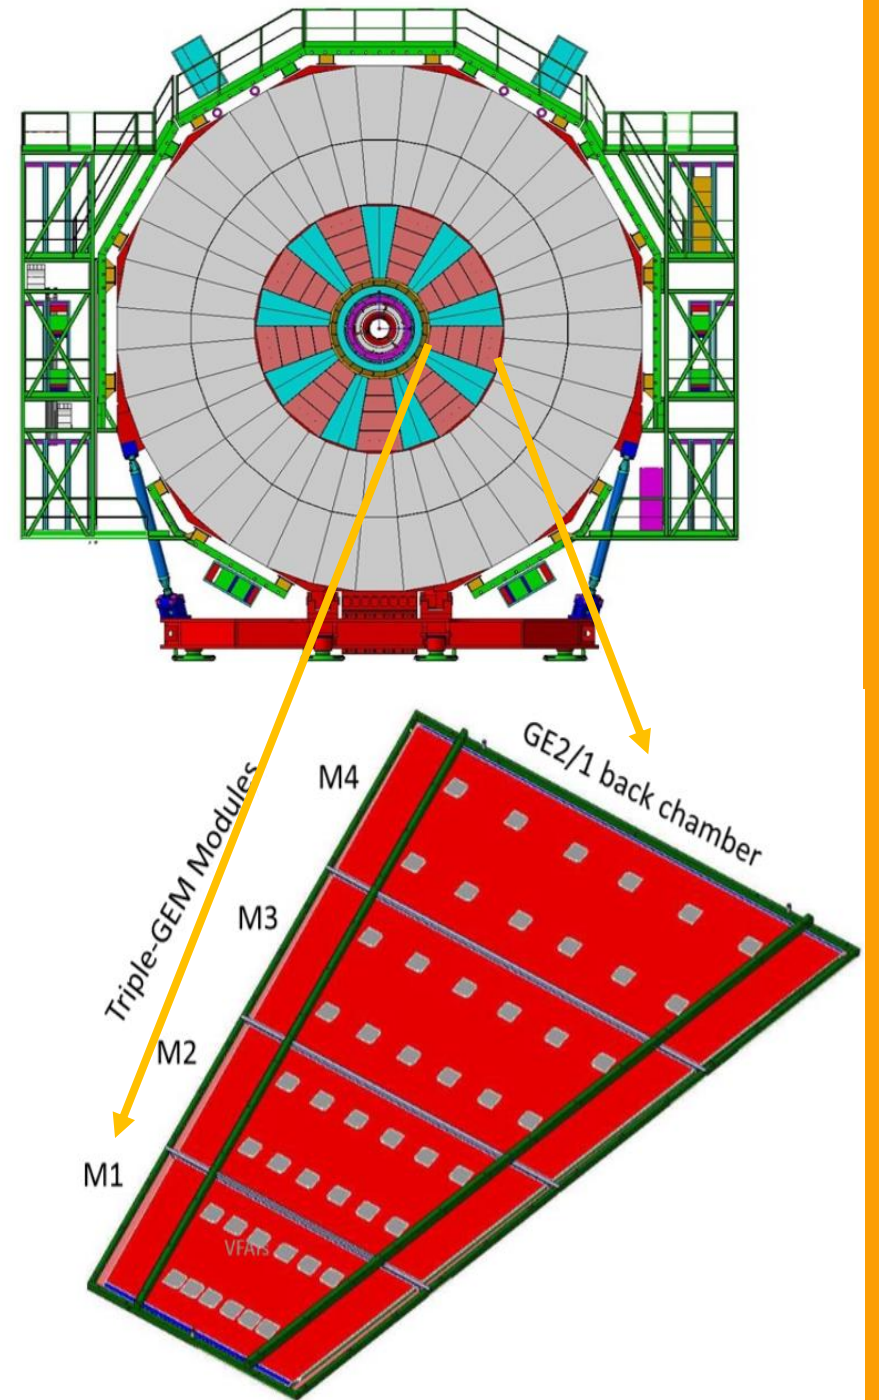
- GE2/1 station consists of “superchamber” : a pair of triple-GEM layers of trapezoidal shape
- In total $2 \times 18 = 36$ superchambers are needed.
- Coverage extends from $|\eta| = 1.6$ to $|\eta| = 2.4$
- Each GE2/1 chamber consists of four modules M1-M4, each being a single CMS triple-GEM detector

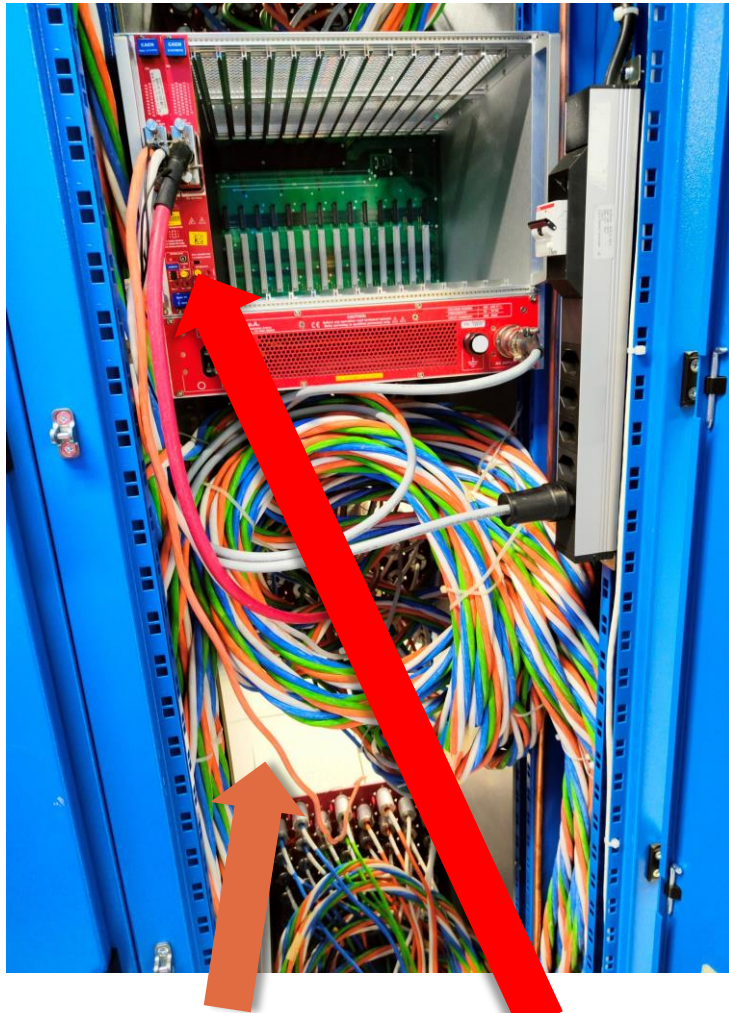
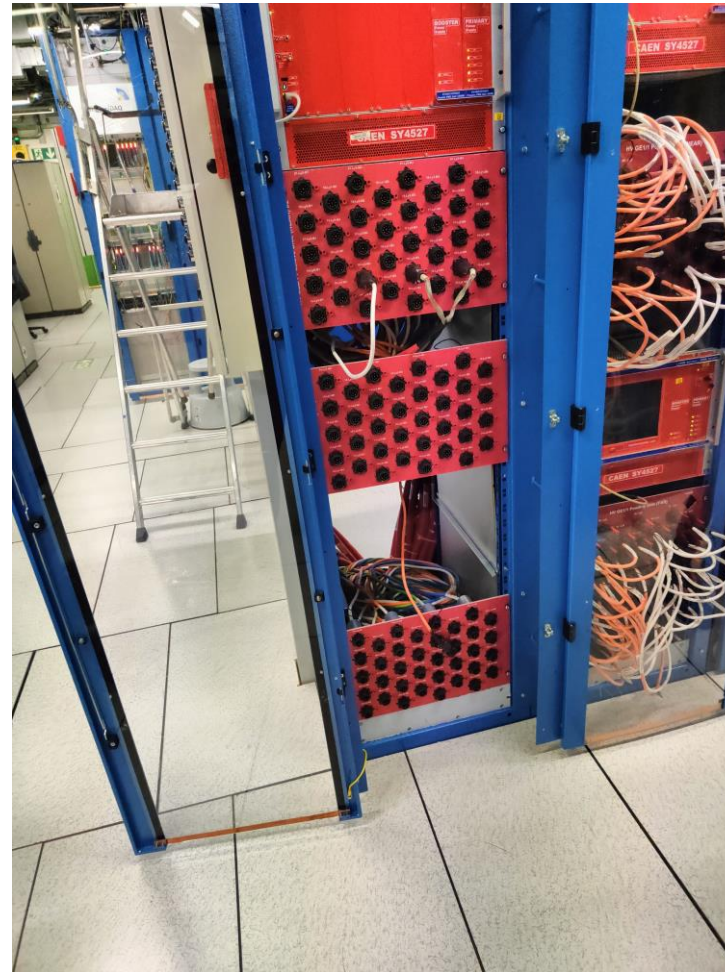
Pico commissioning@GE2/1 demonstrator

Orange cable from CAEN board to pico and then PICO to the chamber

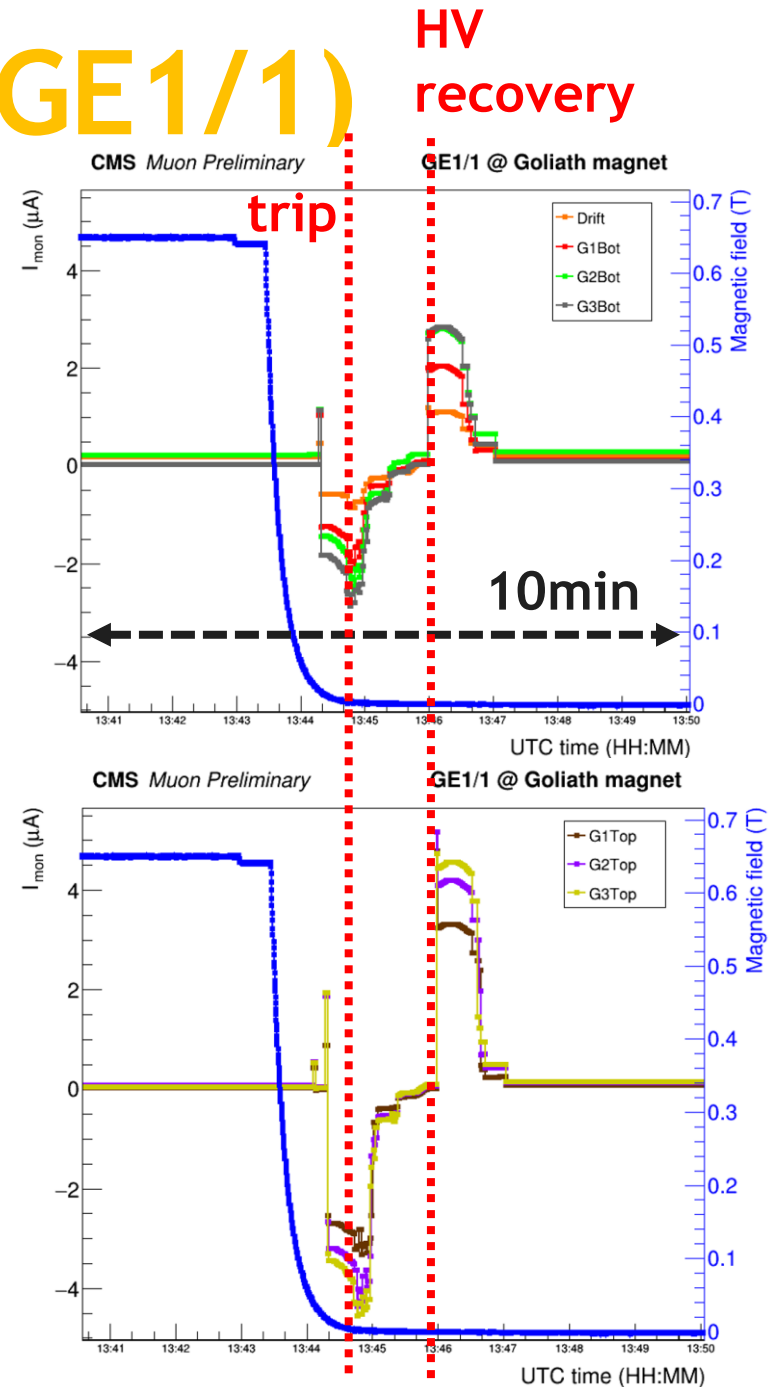
Operation in Magnetic field (GE1/1)

- Examples of discharge recorded by A1515 board during a magnetic field ramp, the discharge induced a trip (negative currents) followed by the HV recovery (positive currents)
- In the upper plot are showed the currents flowing on gaps
- In the lower plot are showed the currents flowing on GEM foils
