Restart of RUN5

Stefano Piacentini

General Meeting

23/05/2024

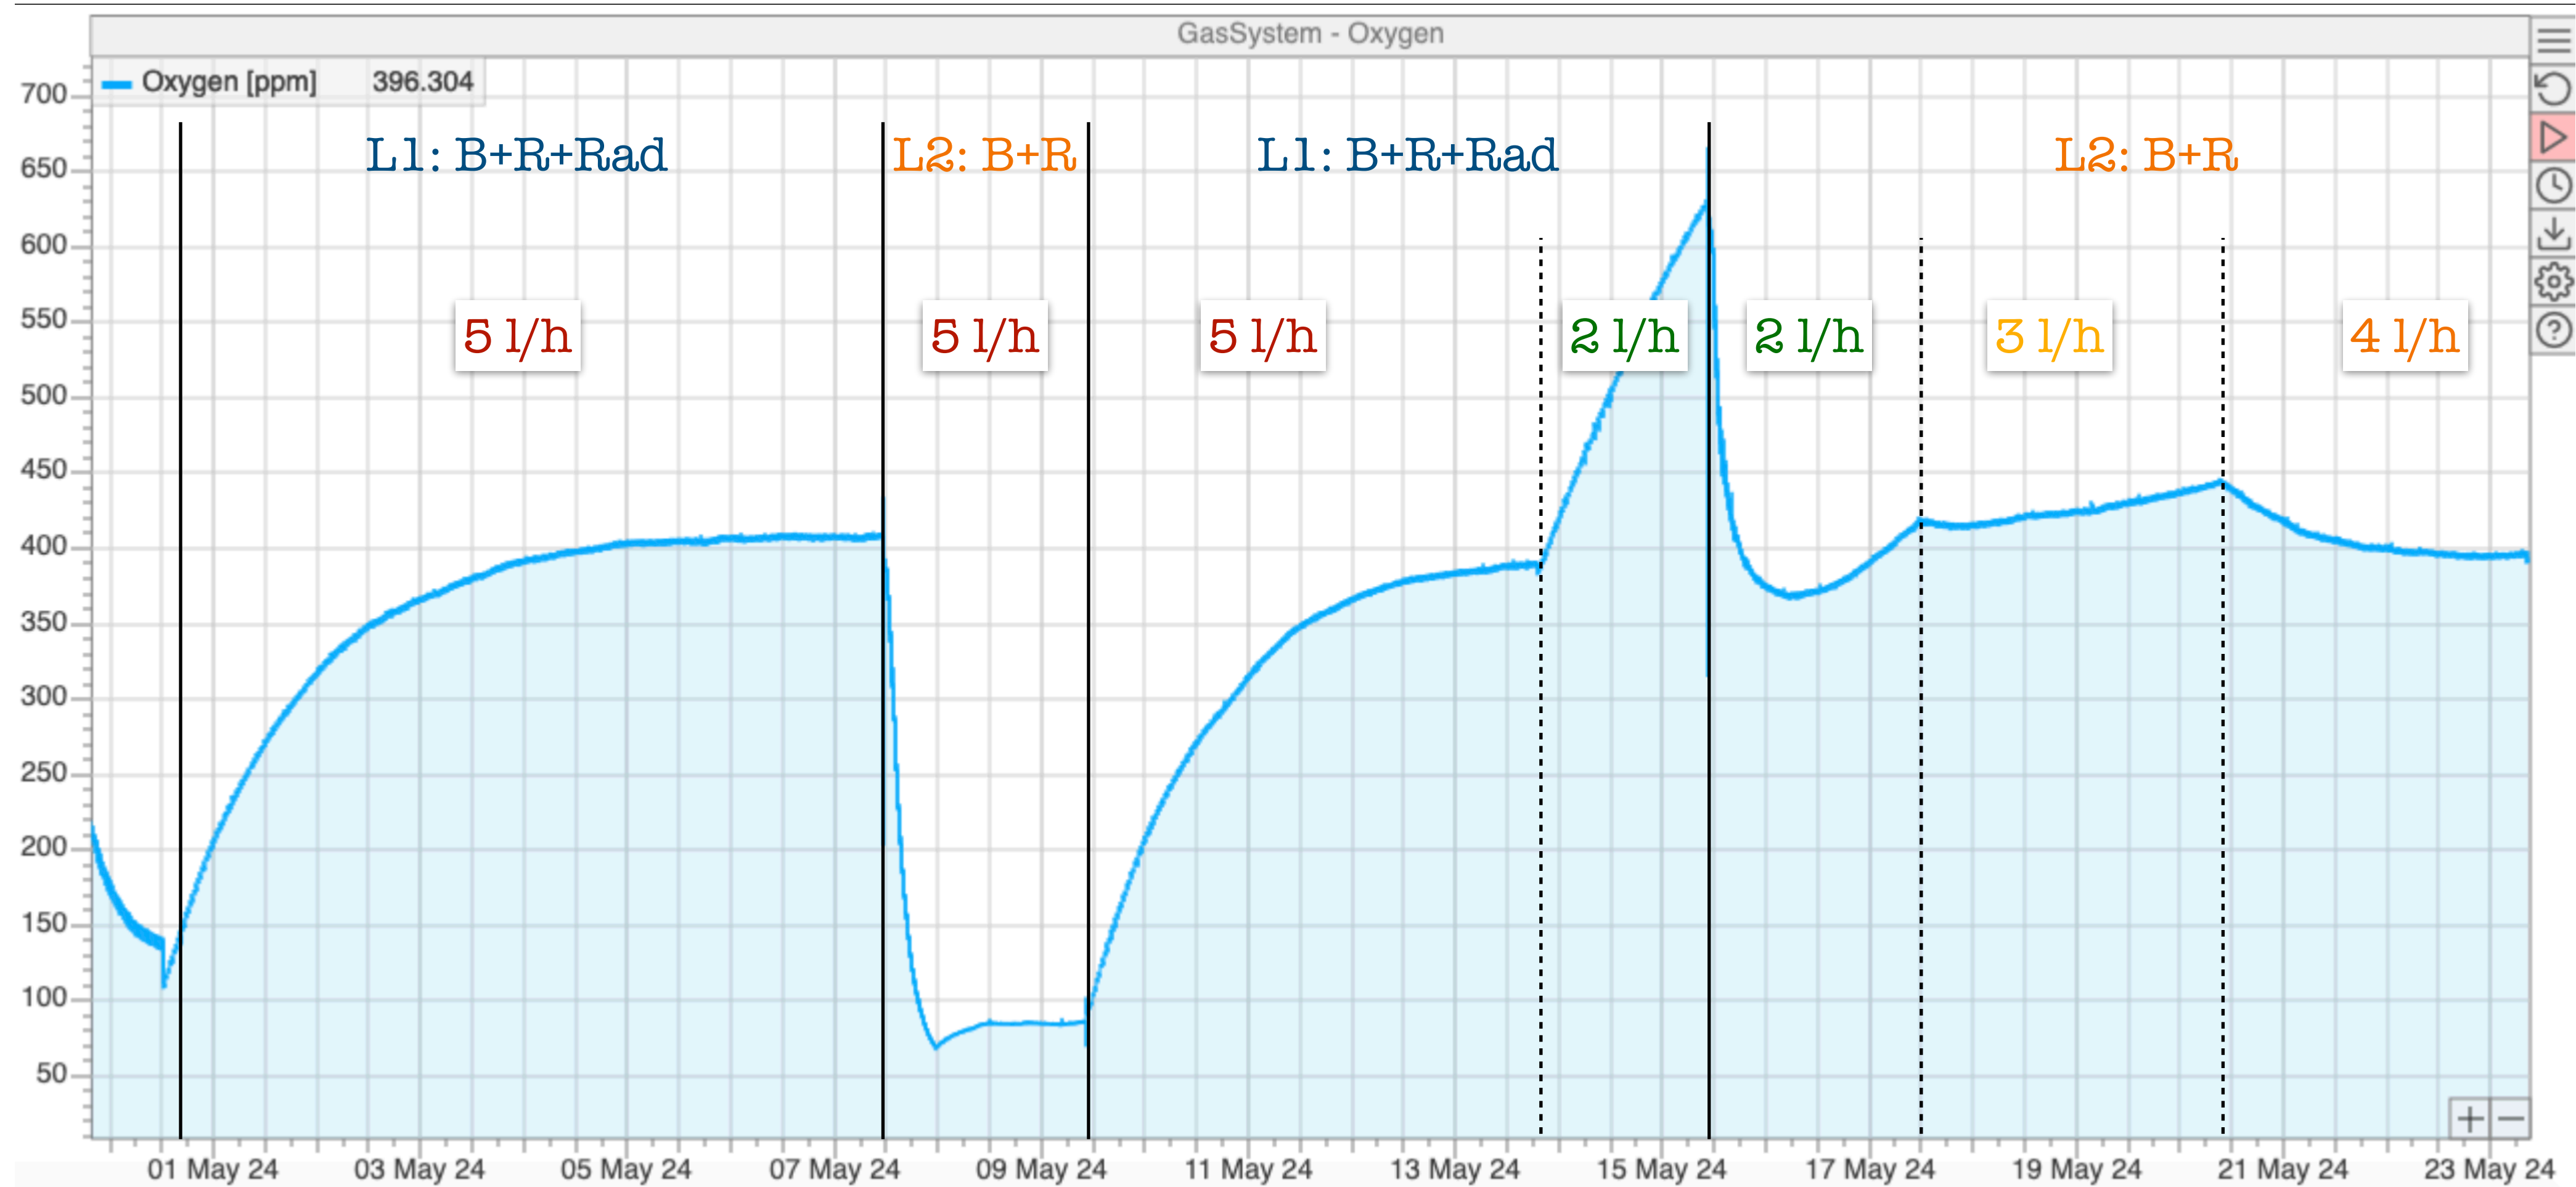
- Oxygen levels now measured with a **new sensor**
- Oxygen filters seem **saturating** and the vacuum pump cleaning seems not to work

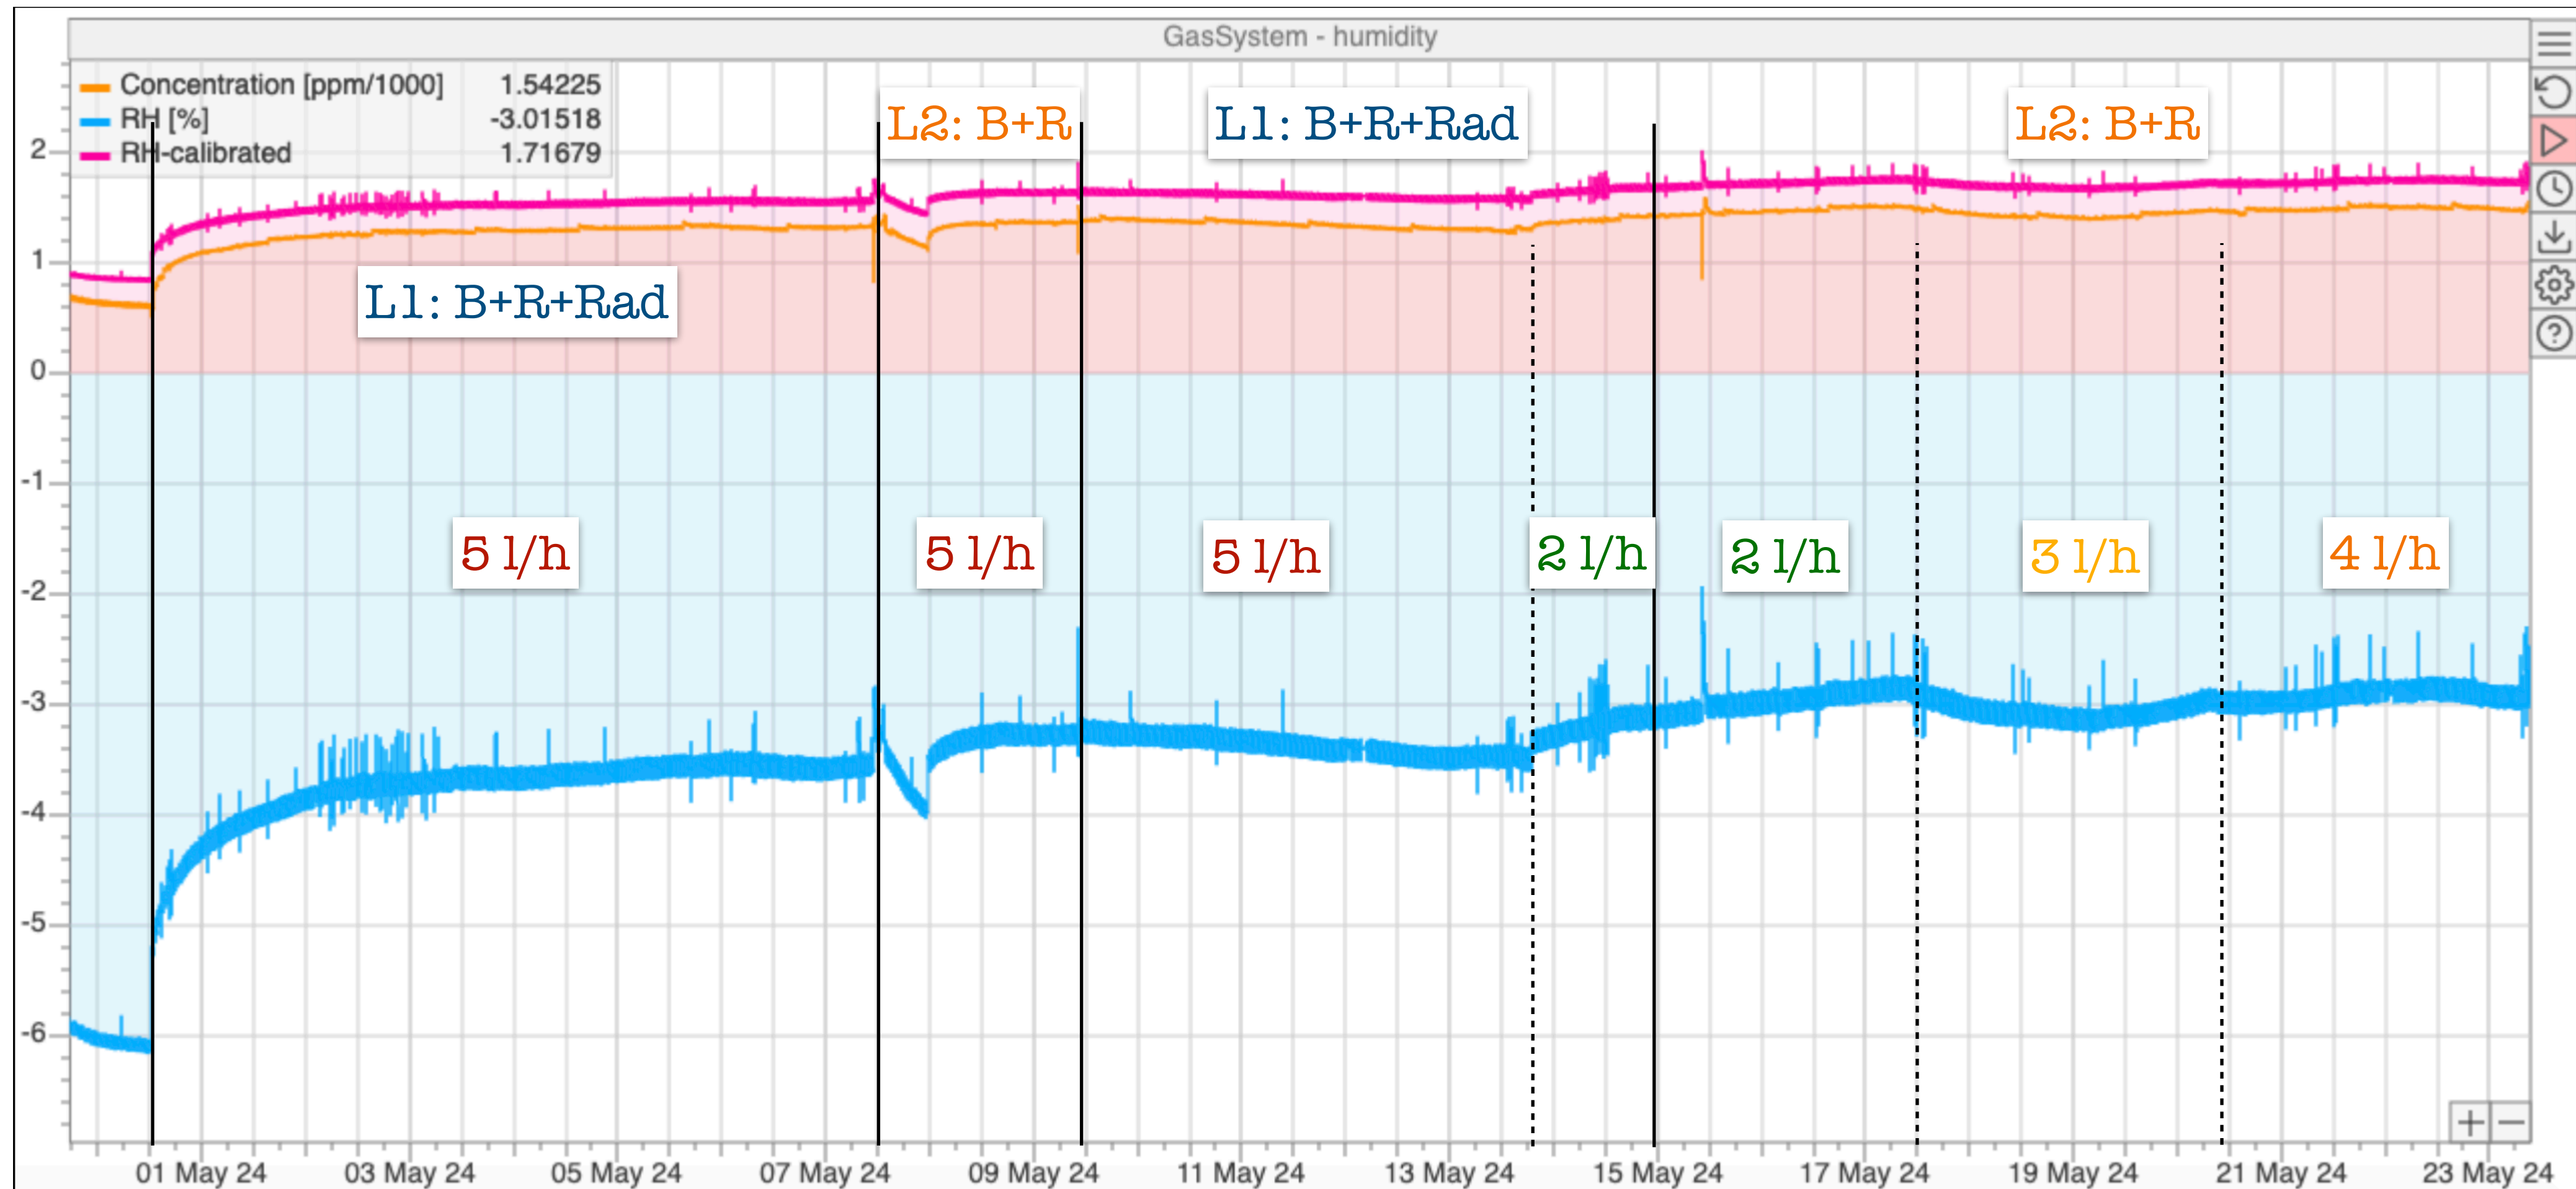
- Humidity levels seems increasing since beginning of the months
- Currently under investigation: possible leakage?
