Trigger and UUB commissioning task

*Fabio Convenga
on behalf of L'Aquila Group*

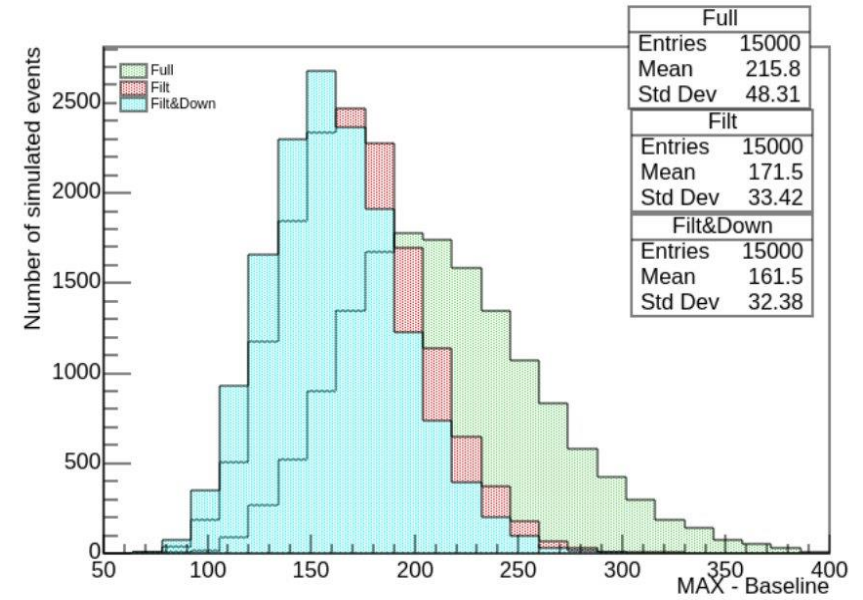
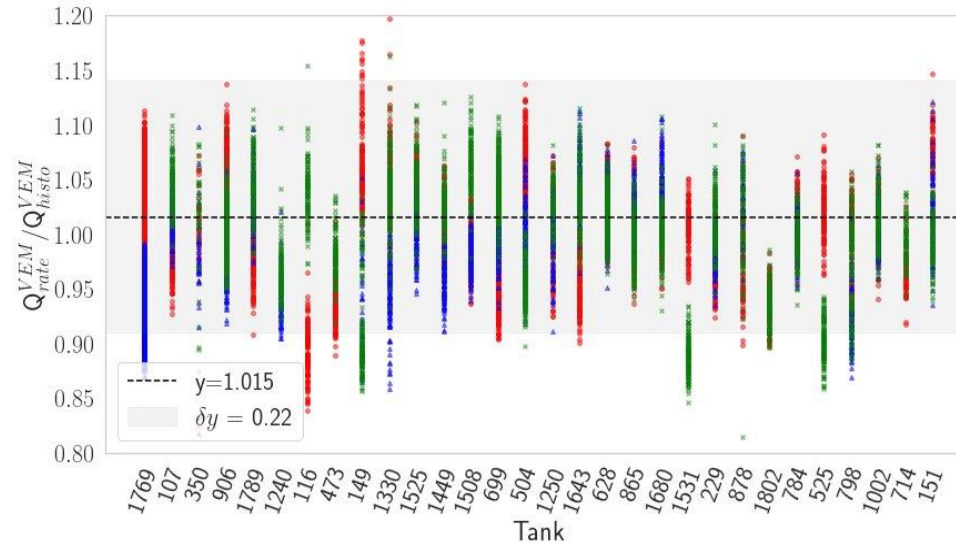
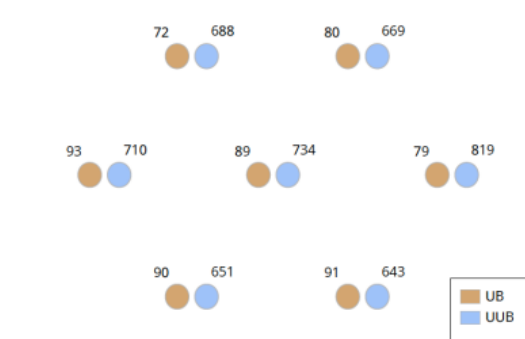
UUB-UB hexagon array

- The estimation of the UUB Calibration online parameters (VEM charge and VEM peak online) has been improved
- The maintenance of UUBs is in progress.
- The UB-UUB compatibility has been verified by using the UUB-UB hexagon array.
- SMPT Calibration fixed and running (maybe we could see what happens with the new VEM charge online)
- Mitigated ToTs/MoPs noise related issues.
- New triggers working progress
- Work in progress on DAQ instabilities

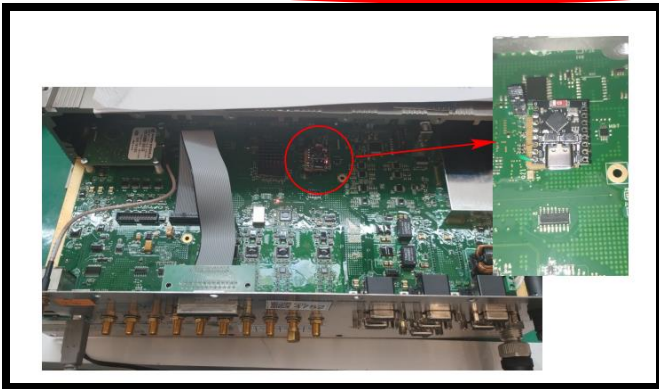
efuse problem: issues with the battery can cause the FPGA to stall in booting; UUBs with this problem must be reprogrammed with a JTag and a PC and then brought to the lab

- A **new e-fuse problem** has been identified in station Amil (1752).
- **Cause:** Likely due to a **bad power connection**, not a battery issue.
- **Mitigation:** A procedure has successfully tested to make the UUB to start using a micro-controller (mini), **without the use of the pc**

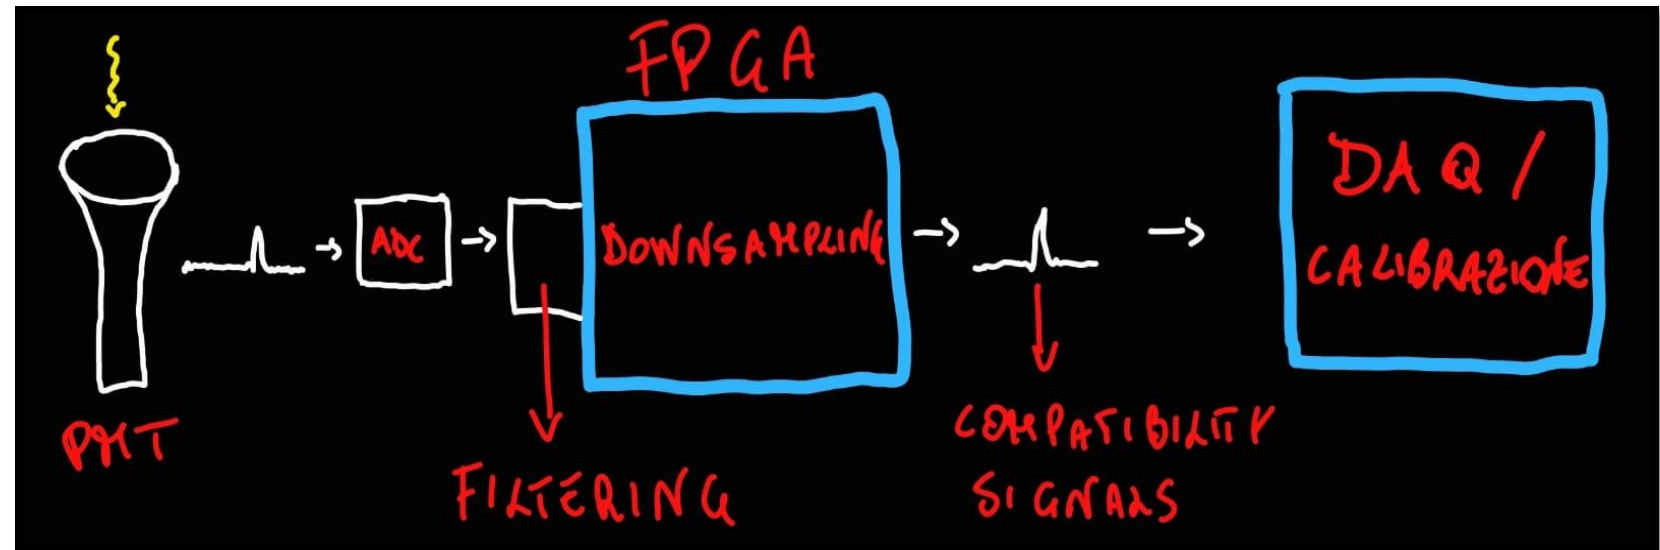
Over-simplified acquisition system

Ricardo discovered that the filtered data for some PMTs have a NULL value even though the raw data for these PMTs seems to be correct.

The problem induces masked PMTs (the 0 value in the filtered signal causes bad calibration and consequently masked PMT).

The problem can be mitigated by reloading the FPGA code.

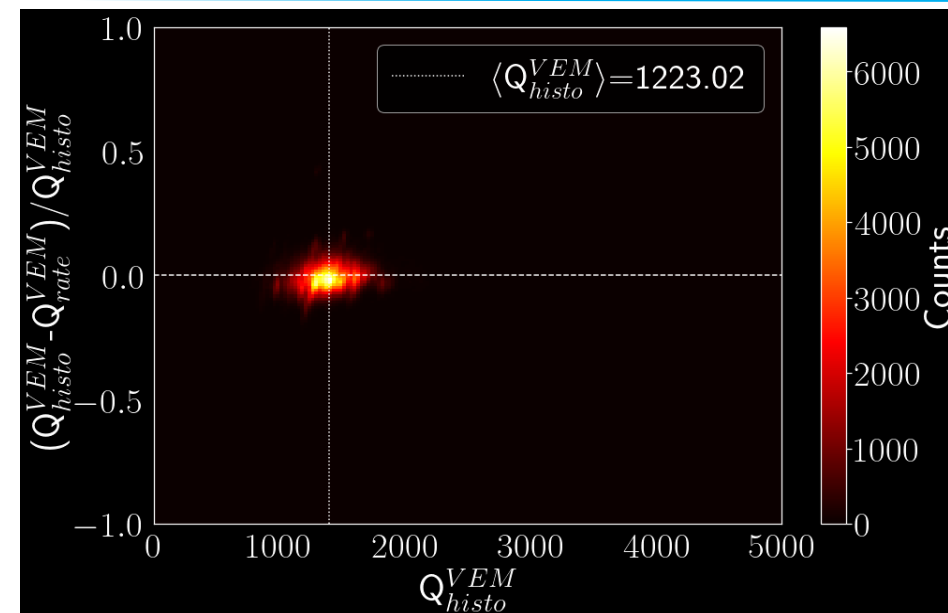
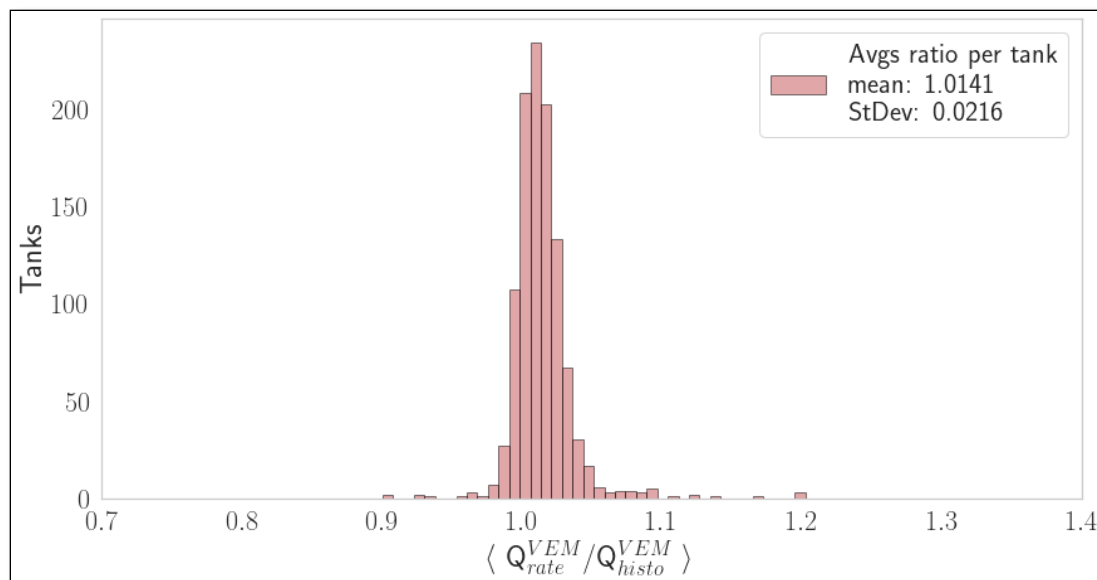
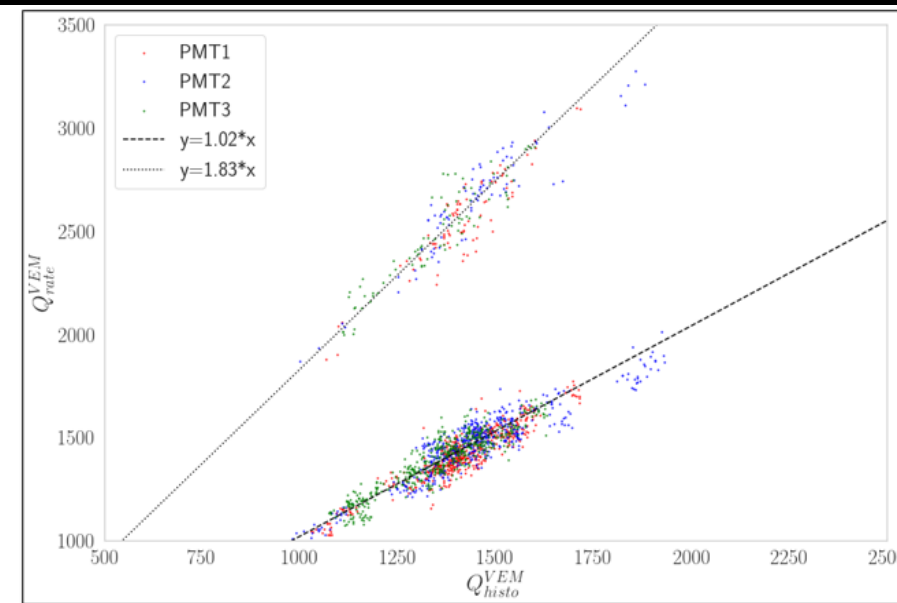
- The estimation of the UUB VEM charge online has been improved
- The estimates seem to be compatible with what was previously seen on UB
- The scatter plot shows also a correlation for the previous configuration, in principle the factor 1.827 could be used to correct the data prior to the inclusion of the DAQ under test.

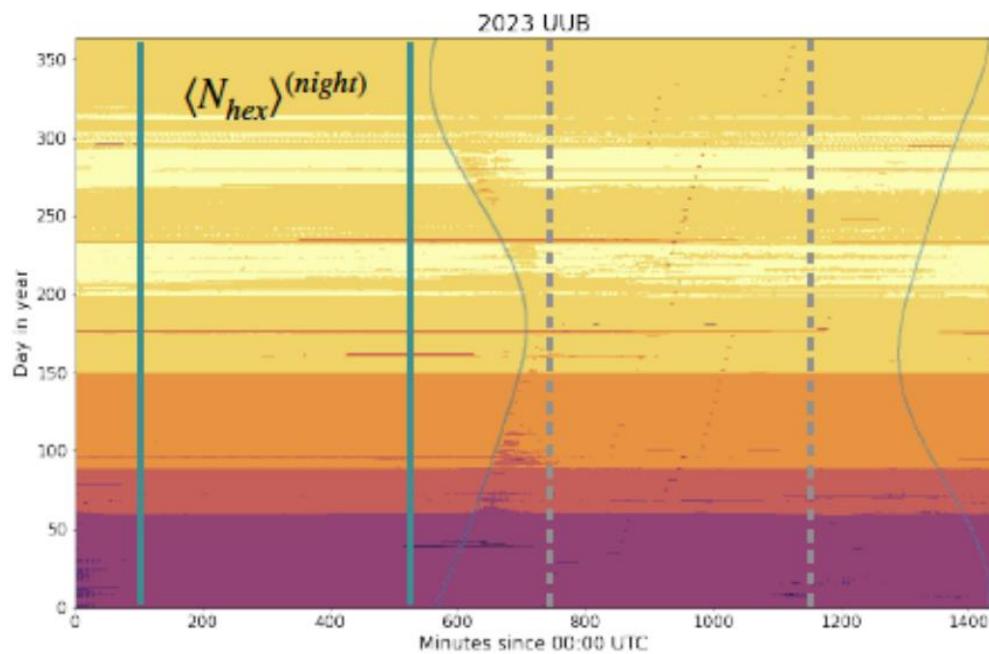
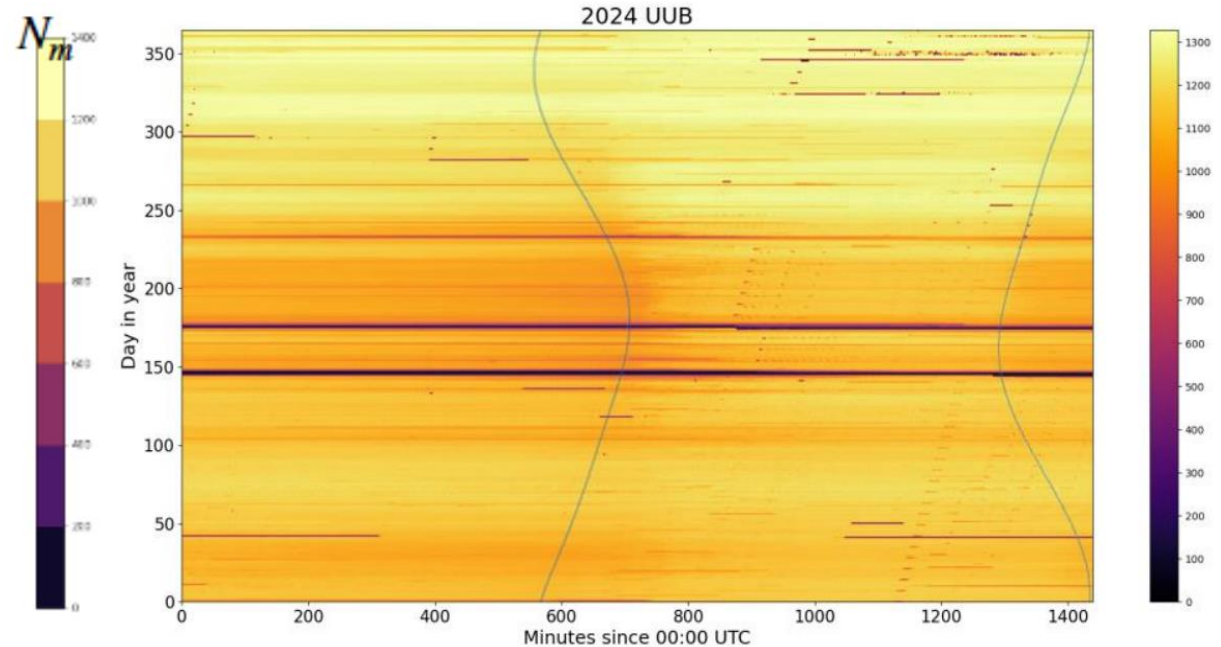
SUNRISE NOISE

Total Upgraded Station Power Consumption: ~14W

Total Pre-Upgraded Station Power Consumption: 10-12W

- **Most batteries are still functioning properly.**
- **Insufficient spare batteries for replacements.**
- **Increase battery maintenance efforts.**
- **Order additional Moura batteries for immediate replacements.**

We should ensure that battery capacity is sufficient for bridging over the night and over a few days without sun
