# TEL62 and TDCB firmware status

NA62 Collaboration Meeting in Ferrara - TDAQ Working Group

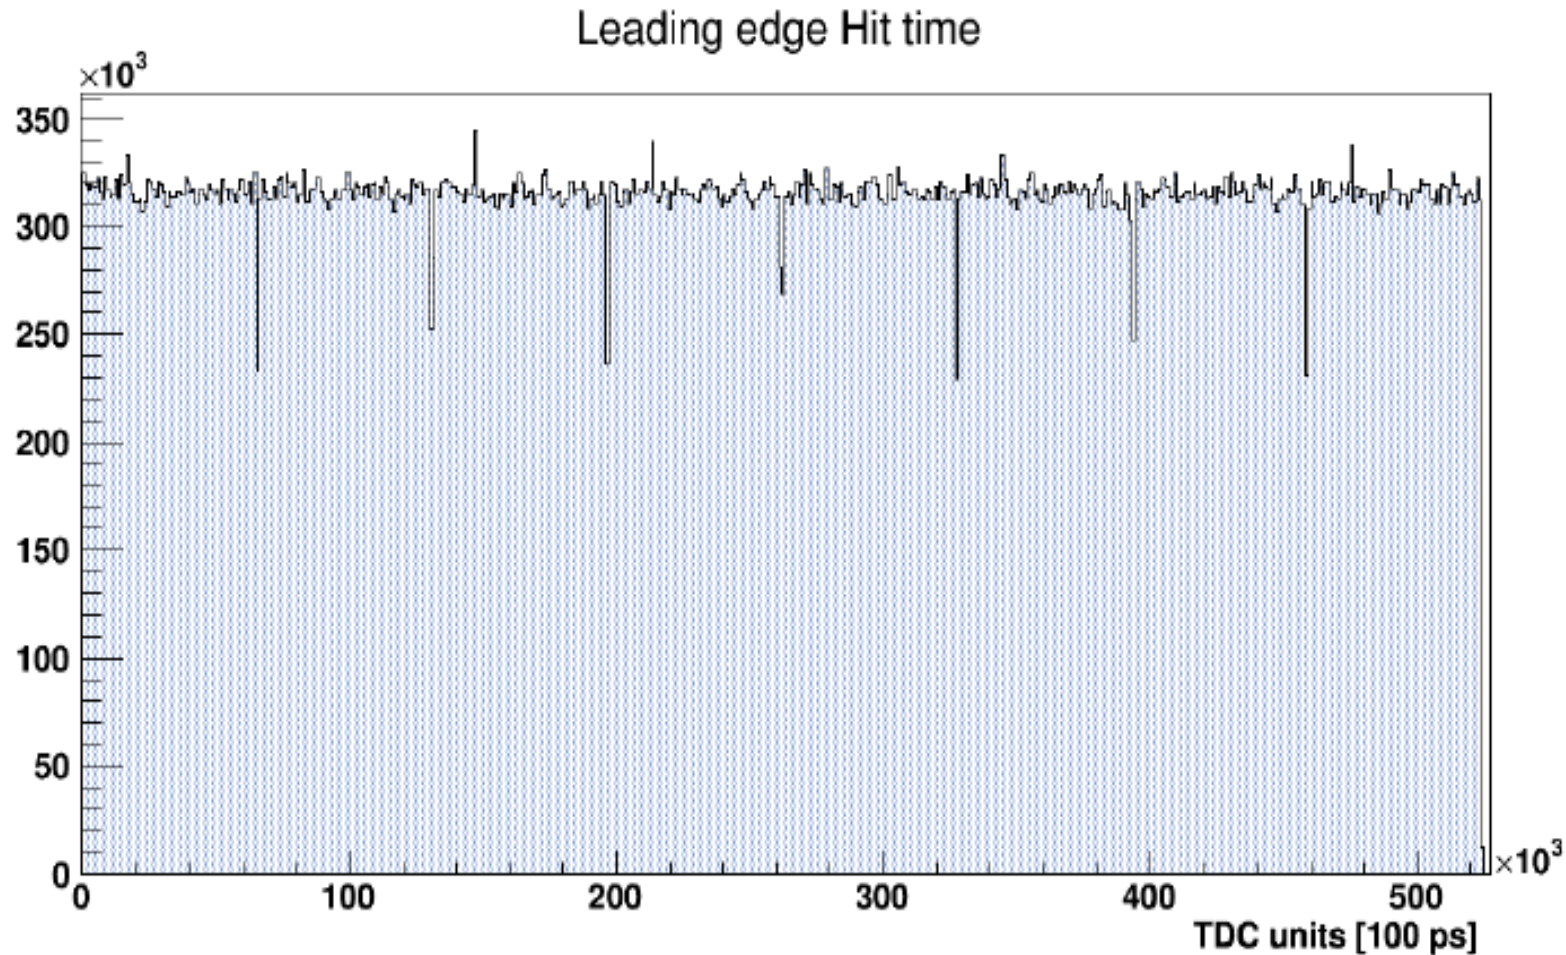
- Visible (and unexplained) structure at 6.4  $\mu$ s

The structure is associated to the TDC fifo saturation: when we have a big amount of hits entering to the TDC ( fifo saturation), we have a word's lost at the end of the 6.4  $\mu$ s readout frame

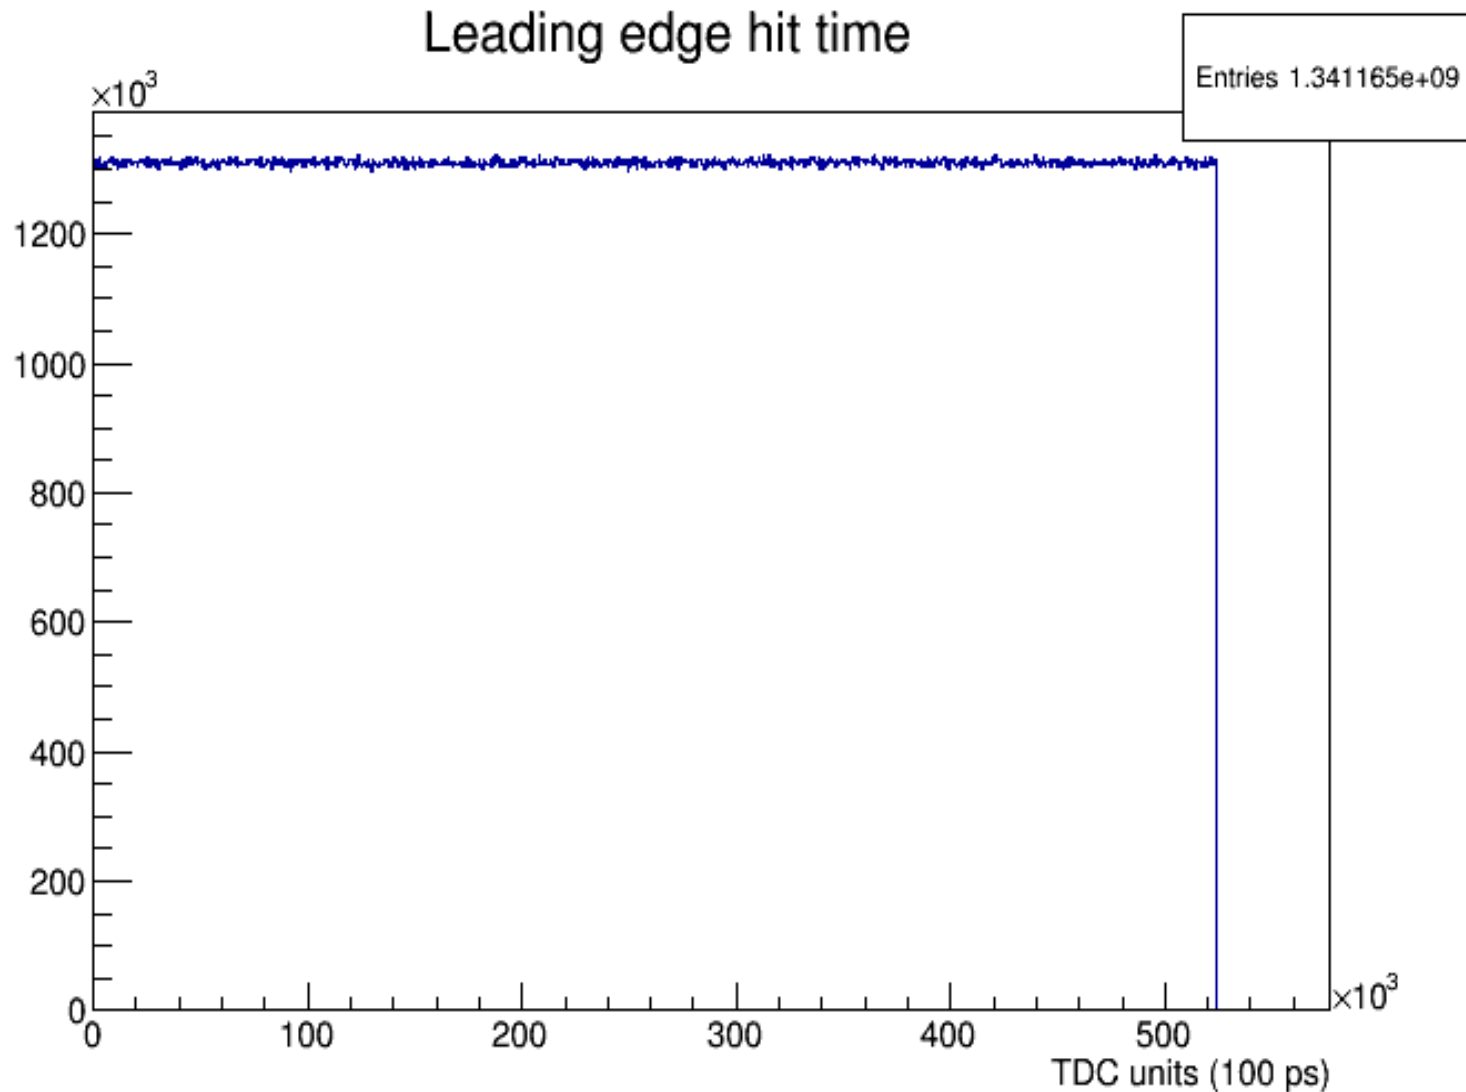
If we have a normal hits rate entering the TDC we have a flat distribution as expected

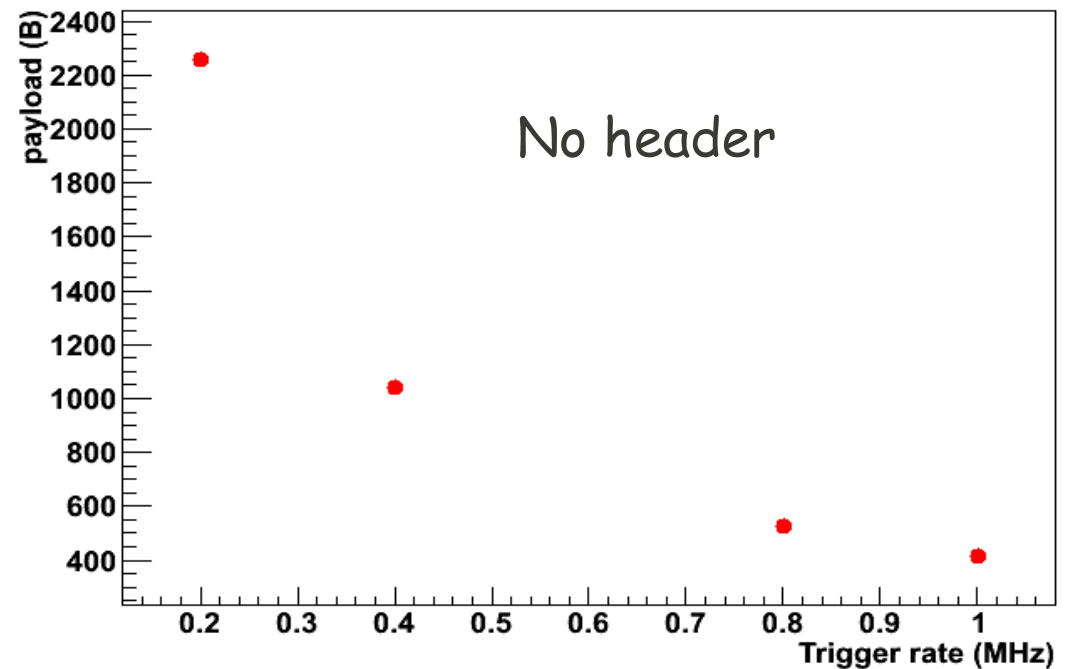
We are practically saturated the gigabit Bandwidth apart in the last point
