# CGEM installation aftermath

G. Cibinetto, M. Greco, G. Mezzadri

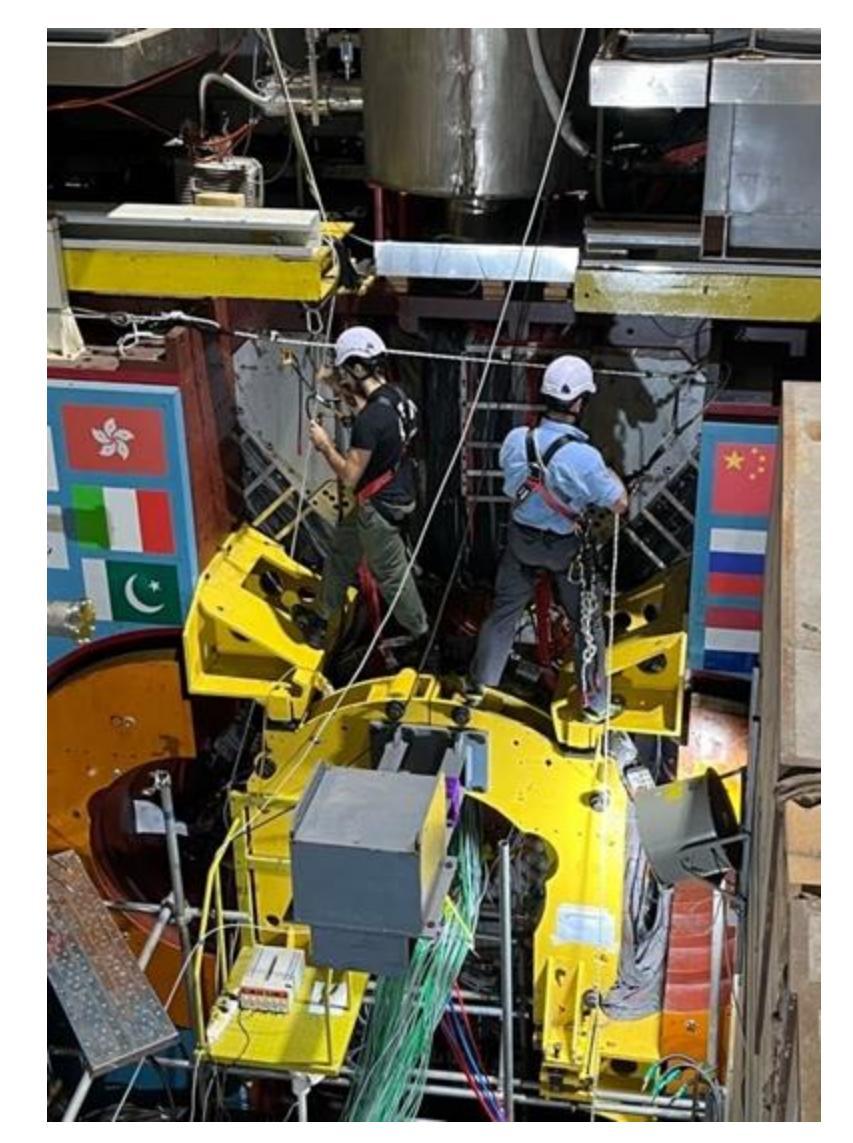
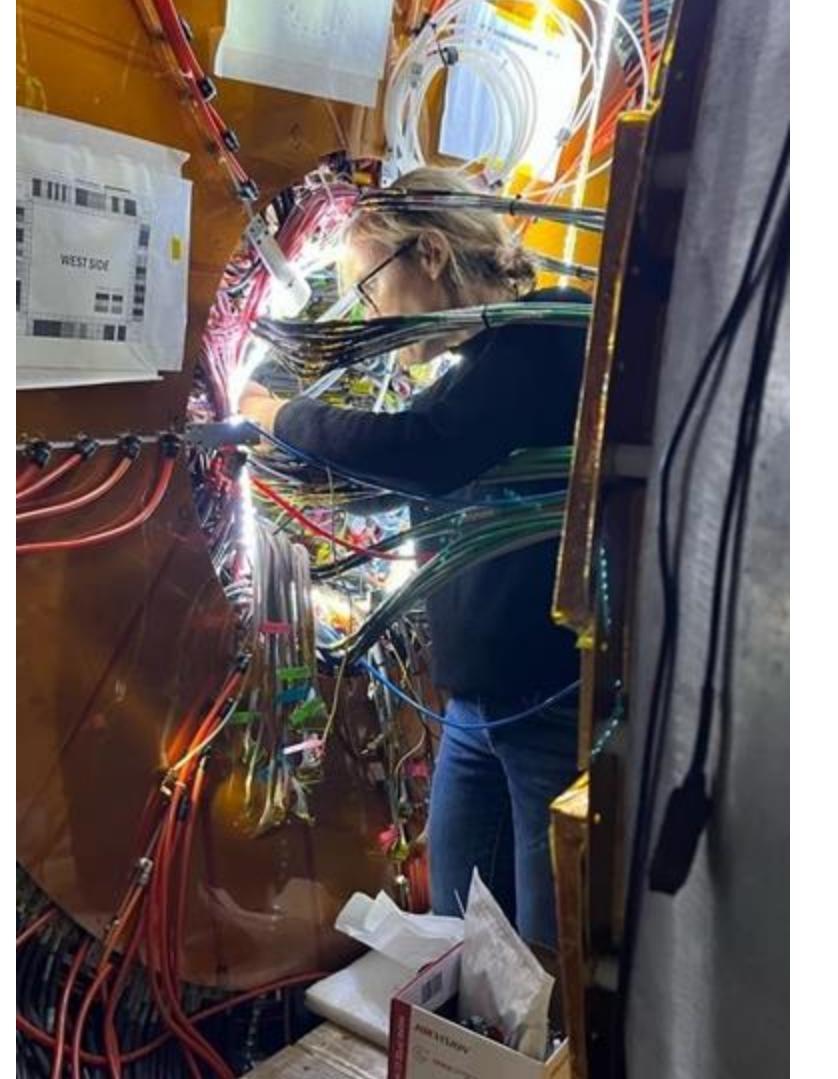
- Cable routing and electronics installation was quite a trouble
- The endcap flux return doors couldn't be fully opened and cables could not be routed in the conduits as planned
- Decision of routing the cables through the EMC endcap hole, and attached to the final focus support has been made
  - The length of the cables was already fixed; therefore, we had to relocate the electronics; for this we had to wait the production of two platforms
  - No cable holders available: we had to design and produce them
  - Interference between cables and operations for final focus, EMC and flux return closing; CGEM cables have been moved several times
- Knowing that in advance could have helped to have a better plan, better infrastructure, less lastminute schedule modification, better cable and board protection, better control and stability of the system

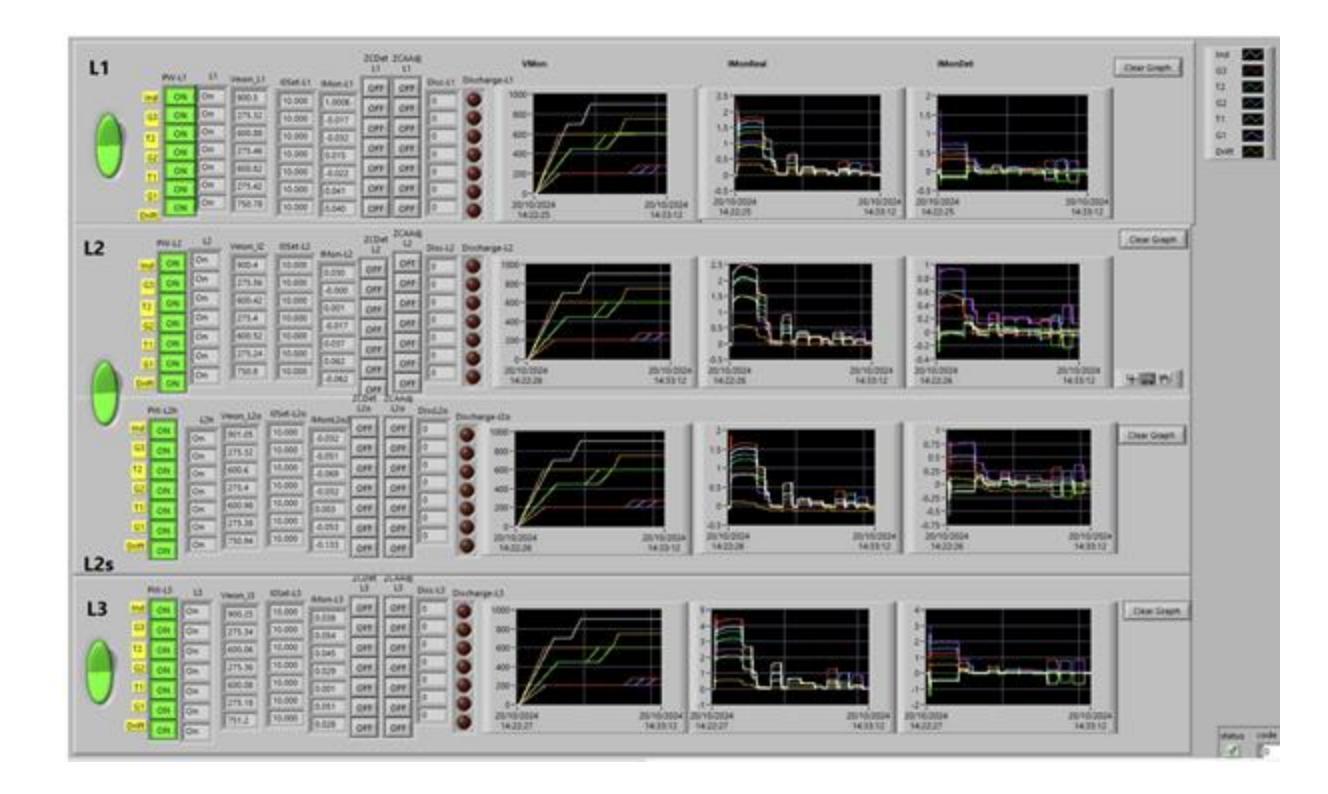
The entire CGEM-IT was firstly powered on at nominal value on October 19<sup>th</sup>

- HV ok
- Noise compatible with the situation in lab 106
