Updates on HRPPD #25 activities *Hardware intervention*

Weekly Meet

Chandra, Fulvio, Jinky 18/03/2025

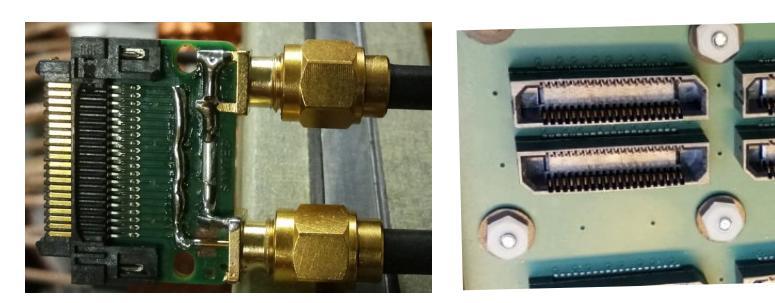
- → Square pulse (2 Vpp; 10 kHz) fed to XoX
- Looking at signals induced on 16 pads for each of the 16 groups (SMA-I fed to Oscilloscope channel via 50 Ω) (using a probe)

1 group 4 rows of (16+4) pins 4 x 16 Anode pads

Chosen corner for tests							
	Val	ues are	in mV				
G	~ 14.4	~ 8.6	~ 8.6	~ 8.6			
	~ 14.9	~ 14.9	~ 15.7	~ 15.9	PC		
	~ 15.9	~ 15.0	~ 15.0	~ 15.5			
	~ 13.1	~ 12.5	~ 14.7	~ 15.9

Mapping from rear end

The amplitudes are position dependent, Similar values for the four rows of one group

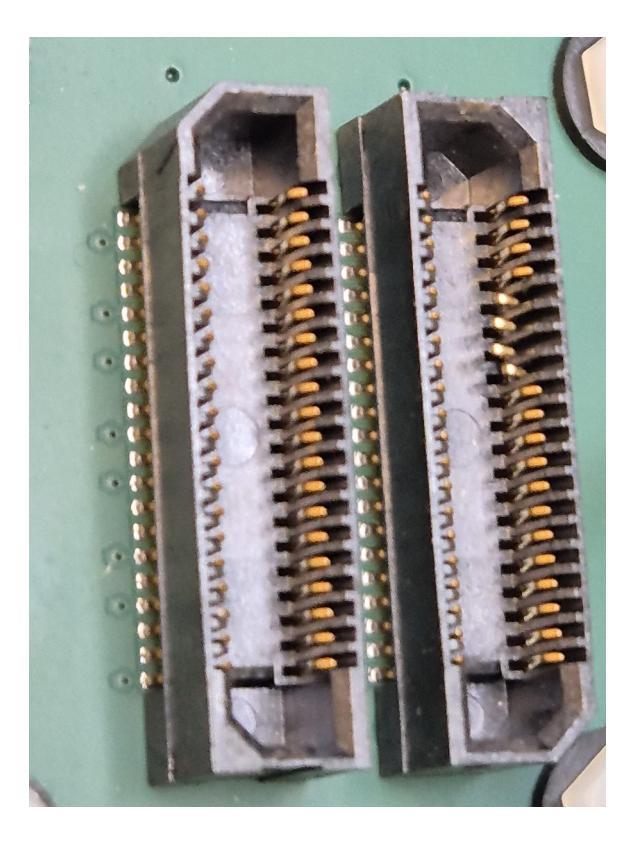
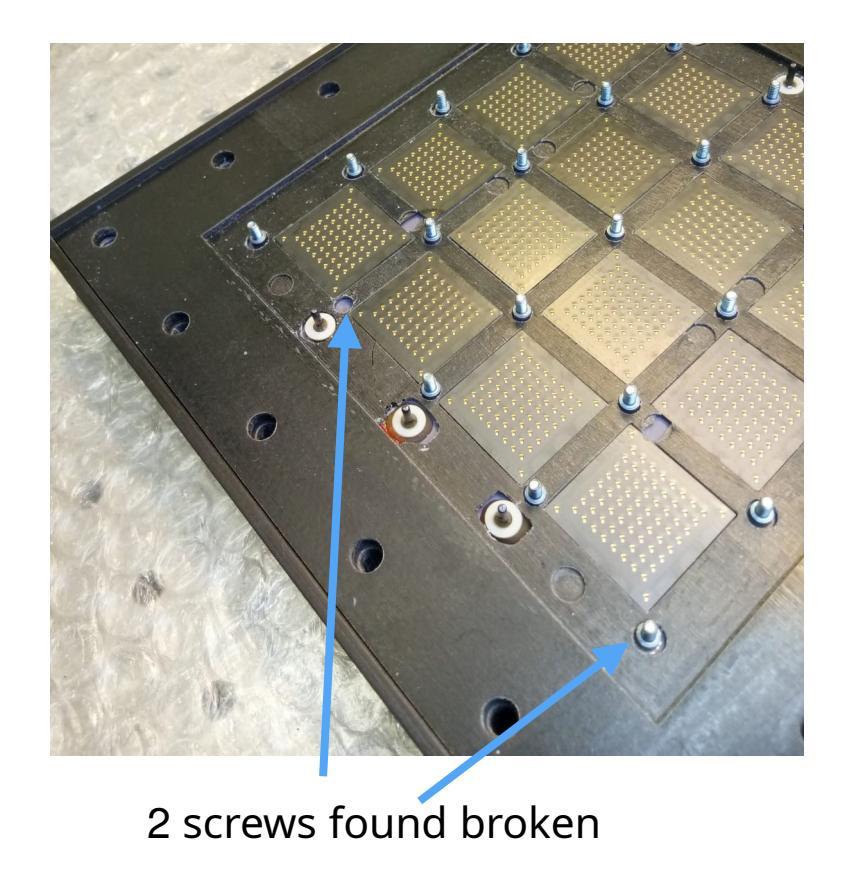
# Samtec pins damaged, screws broken

4 pins (from chosen corner) found damaged

- → All interposers remounted in similar fashion (knotch at same position for 16 groups)
- Broken screws glued (non-conductive)
- Pressure applied uniformly on the backplane for better mechanical contacts (planarity improved ~few tens of µm)
- → 3/4 broken pins repaired
- → HV connection optimised (ensuring that the pins do not touch the PCB)
- Interface robust ground reversible

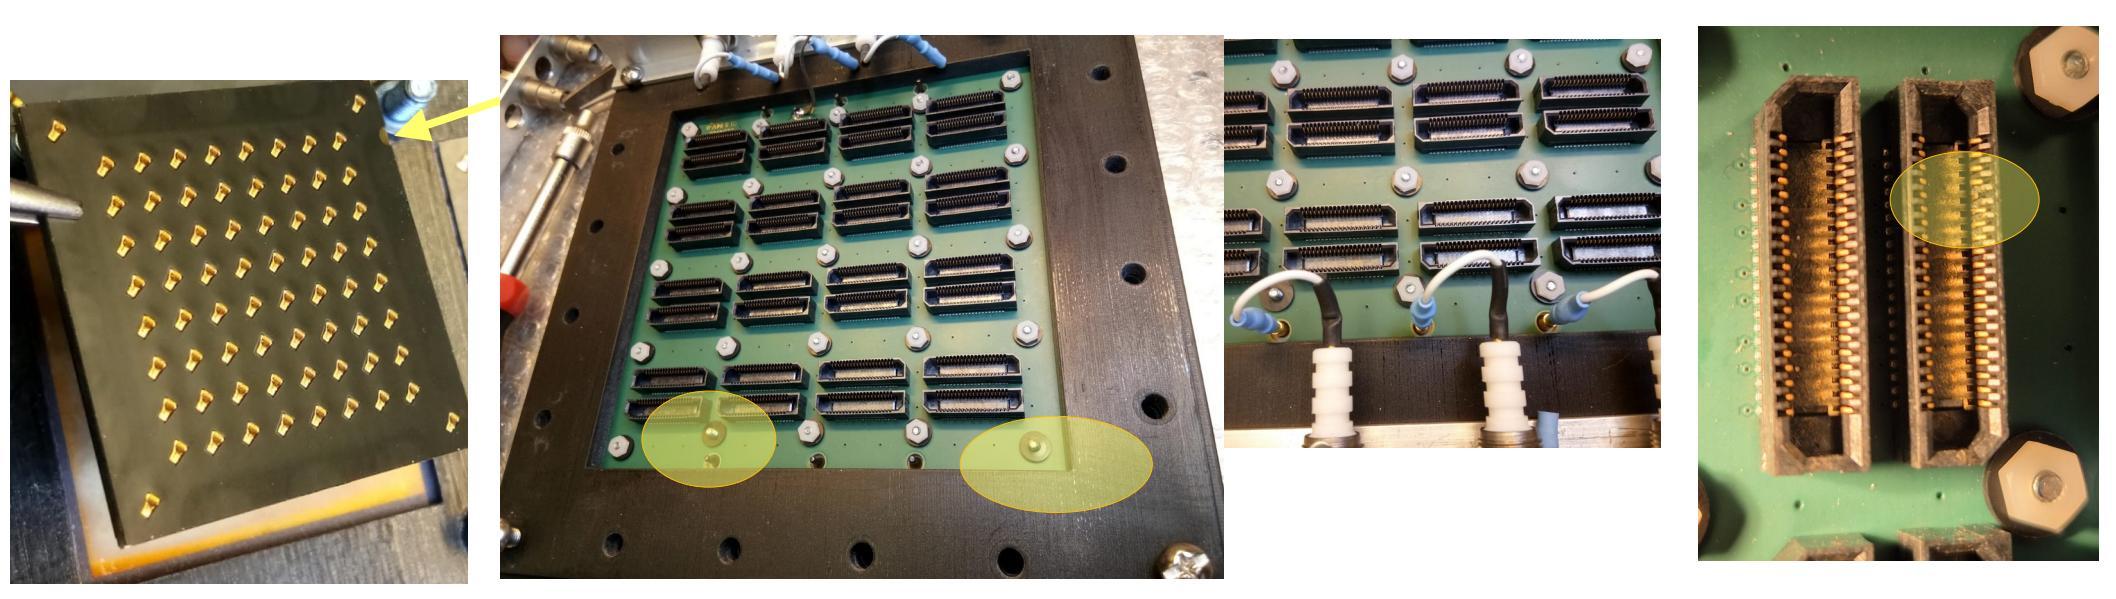
# **Hw Intervention**

All tests are without robust grounding of the backplane

- → Square pulse (2 Vpp; 10 kHz) fed to XoX
- Looking at signals from Pin 1 of a group of 32 Pins

One pin still

- Still some position dependency. Overall mechanical contacts improved
- With SMA-I (16 pads) amplitude becomes ~ 200 mV (It was few tens of mV)

damaged Chosen corner for tests Values are in mV PC						
		~ 160		~ 492	~ 486	~ 168
		~ 476		~ 492	~ 486	~ 488
		~ 476		~ 492	~ 486	~ 144
		~ 476		~ 492	~ 486	~ 168
		~ 146		~ 492	~ 146	~ 140
		~ 492		~ 492	~ 476	~ 158
		~ 492		~ 492	~ 476	~ 132
		~ 492		~ 492	~ 476	~ 486

Amplitude from Pin 1 of a group of 32 pins Mapping from rear end

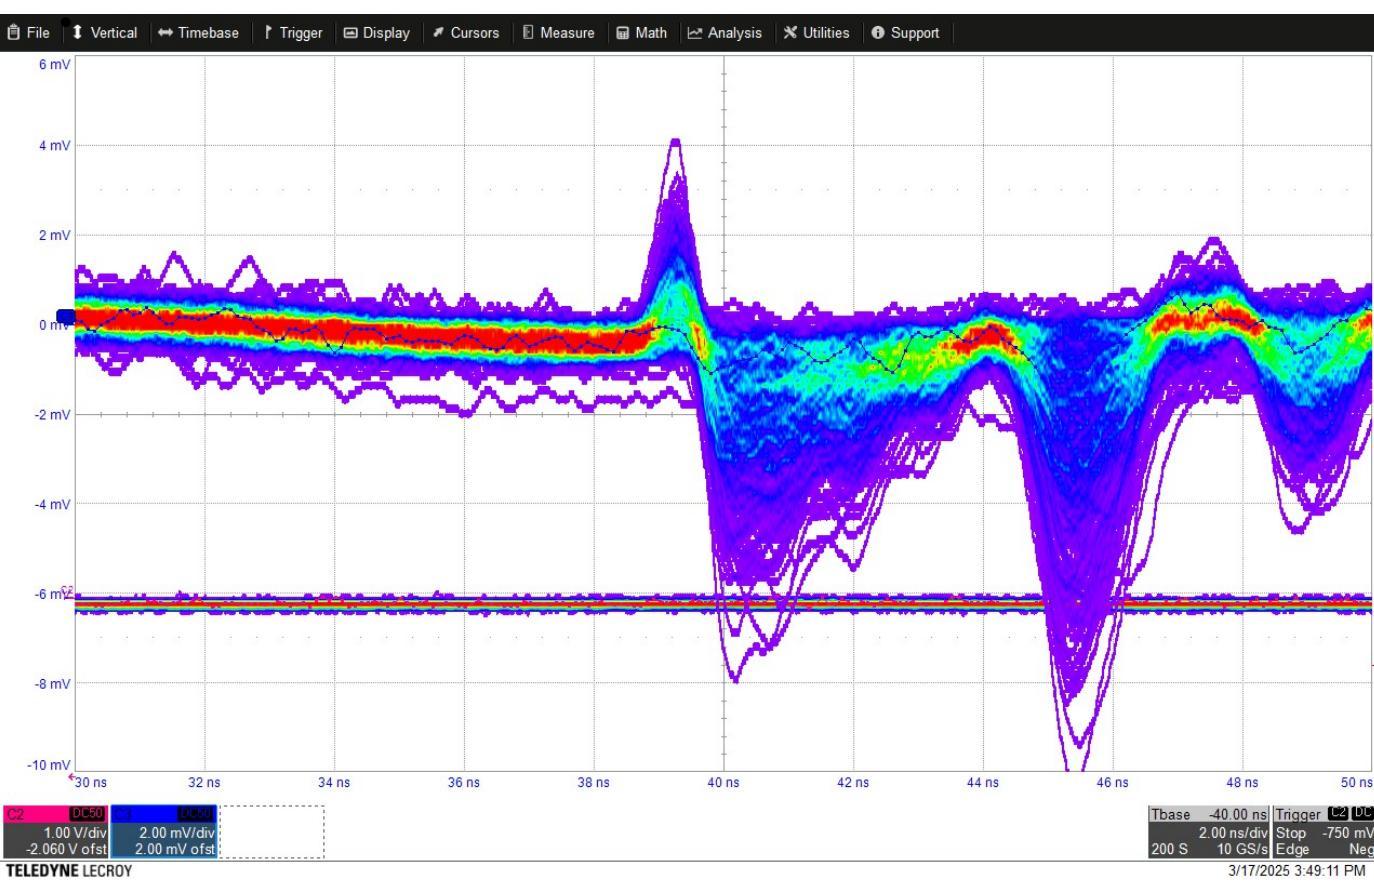
- HV configuration: -200\_700\_-200\_700\_-30 V @ XoX\_NoX\_XoN\_NoN\_PC
- Trigger on Laser pulse: Intensity 1.8, Rep. frequency 600 Hz
- Without robust grounding and Anode HV pin terminated with 0  $\Omega$

All tests are without robust grounding of the backplane. Usual set up with protection card and 8 mm diameter hole.

- Noise level did not improve
- → Trigger at Laser sync pulse
- → Signals from 16 pads (SMA-I) (from usual corner); amplitude ~2 mV
- → Appears at ~ 40 ns
- → Very fast rising edge
- Nothing similar is found from the other SMA-II and micro-coax cables

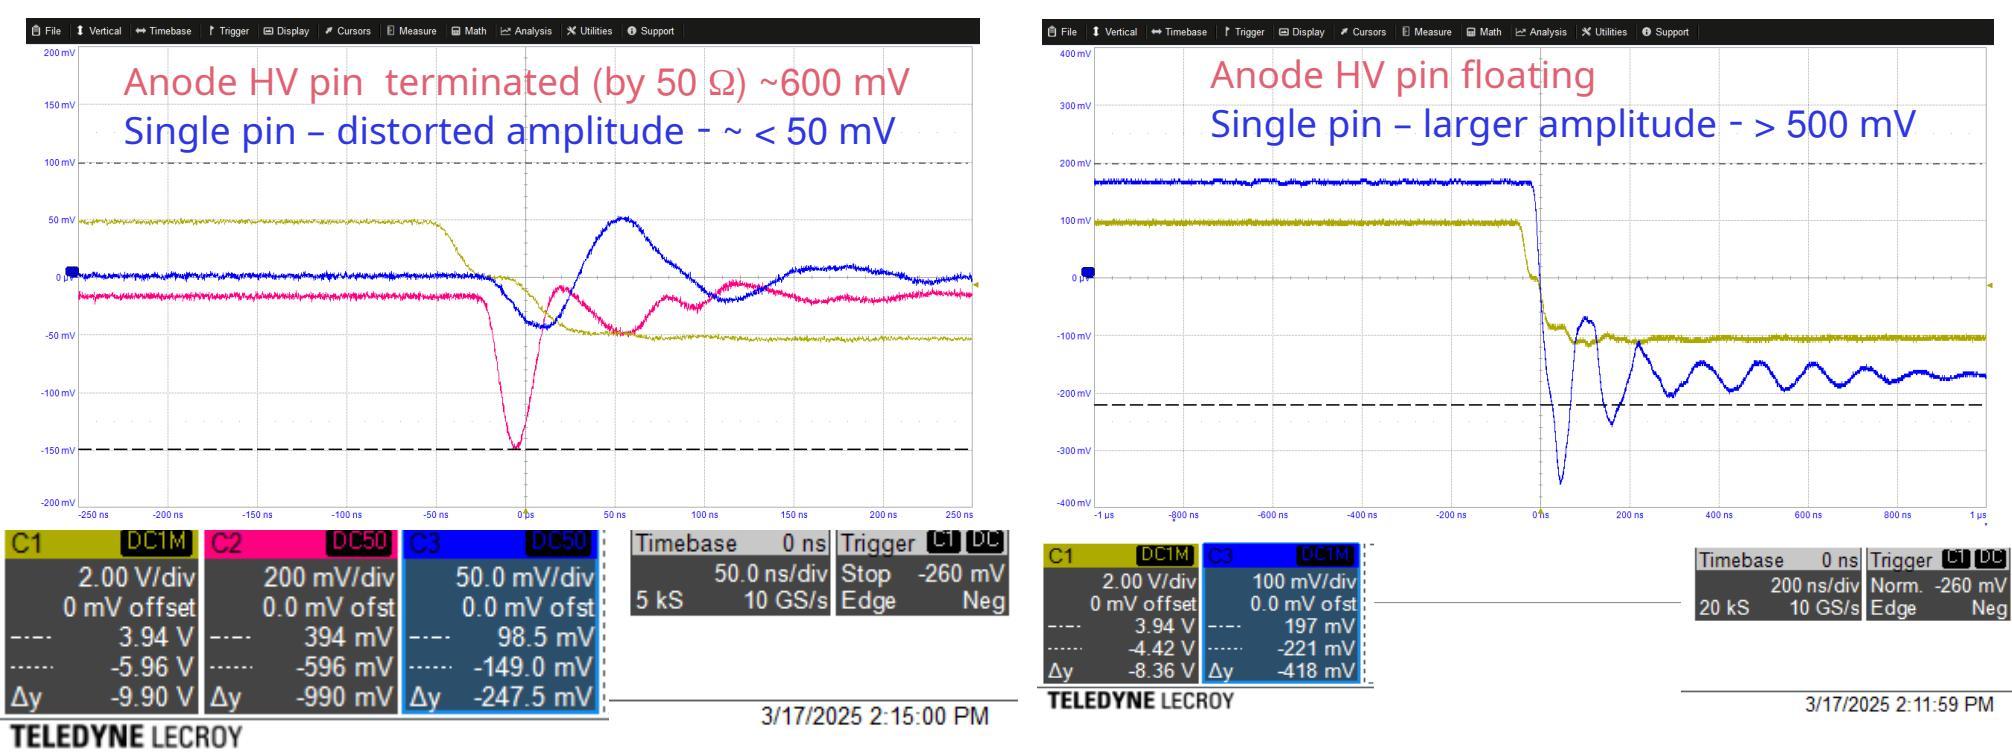
- $2 V_{PP}$  (100 kHz) square pulse provided to XoX
- Triggering on the square pulse
- Looking at single channels (using probe)

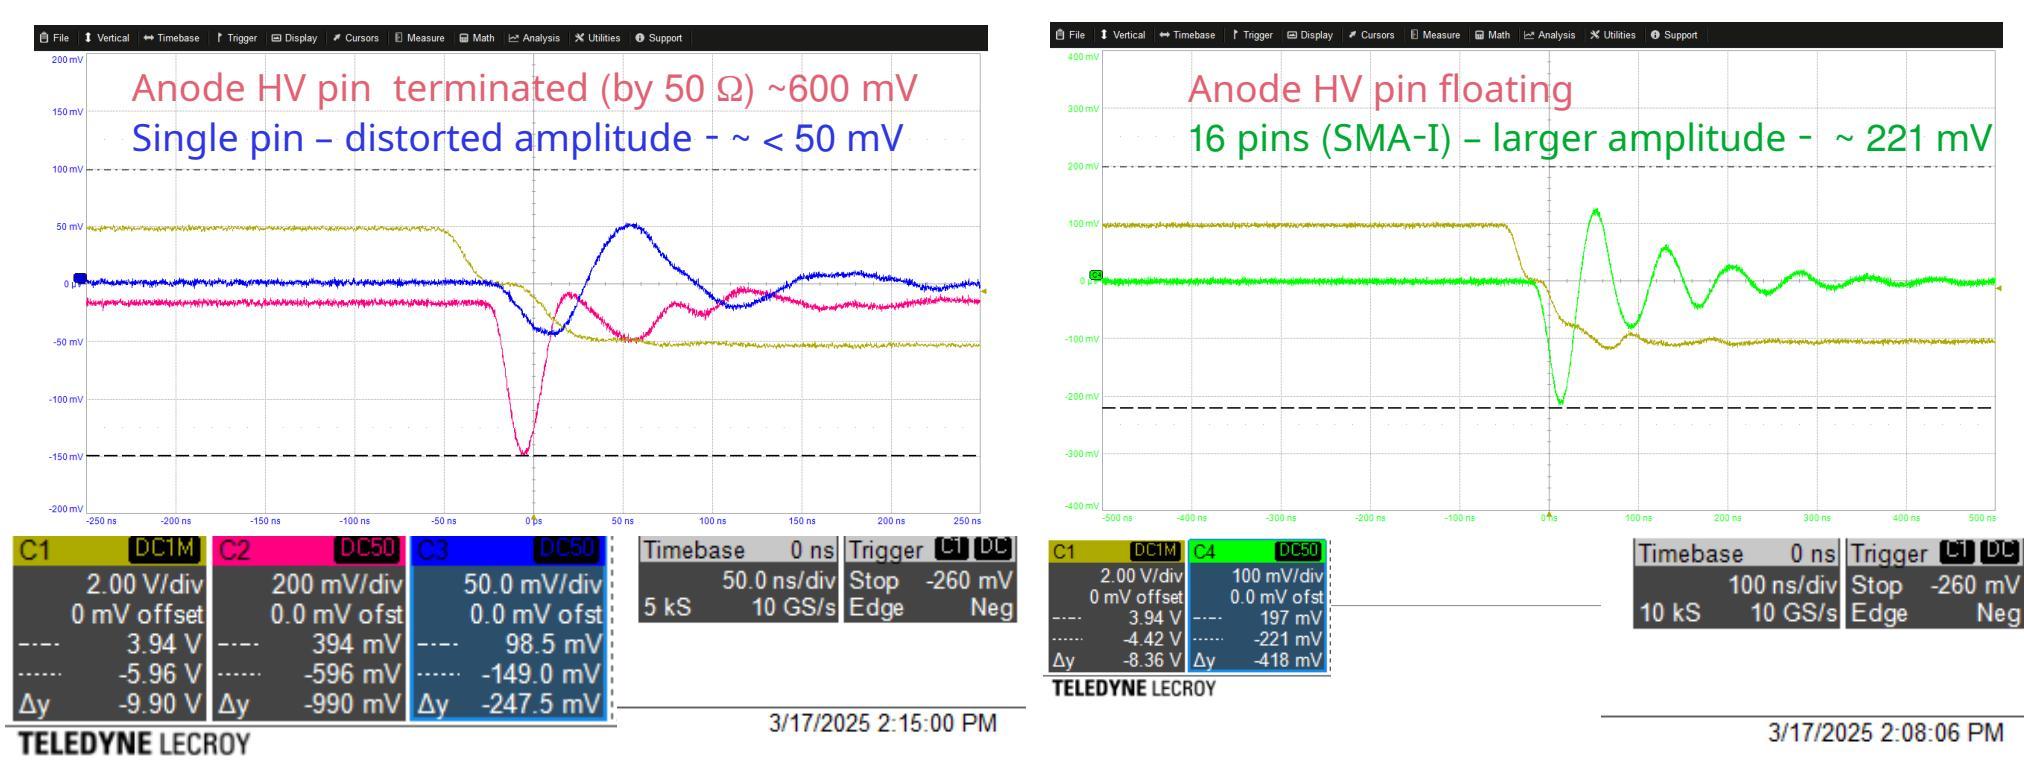
- 2 V<sub>PP</sub> (100 kHz) square pulse provided to XoX
- Triggering on the square pulse
- Looking at single channels (using probe), 16 pads (using SMA-I)

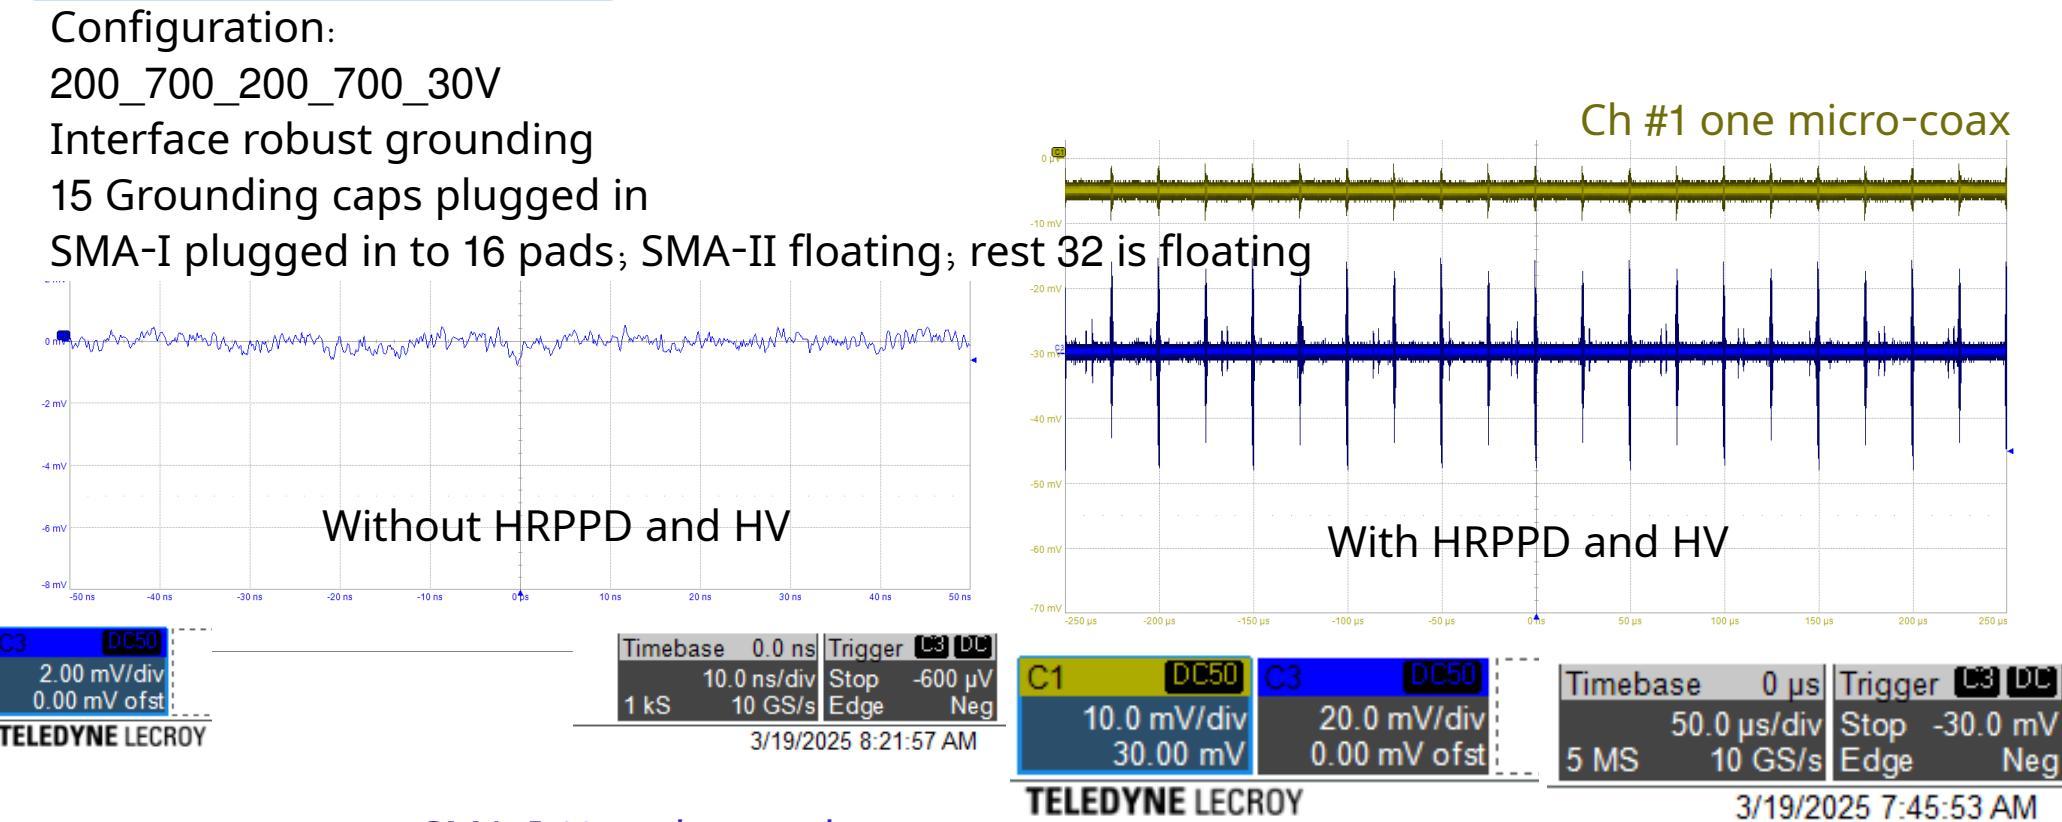
#### SMA-I 16 pads together

Noise level (without HRPPD and HV) ~ 0.6 mV Noise level (with HRPPD and without HV) ~ 40 mV Noise level (with HRPPD and HV) ~ 45 mV
