The tracking detector of the CMS Precision Proton Spectrometer in LHC Run 3

A. Bellora¹, on behalf of the CMS Collaboration

TREDI 2024, Torino, 20th Feb. 2024

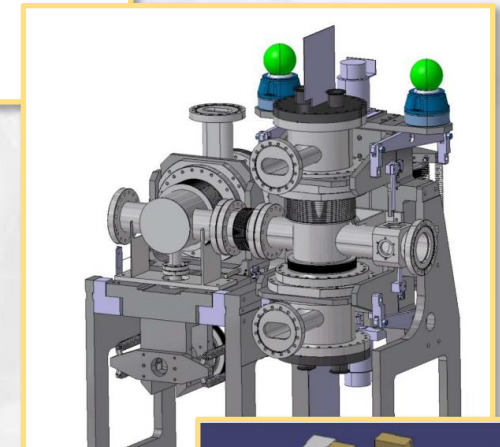
Beam pipe insertions that approach the LHC beam down to ~ 1.5 mm

Detectors on both sides of CMS interaction point in Roman Pots (RPs):

- 4 horizontal RPs: physics data-taking
 - 2 tracking stations: 3D pixels (6 planes each)
 - 2 timing stations: scCVD double diamonds (4/3 planes)
- 4 vertical RPs: alignment runs
 - Legacy TOTEM Si-strips detectors

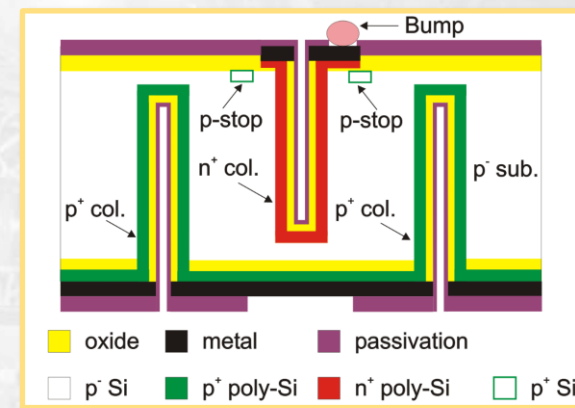
New production of 3D pixels for Run 3:

- Made by FBK, single-sided process
- 150 μm -thick, 5 μm -diameter columns
- 80 μm -thick handle wafer, after thinning
- 150x100 μm^2 pixels, 2x2 matrix of 52x80 pixels
- 13 wafers, 36 2x2 sensors each

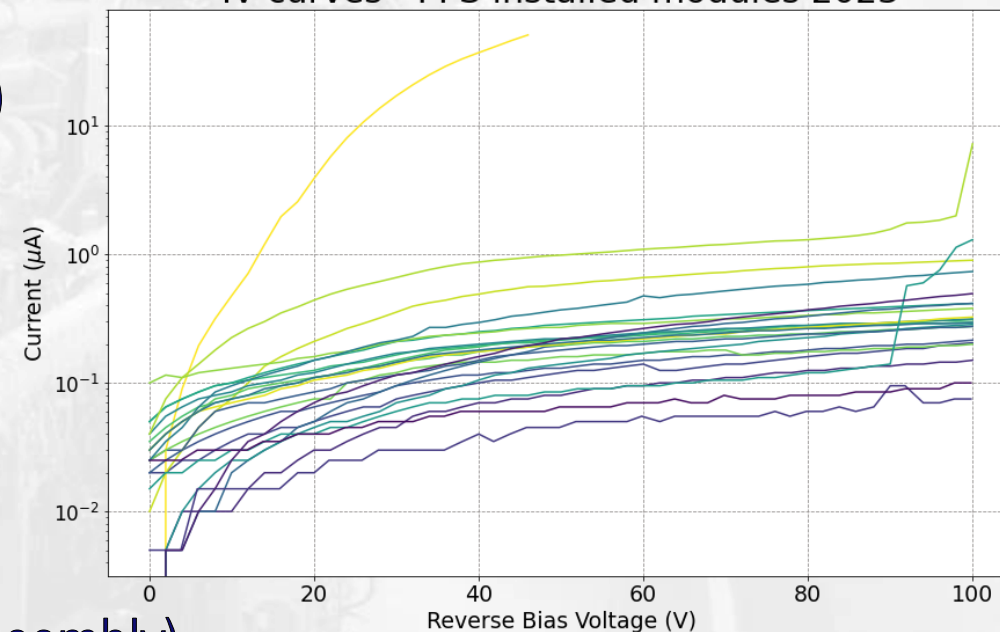
IV curves - PPS installed modules 2023

3 wafers bump bonded to PROC600 chips at IZM

- IV measurement repeated after bump-bonding

24 quad modules installed for data-taking

- One sensor per detector plane
- 22 worked well (2 mechanically damaged during assembly)

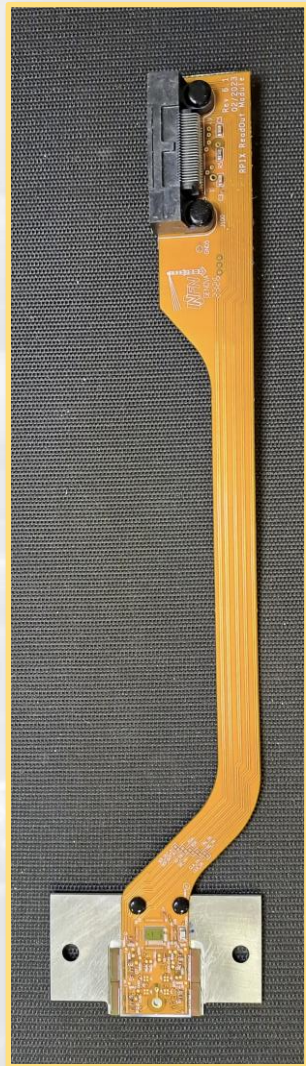
- Each sensor is read out by 4 PROC600 readout chips (ROCs)
 - Same ROC used for the first layer of the CMS pixel barrel
- Sensor+ROC glued to an aluminum plaquette and a flex hybrid forming a module
 - Flex hybrid hosts the Token Bit Manager (TBM10d) to coordinate the ROC data transfer to the back-end
- 6 modules are assembled in a detector package
 - 20° tilt w.r.t. incoming particles
- Each package is connected to a ‘portcard’
 - Motherboard that distributes power, clock, trigger and receives/transmits optical signals from μ TCA back-end
 - ~equivalent to the CMS pixel readout chain

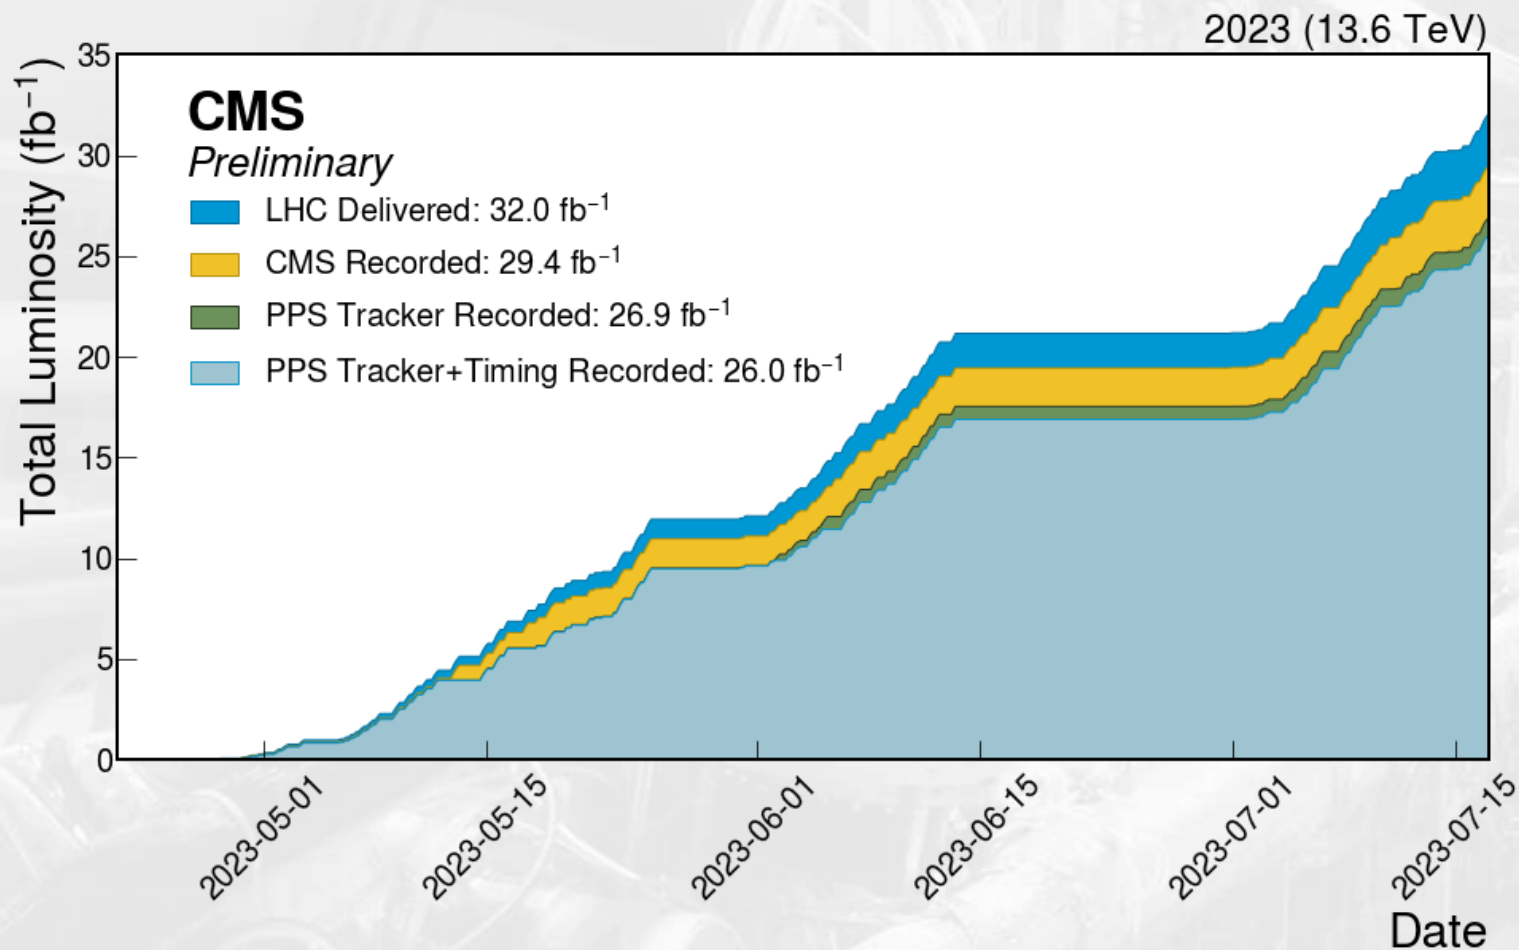
PPS tracker recorded ~ 26.9 fb⁻¹ of data in 2023:

- 84% of total luminosity delivered by LHC
 - Losses mainly caused by the nominal RP insertion delay + 1 LHC fill for testing

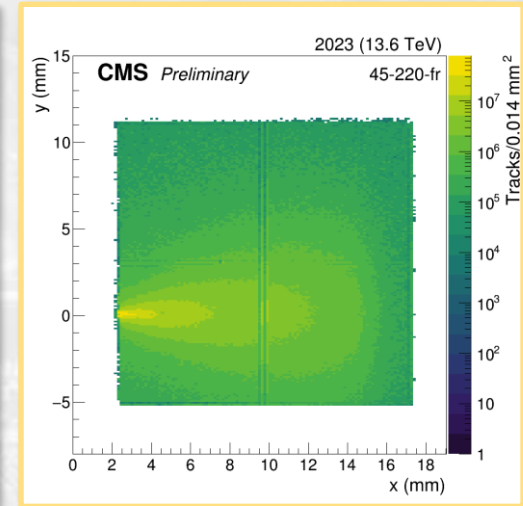
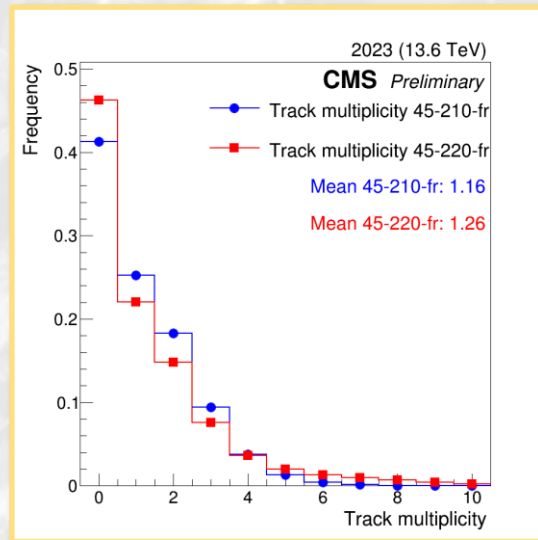
CMS DP-2024/008

Preliminary look at the collected data:

- Non-uniform irradiation visible in the track hit distribution
 - Mainly concentrated close to the beam – at (0,0)
- Higher track multiplicity observed in far stations
 - Protons reaching 220 stations have a higher chance of interacting, producing secondary particles

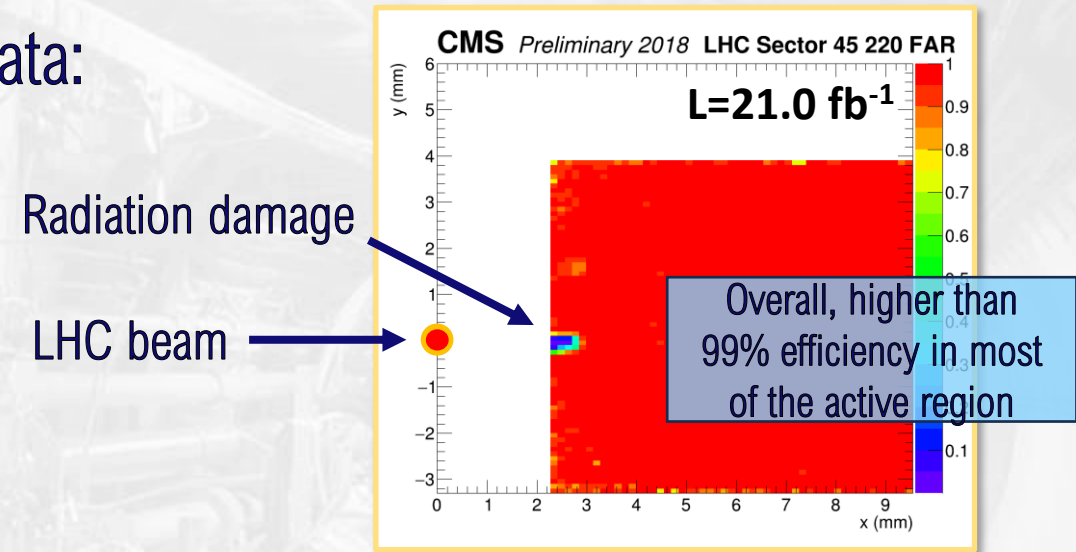
2-step procedure:

1. Estimate the efficiency of each detector plane in a chosen data-taking run
2. Convolve the efficiency of the 6 planes in the detector package to obtain a global track efficiency for the pixel unit, as a function of the track coordinates
 - Proton tracks are mostly parallel, no strong dependence on their angle is observed

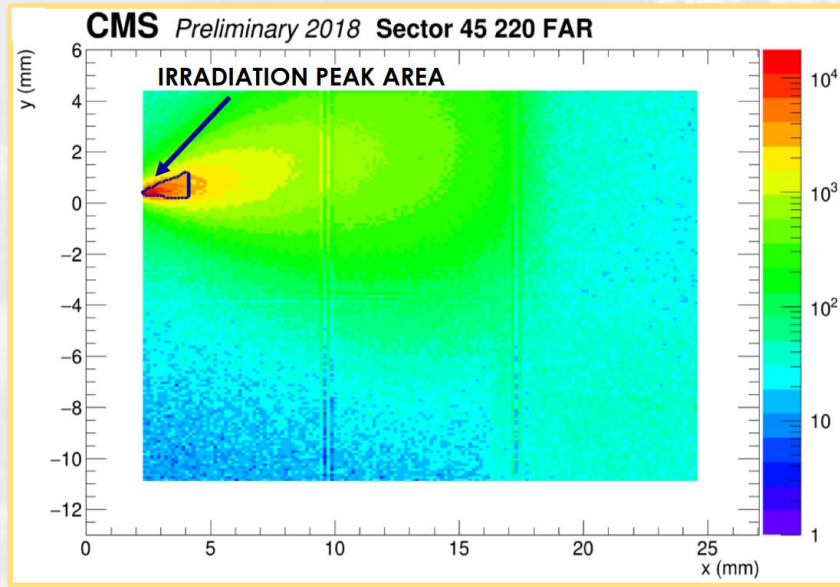
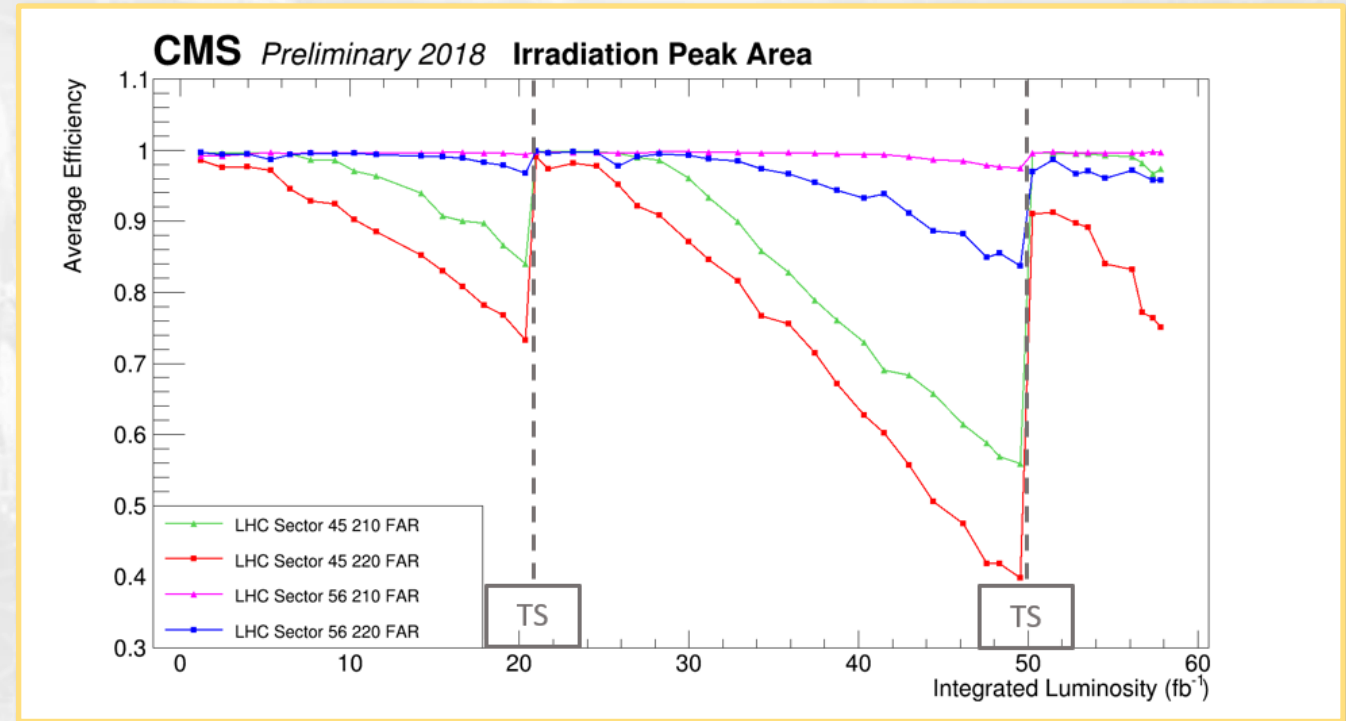
Average efficiency in the irradiation peak studied in Run 2 (2018):

- Differences in efficiency loss mainly due to different irradiation profiles in the stations
- Proved that the manual vertical shift effectively mitigated the loss of performance

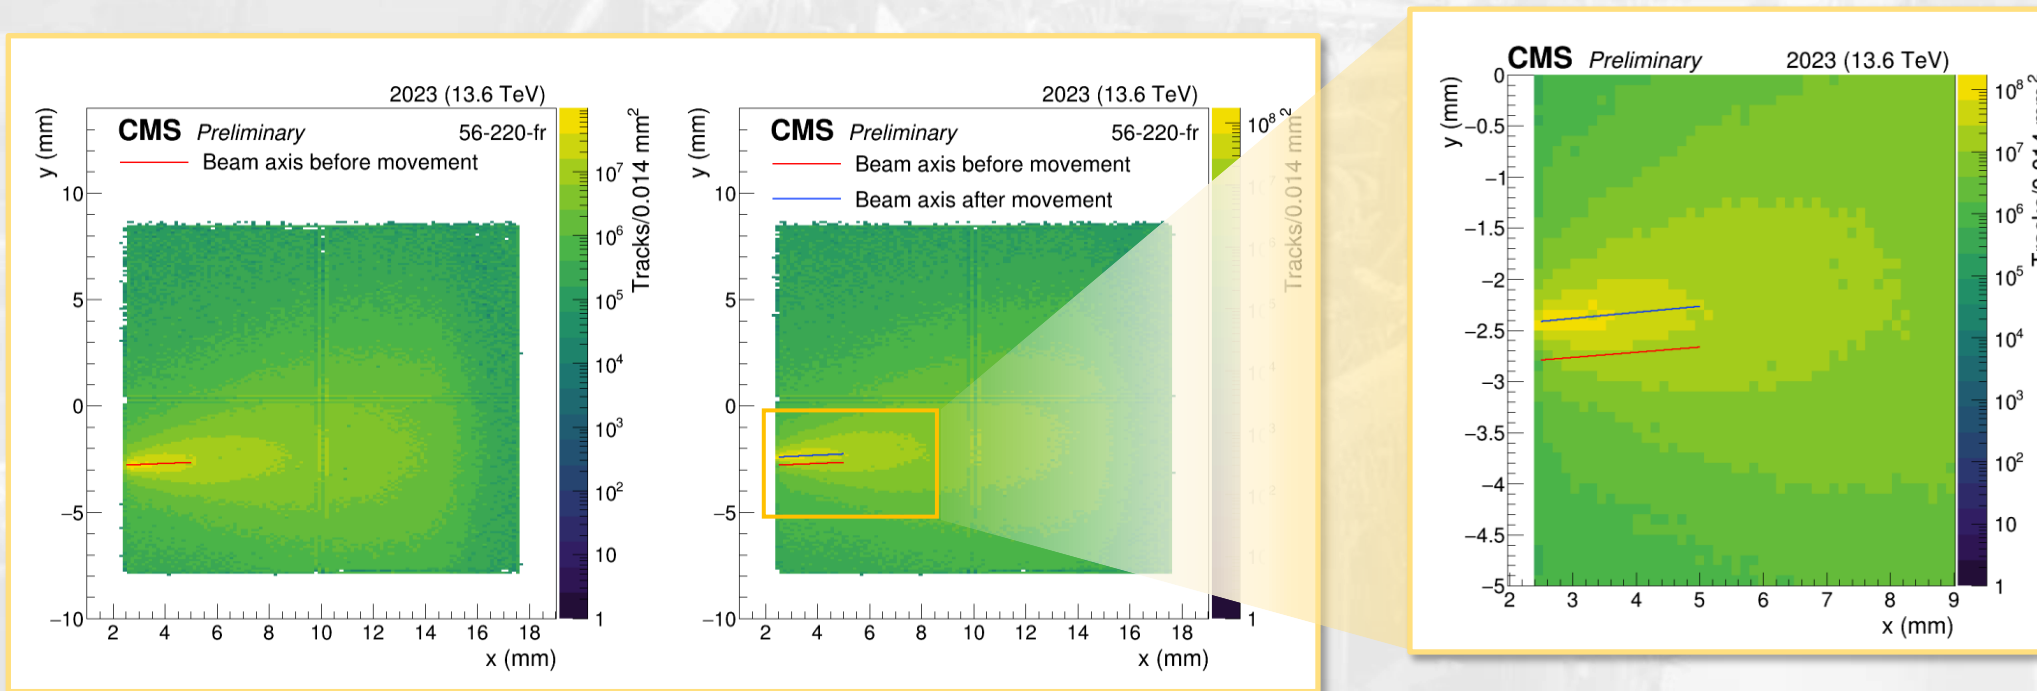
Initial movement strategy: move all stations every $\sim 10 \text{ fb}^{-1}$ by $\sim 500 \mu\text{m}$

- Two movements performed in 2023 after $\sim 8.8 \text{ fb}^{-1}$ and 18.5 fb^{-1}

Vertical shift verified and confirmed using the track hit distribution in physics runs

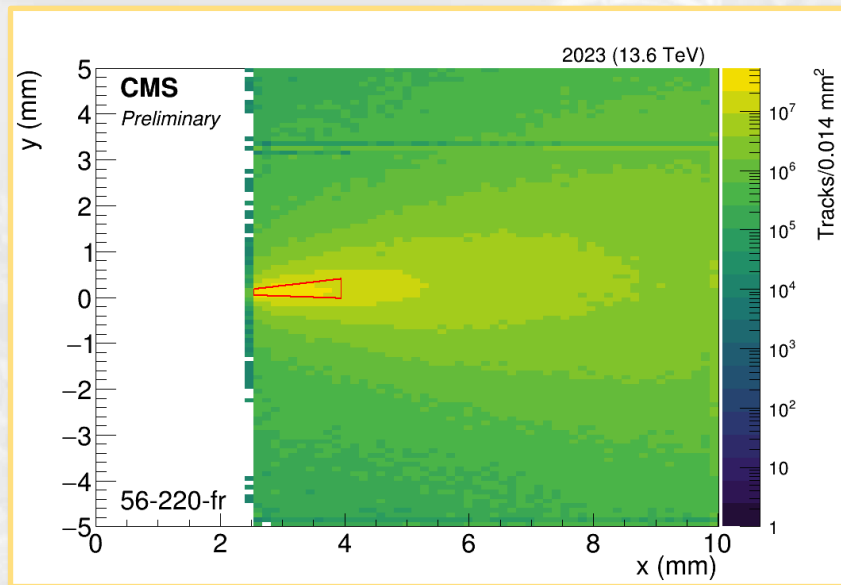
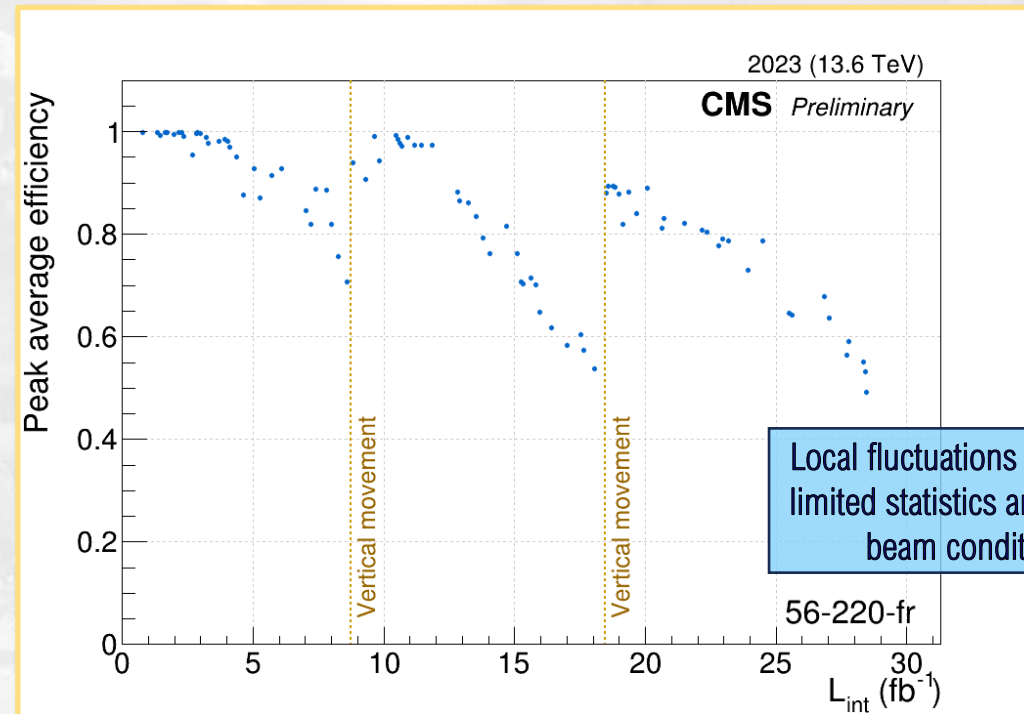
Preliminary results on the average efficiency in the irradiation peak region:

- The movement assures the recovery of the detector performance
 - Incomplete recovery after the second movement due to the damage still overlapping with the most irradiated region
 - A movement strategy implementing larger (or more frequent) movements could reduce this effect
