Test on PMMA vessel

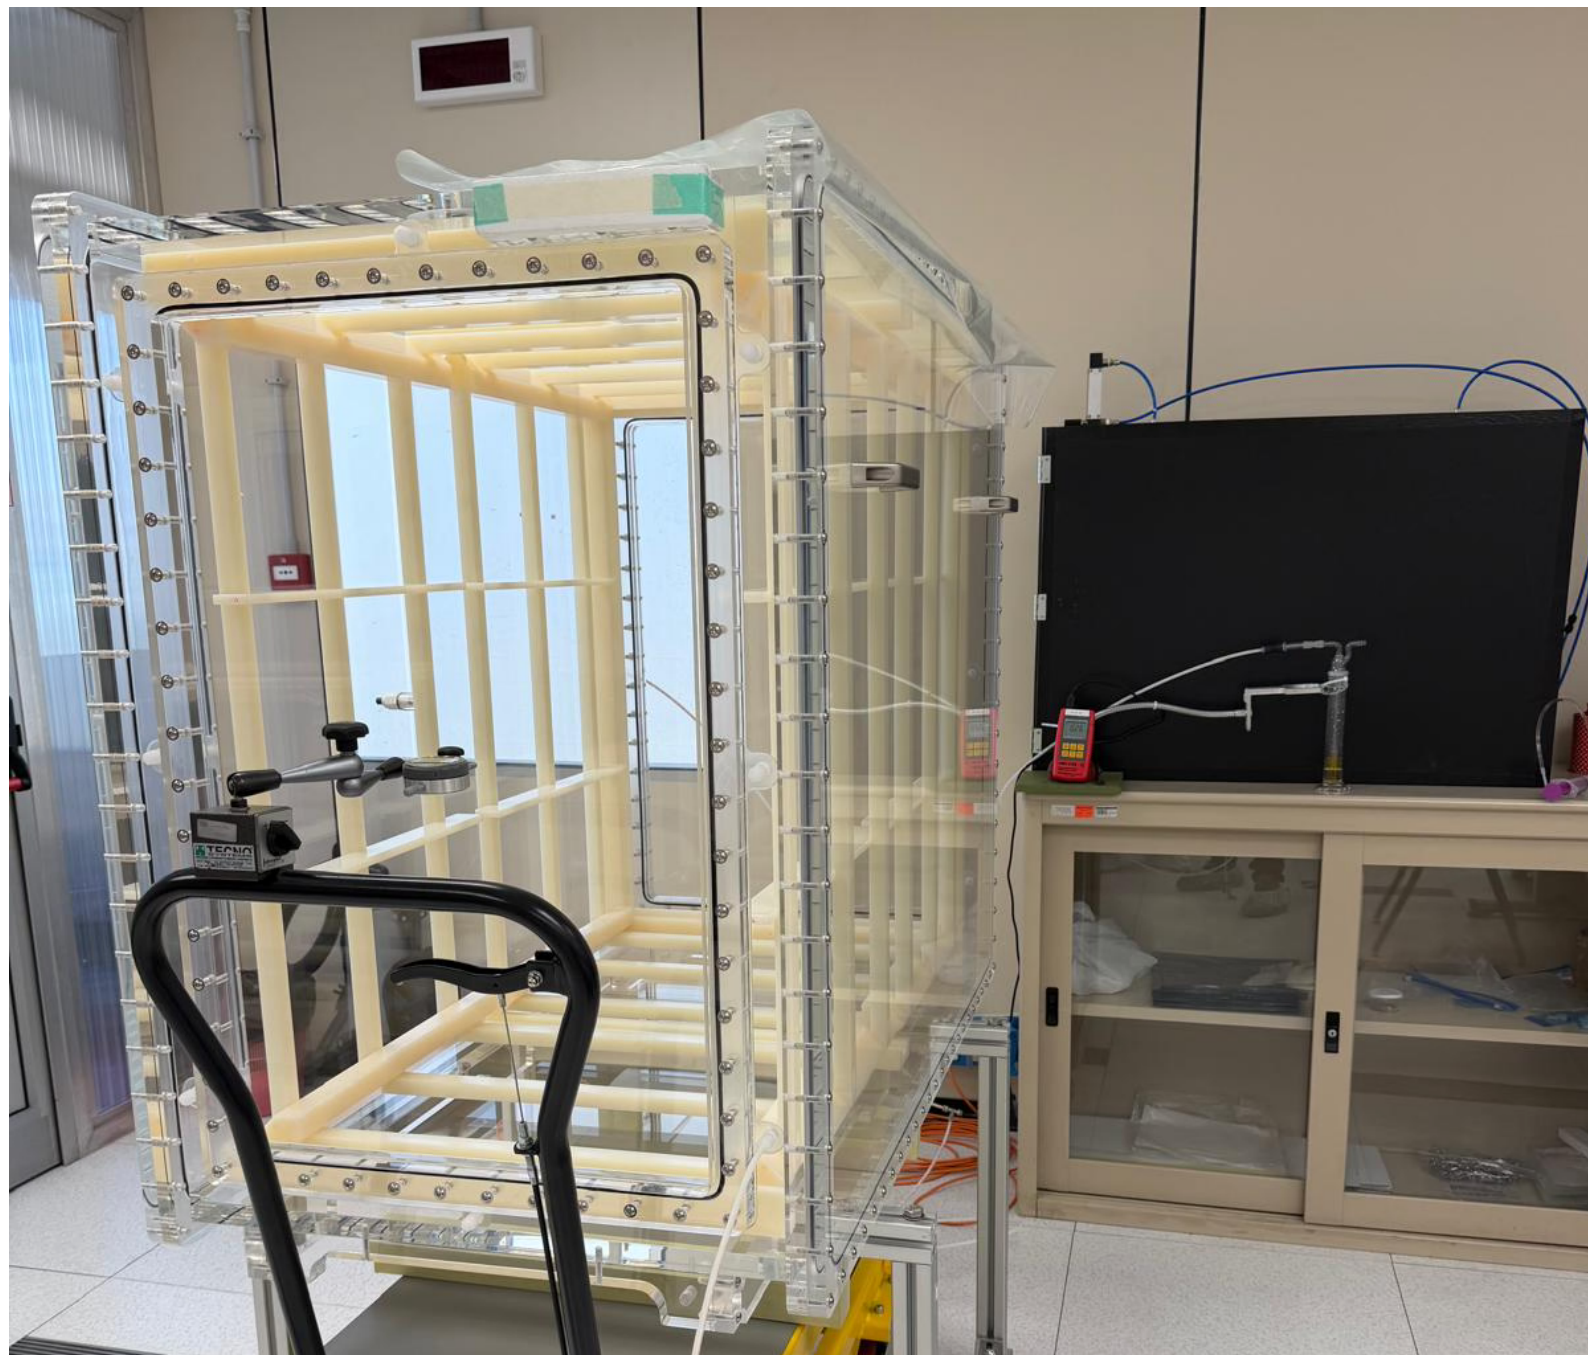
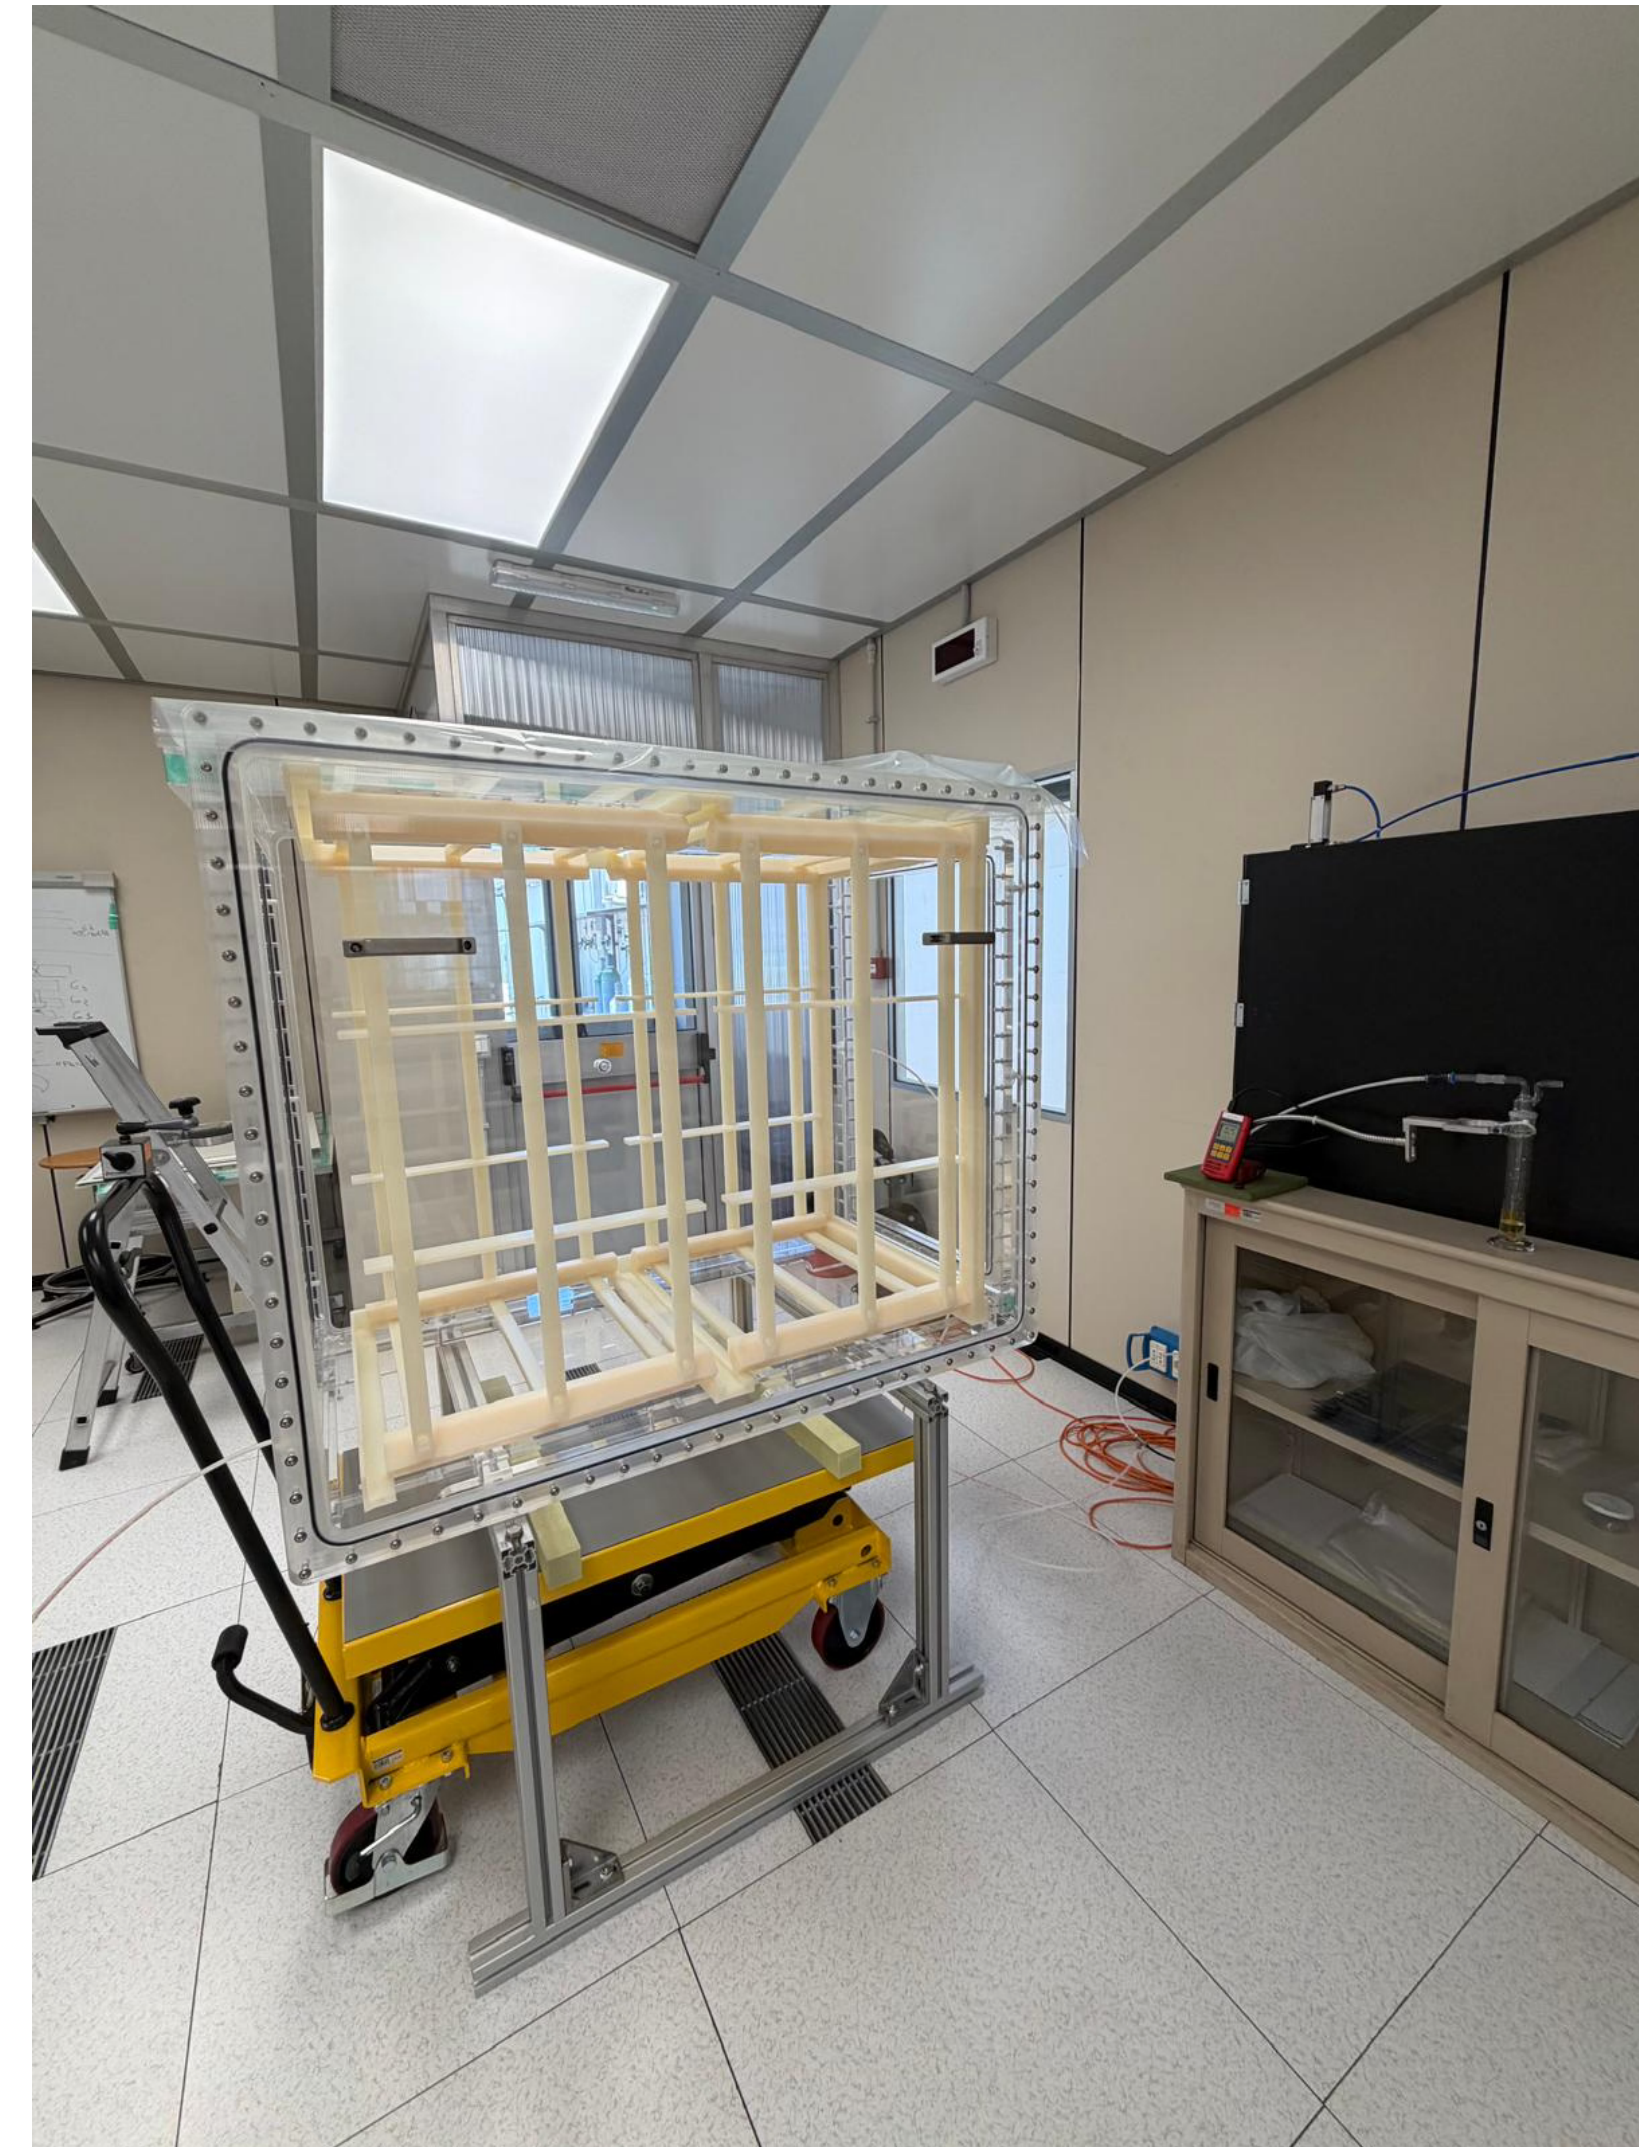
Gas Leakage

- The small leakage found on the HV flange was successfully fixed;
- The leakage of the “full” vessel is well below 1 cc/min

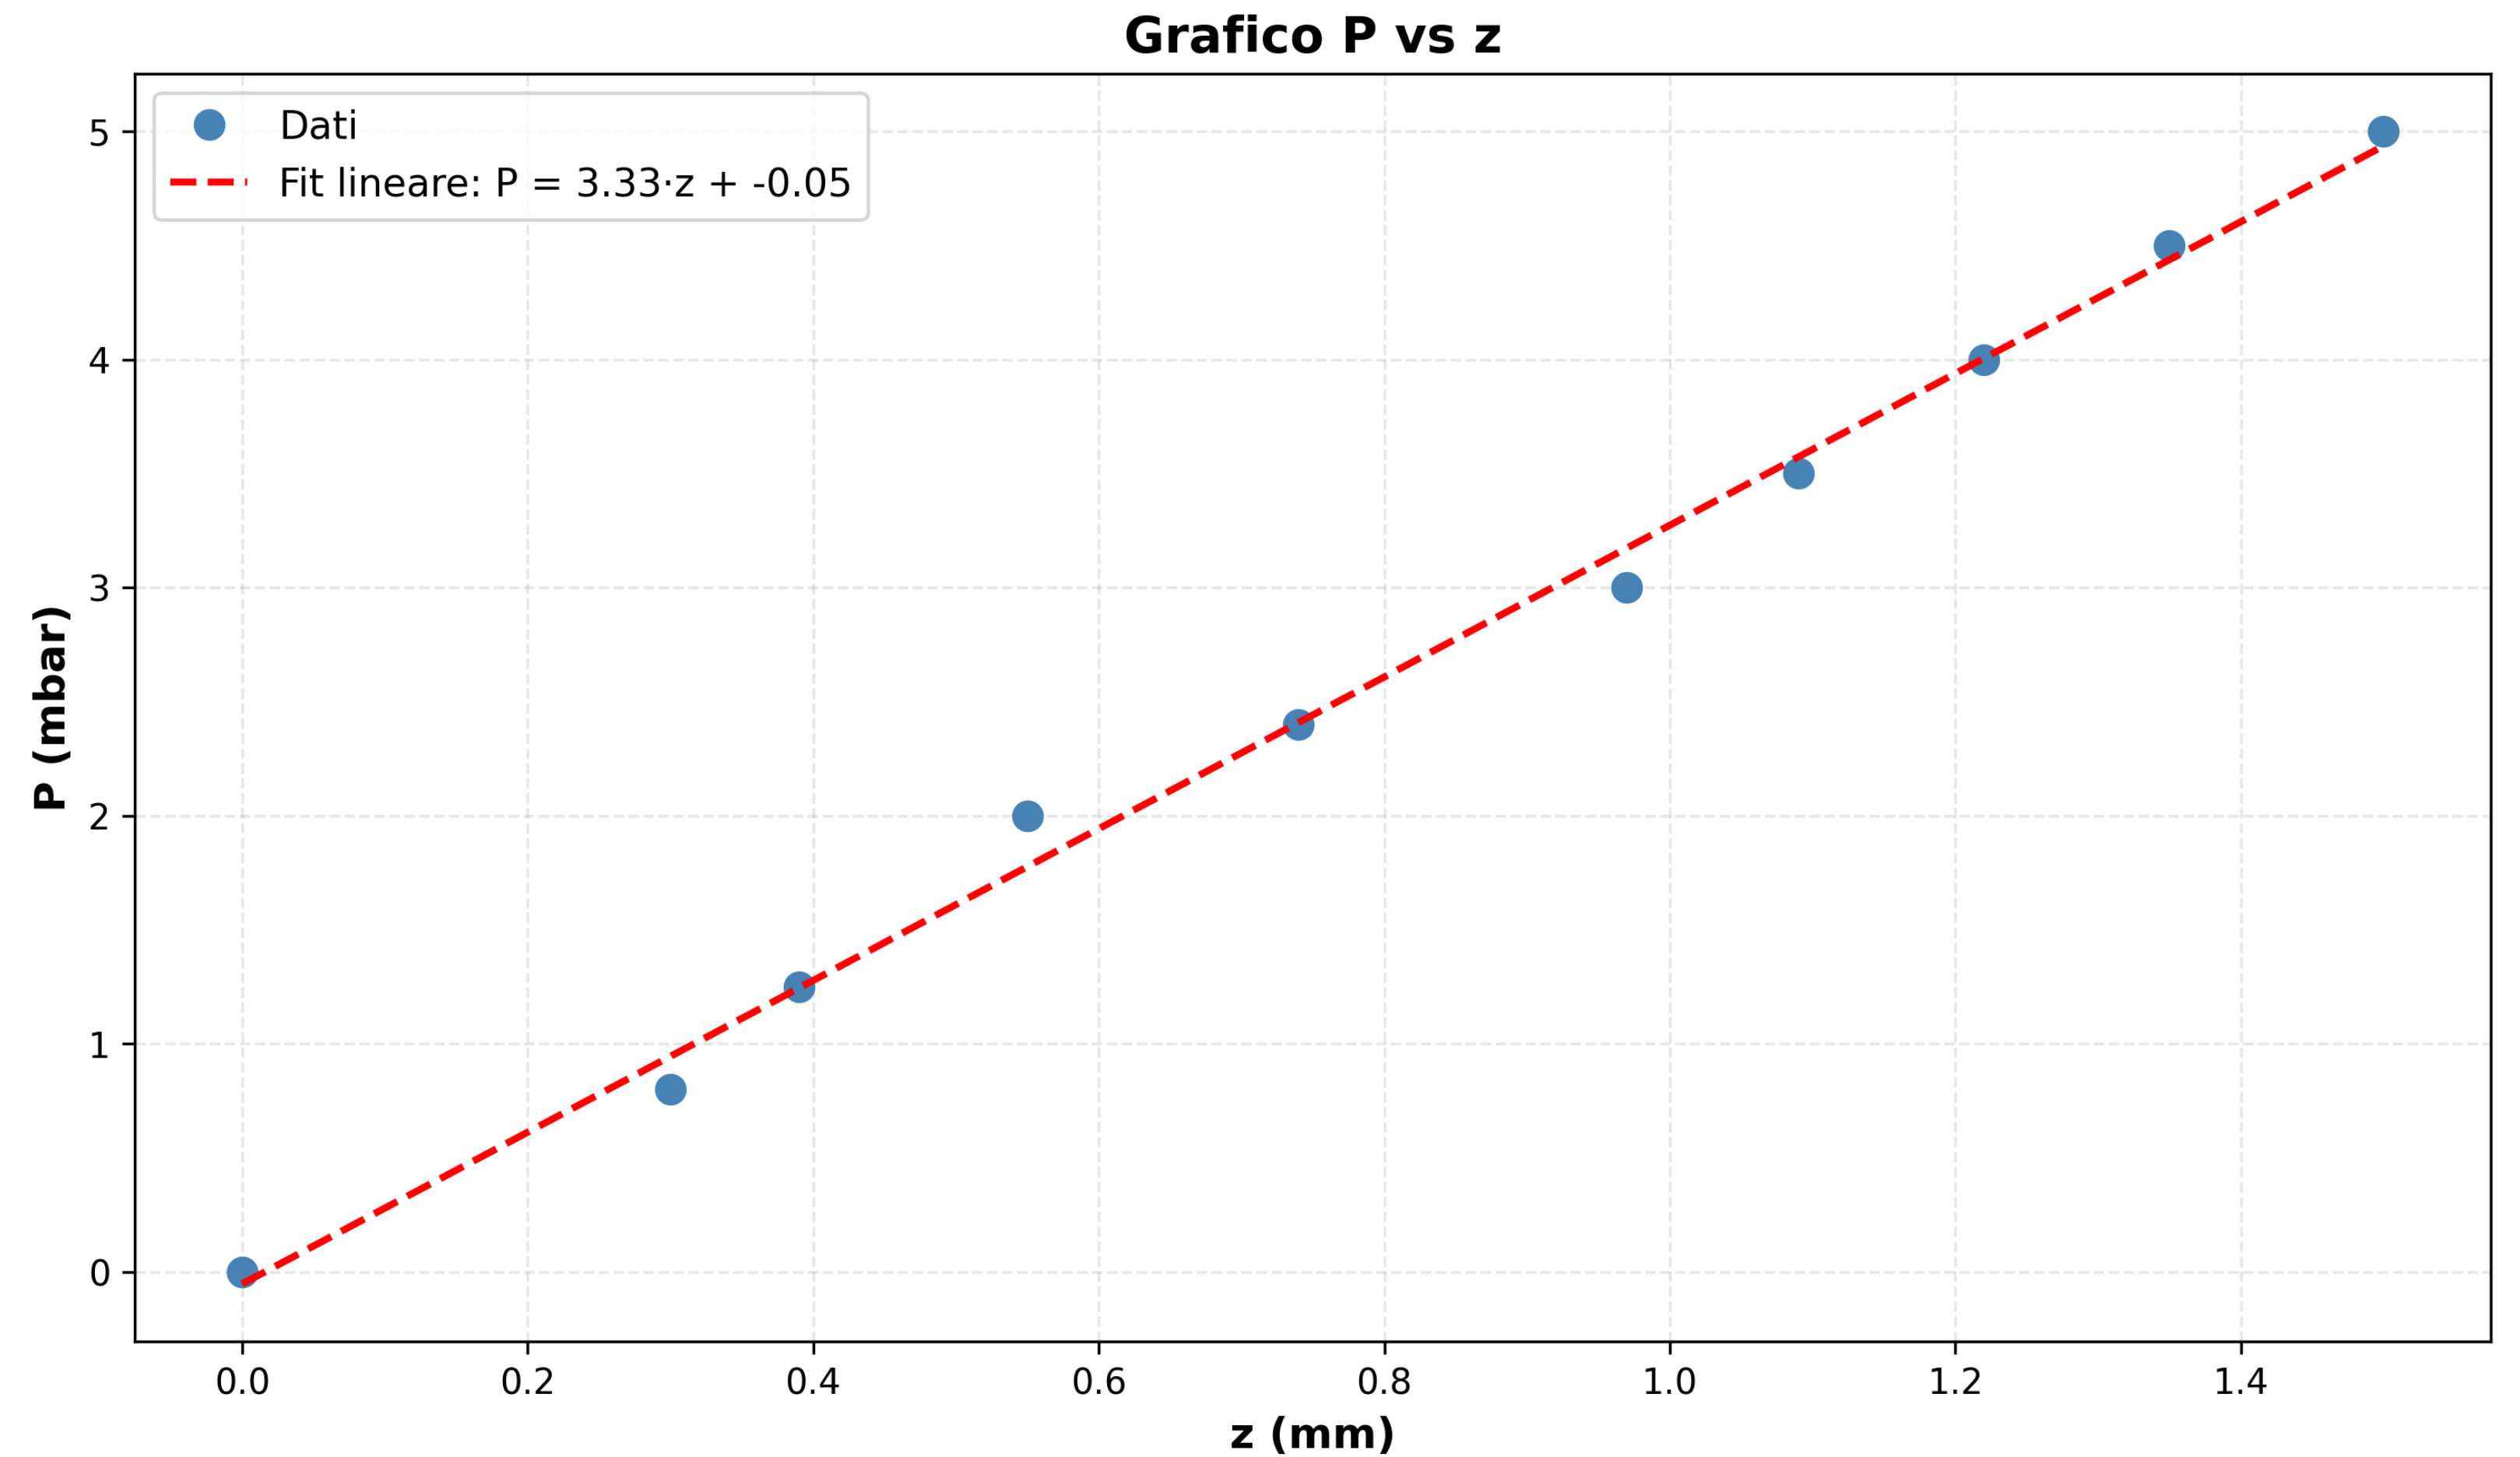
Overpressure

The optical window sagitta was tested as a function of the difference between internal and external pressure:

- up to 5.0 mbar a linear response was found
